NIST NCSTAR 1-9

**Federal Building and Fire Safety Investigation of the
World Trade Center Disaster**

**Structural Fire Response and
Probable Collapse Sequence of
World Trade Center Building 7**

VOLUME 2

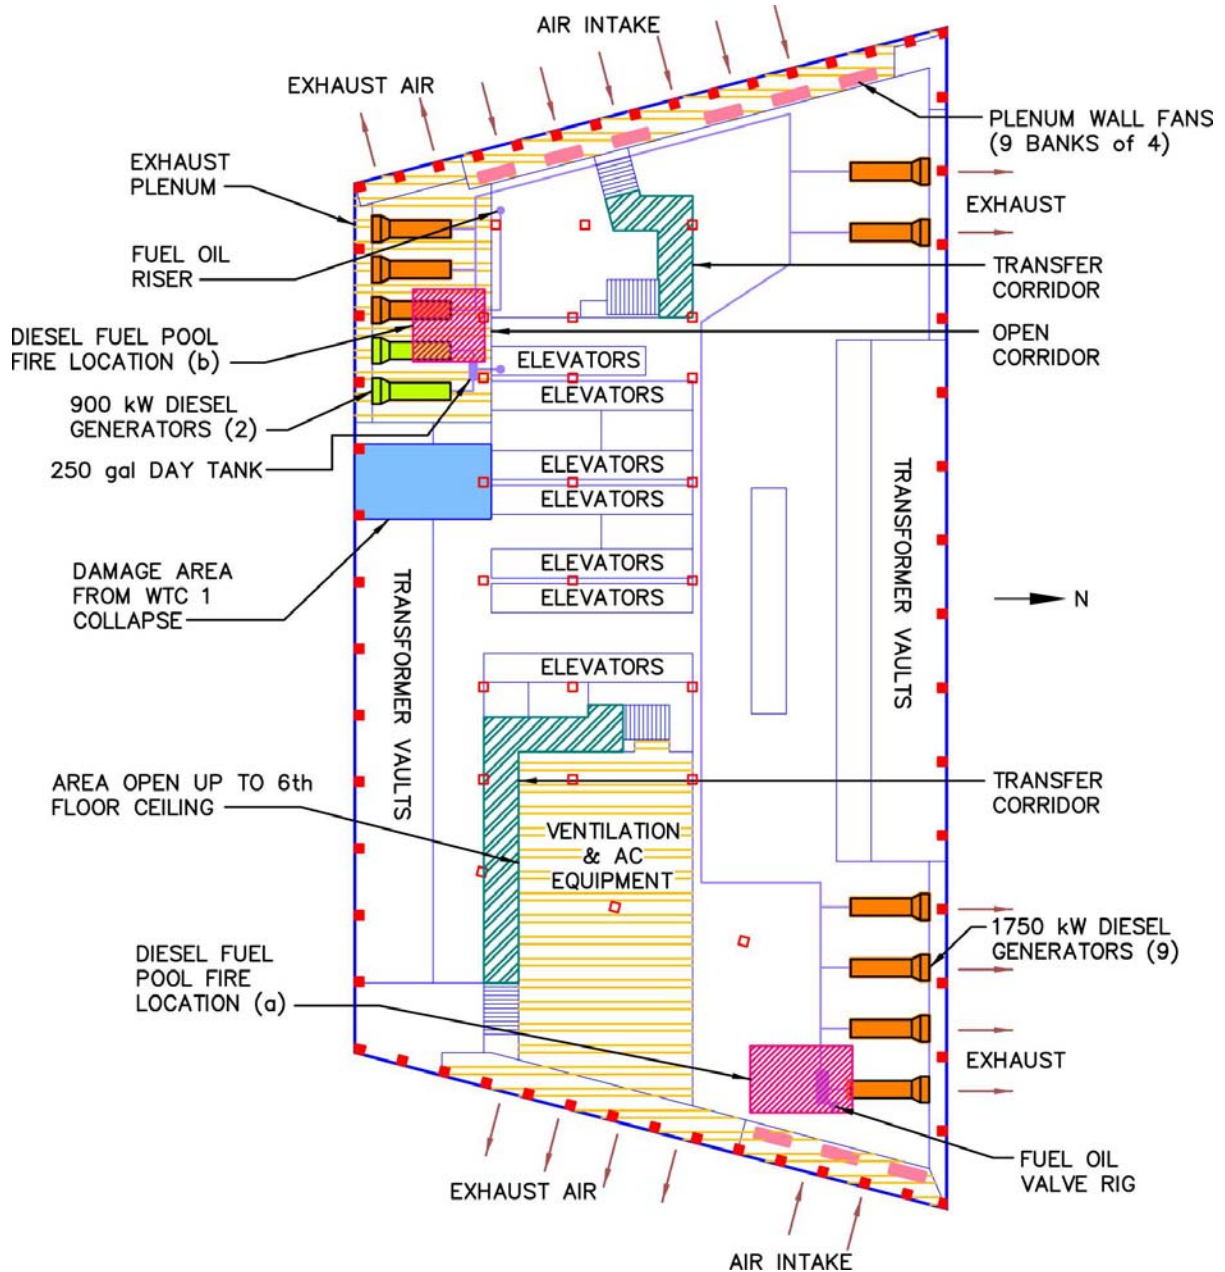
Figure 9–1. Plan view of the 5th floor, including estimated debris damage from WTC 1.

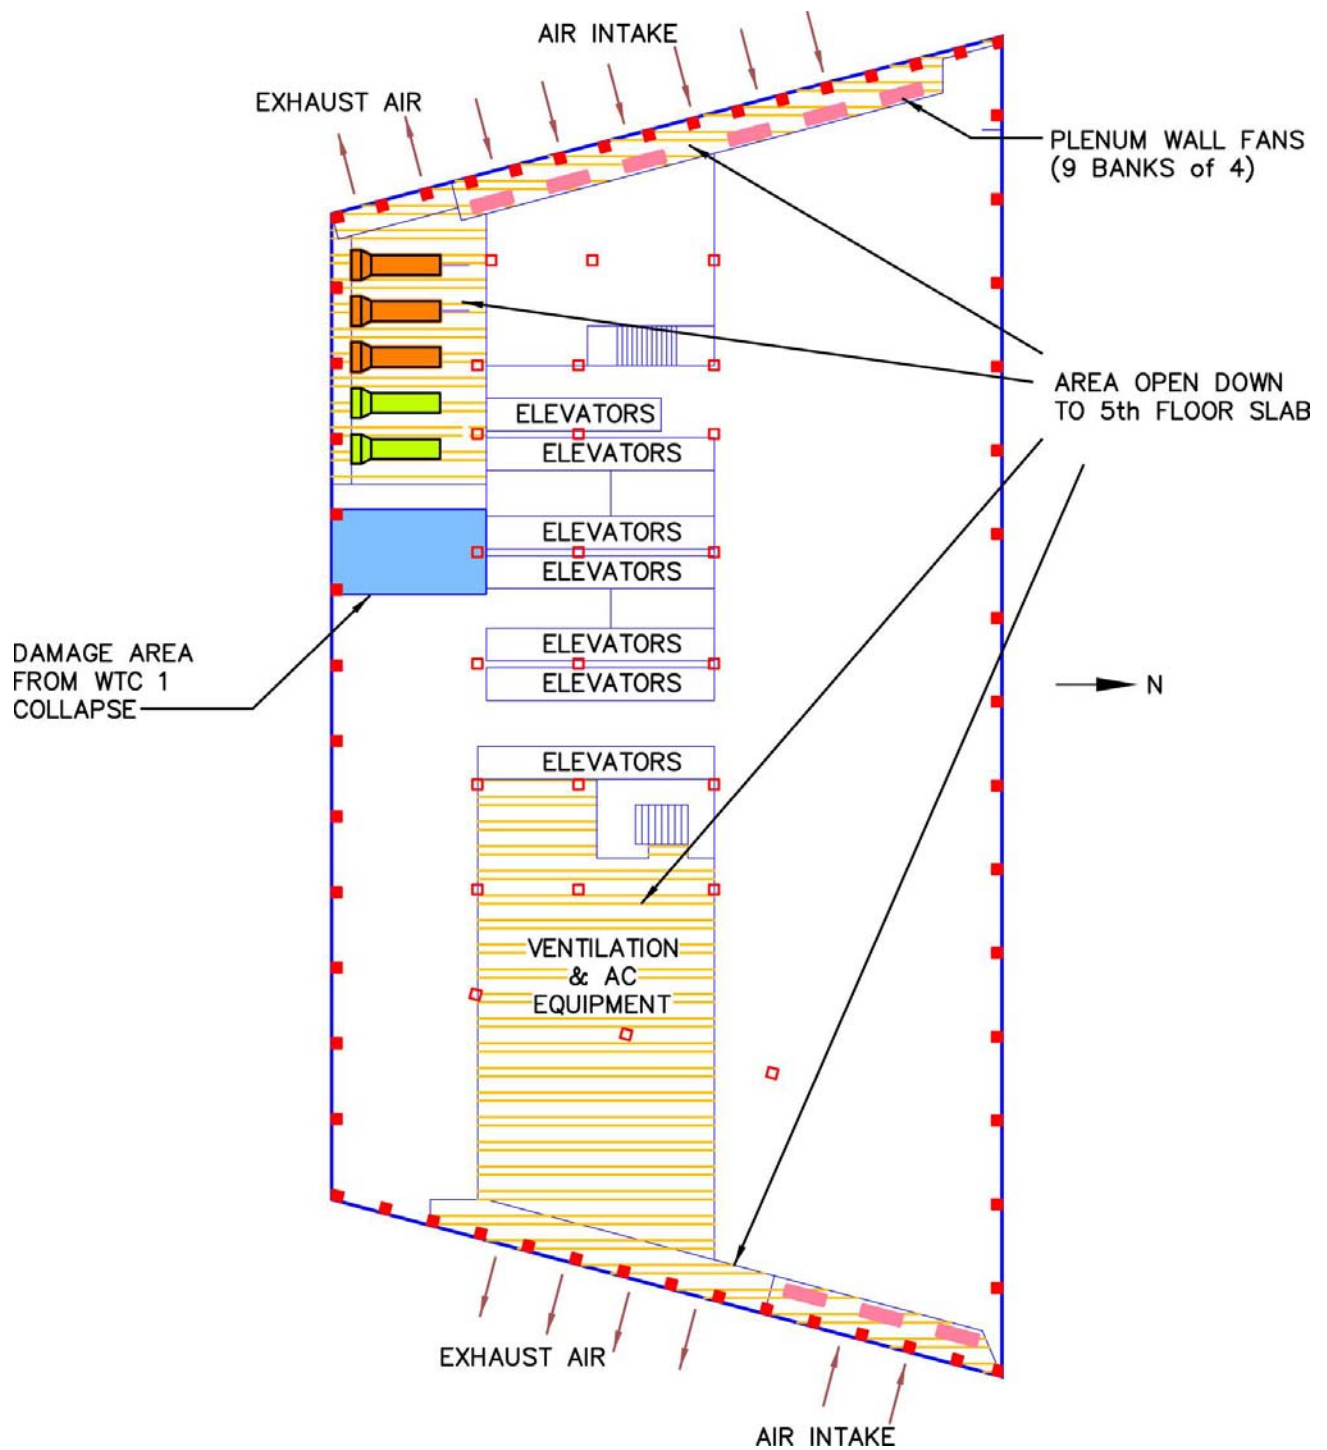
Figure 9–2. Plan view of the 6th floor, including estimated debris damage from WTC 1.

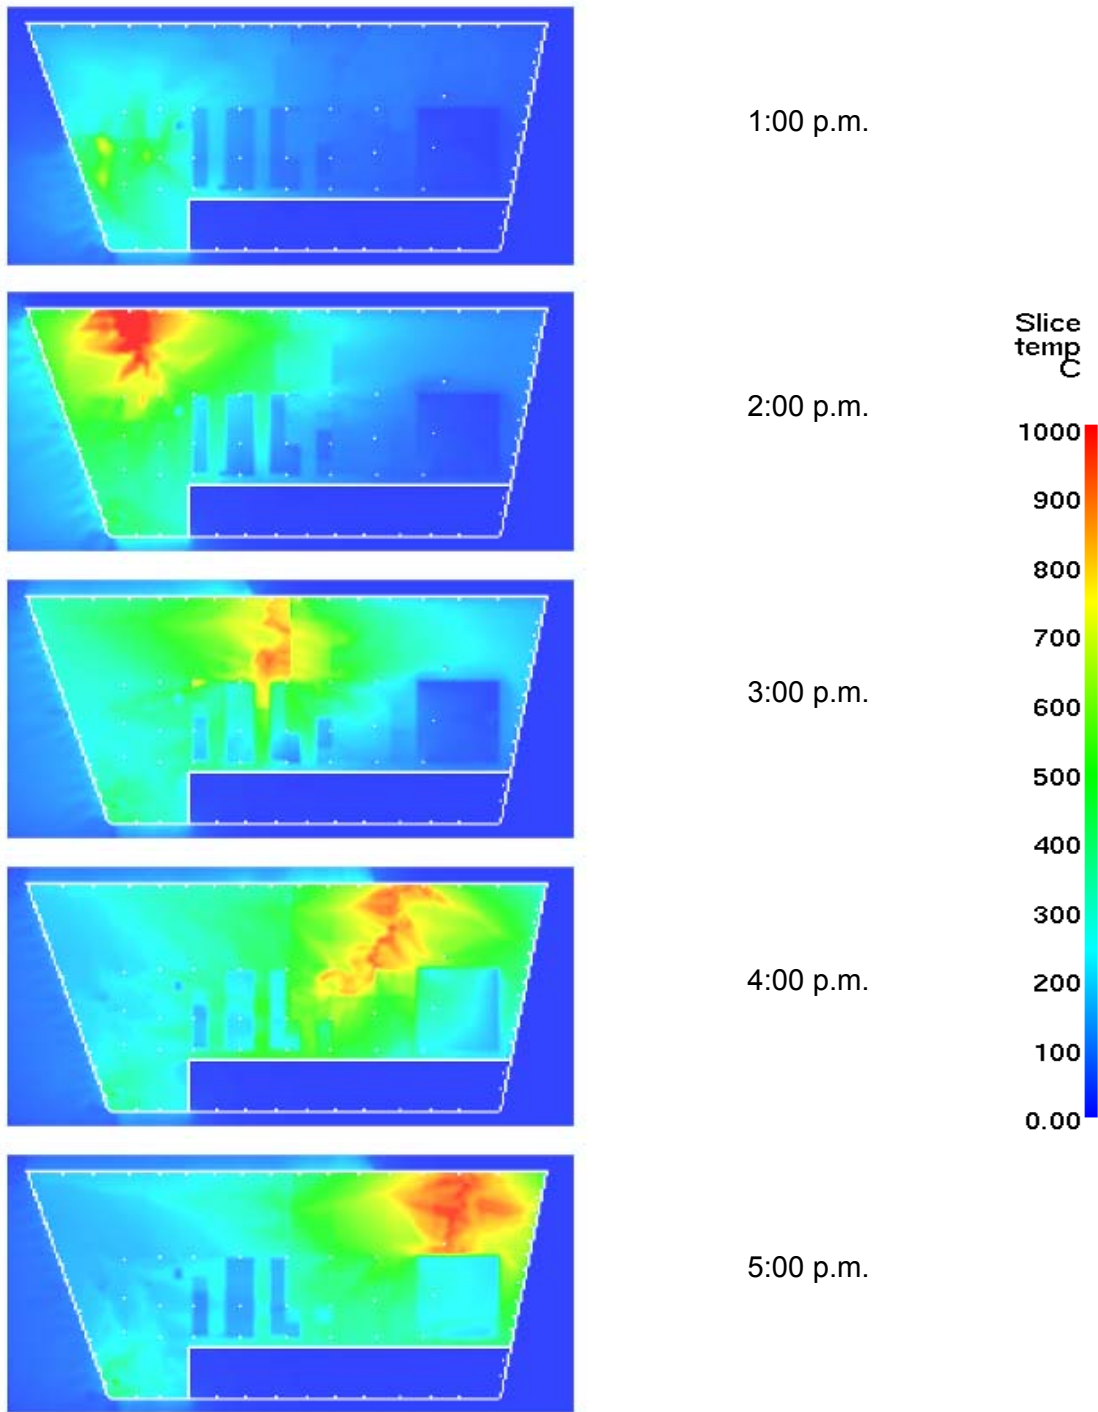
The spread rate and intensity of the observed fire and the simulated fire were similar. The simulated fire reached the north face of the building a little later and spread a little more slowly to the east than the visuals indicated. (Note that the start time of the simulated fires was defined as 12:00 p.m., for lack of visual evidence, and that the visuals only indicated burning near the windows, not in the building interior.) The principal difference between the photographs and the simulation was that, unlike the actual fire on Floor 7, which stopped and then flared up to the east, the simulated fire slowed briefly near the middle of the north face and then continued toward the east. (There were office walls in this vicinity, but doors were left open in the simulation, and the fire eventually passed through the middle section of the building and moved to the east face, where it finally consumed the remainder of the furnishings.) The effect of these differences on the thermal environment would have been small.

Figure 9–9. Progression of simulated fire on Floor 7 of WTC 7.
Shown are upper layer temperatures.

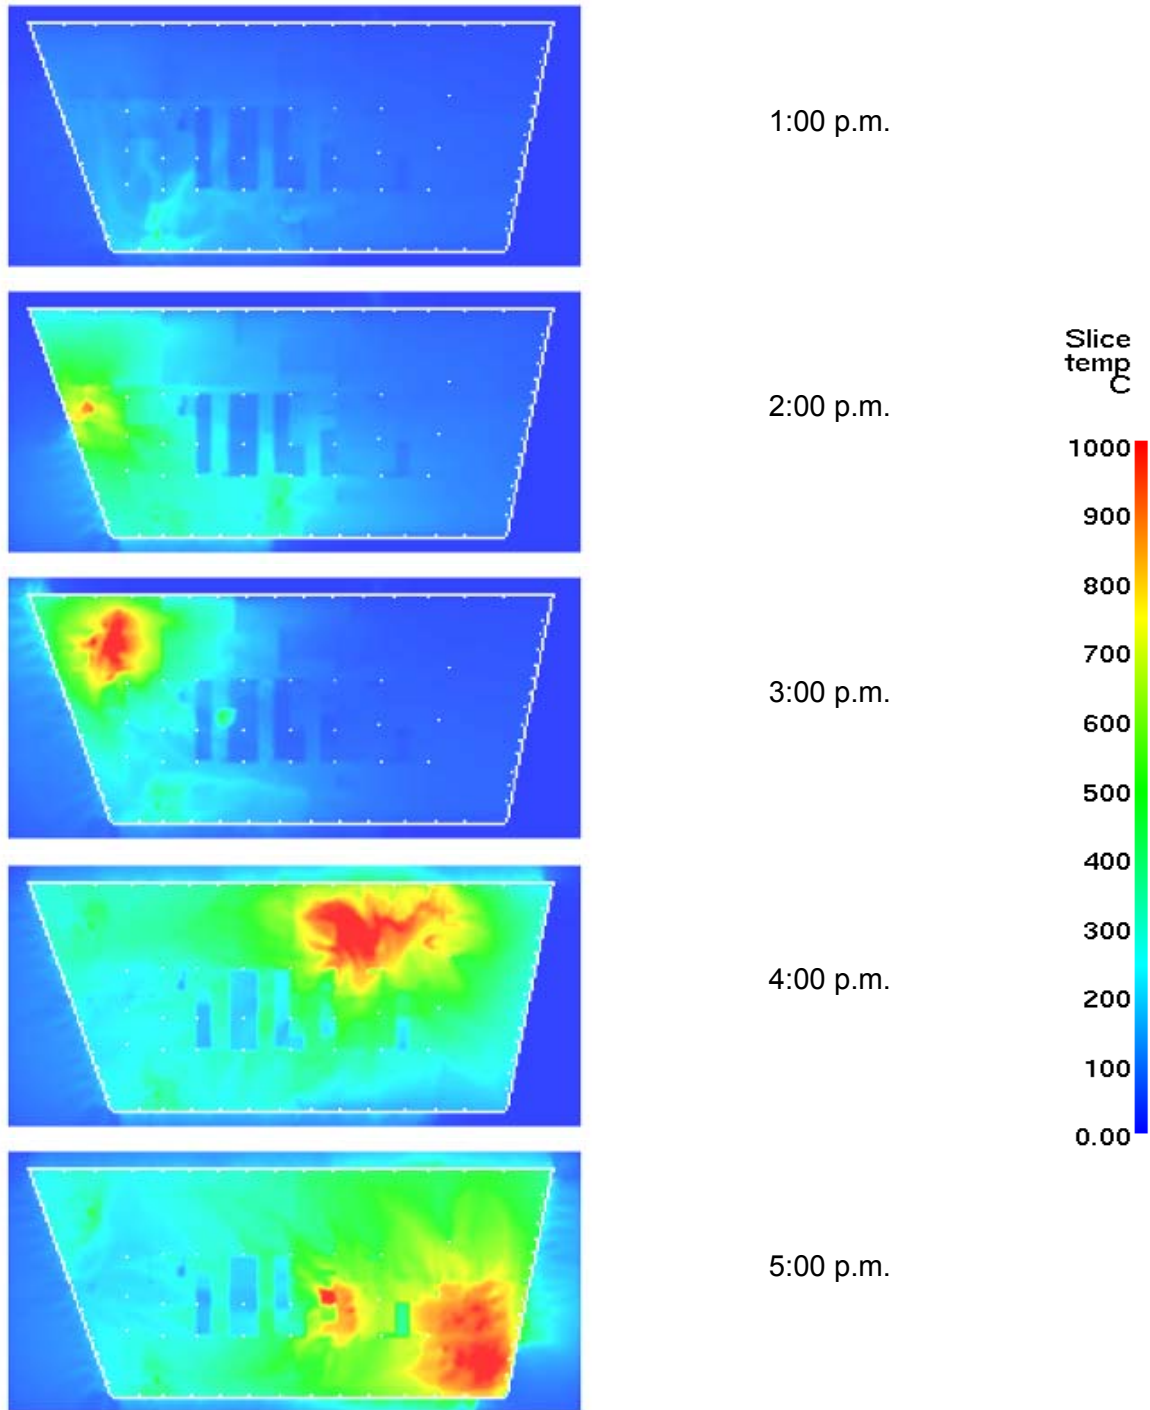
Between 4:00 p.m. and 4:40 p.m., the progress of the simulated fire matched the visual evidence. The simulation added descriptions of the fires prior to and subsequent to this period. Since the fire physics should have been similar to that on the 7th and 8th floors, the overall fire progress on the 9th floor was assumed to be of the same accuracy as the fires on the two floors immediately below, despite the lack of visual corroboration.

Figure 9–10. Progression of simulated fire on Floor 8 of WTC 7.
Shown are upper layer temperatures.

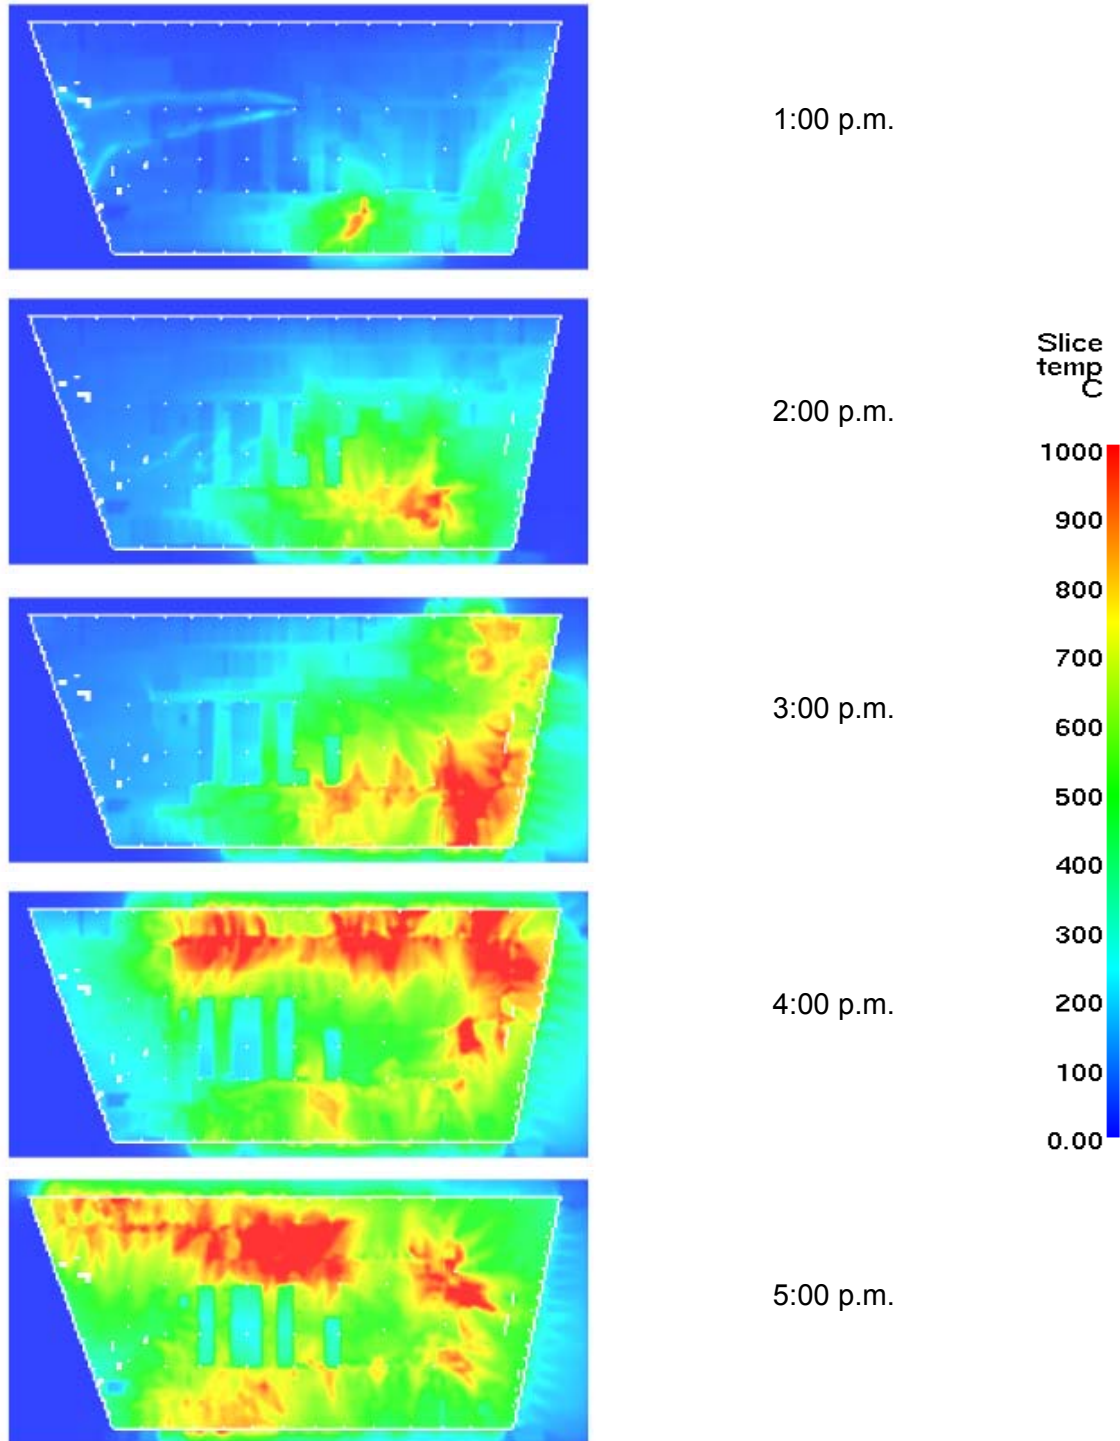
Figure 9–11. Progression of simulated fire on Floor 12 of WTC 7.
Shown are upper layer temperatures.

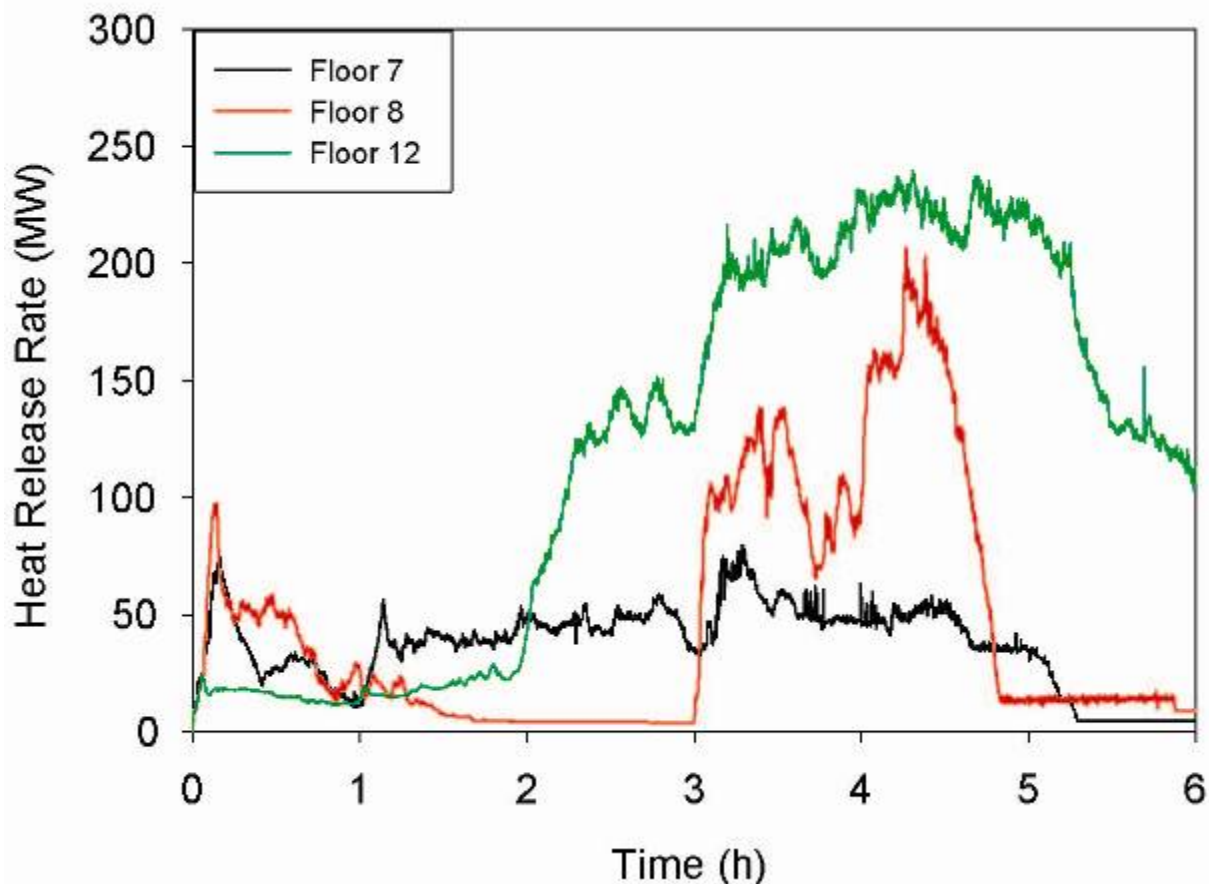
In the computations, the fire on the 12th floor, and thus the derivative fires on the 11th and 13 floors, generated significantly more heat than the fire on the 7th or 8th floor. This was in large part due to the higher fuel load in the simulations and the larger burning area of the Floor 12 fires.

Figure 9–13. Rates of heat release of simulated fires in WTC 7.

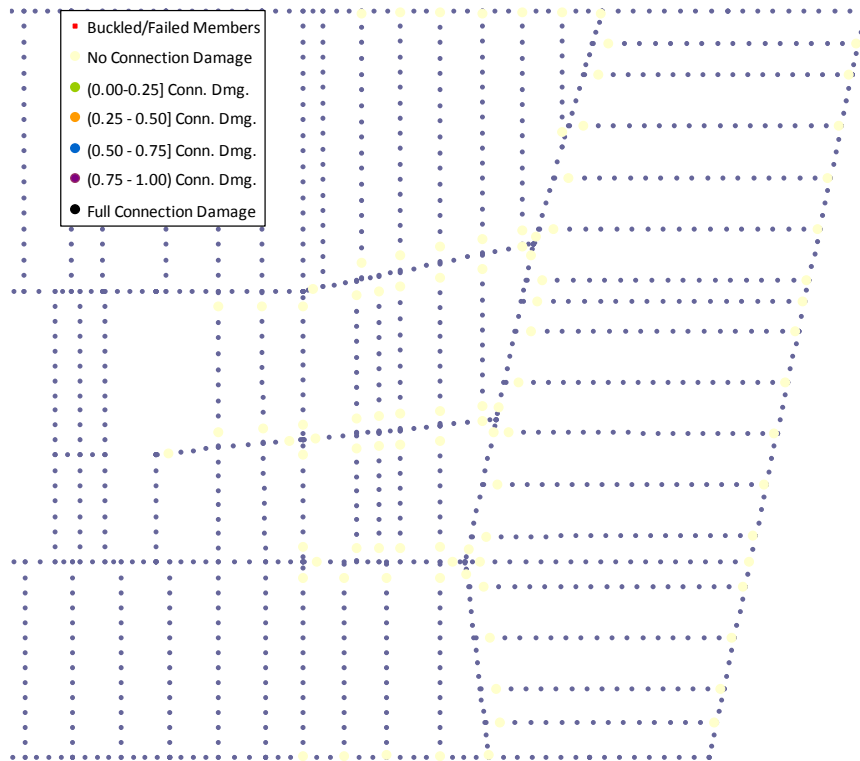
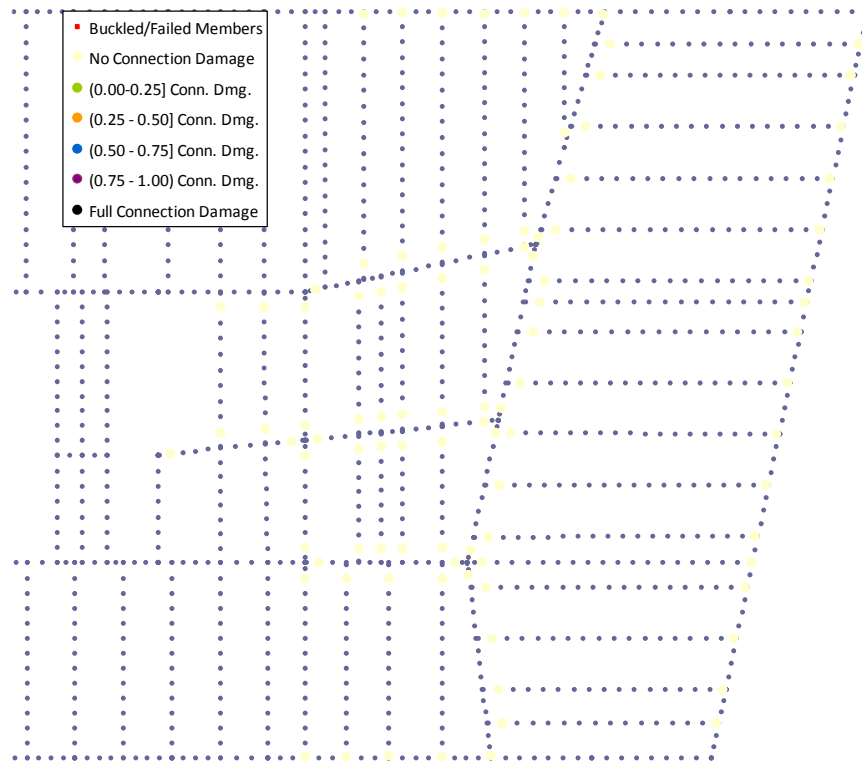
Figure 11–40. Damage state of connections, beams, and girders in Floor 9 at 4.0 h for Case C temperatures.

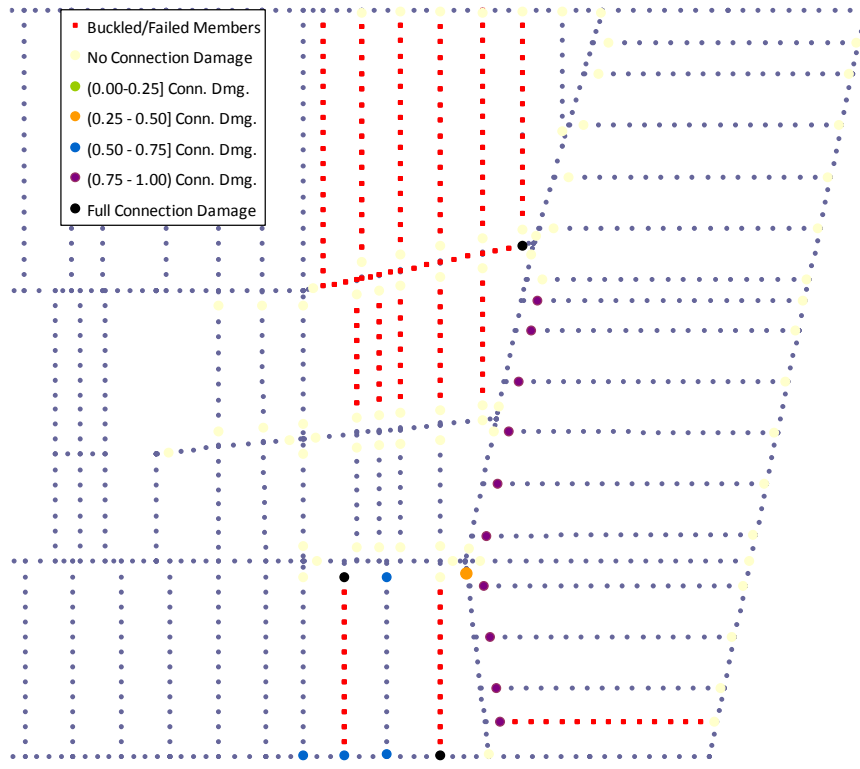
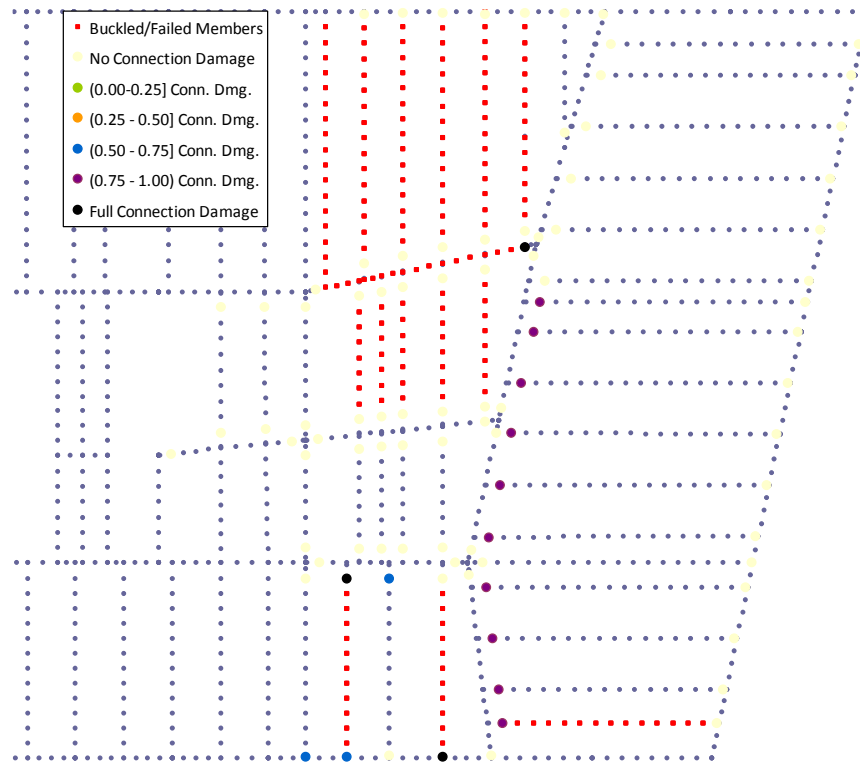
Figure 11–41. Damage state of connections, beams, and girders in Floor 10 at 4.0 h for Case C temperatures.

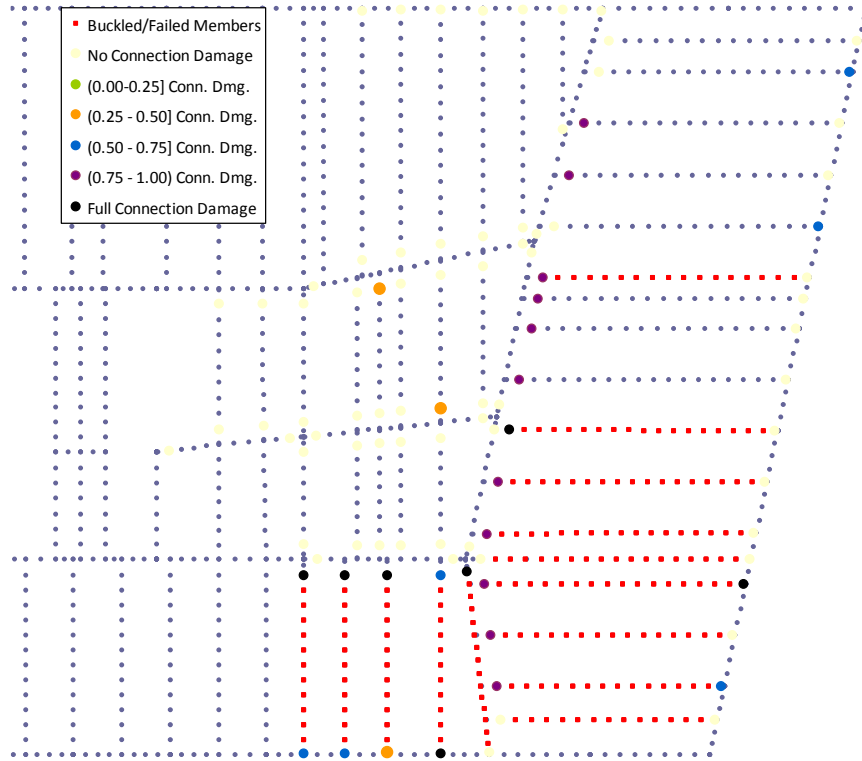
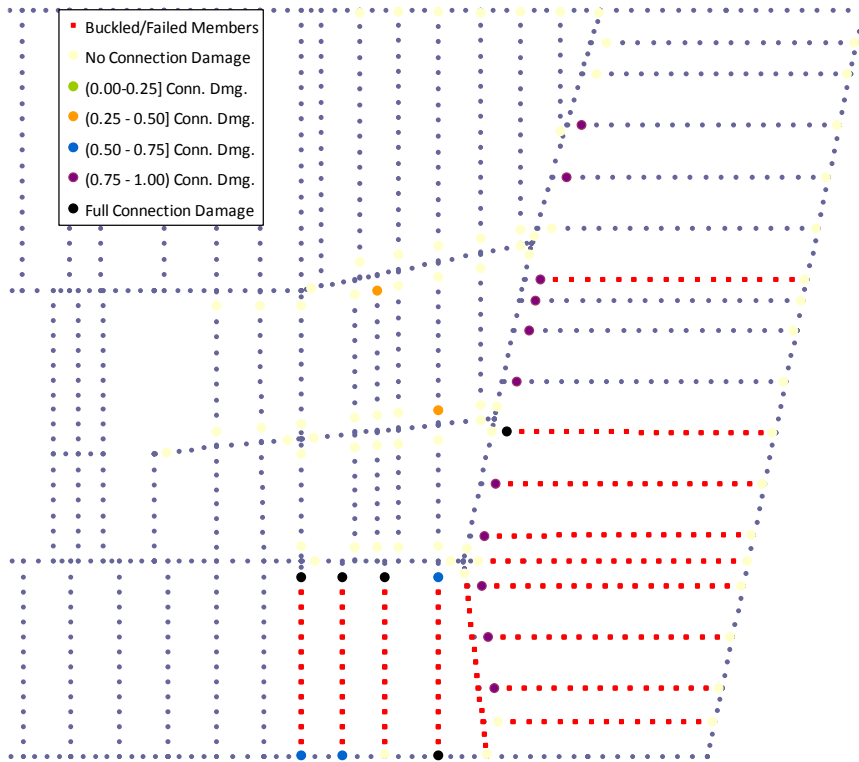
Figure 11–42. Damage state of connections, beams, and girders in Floor 11 at 4.0 h for Case C temperatures.

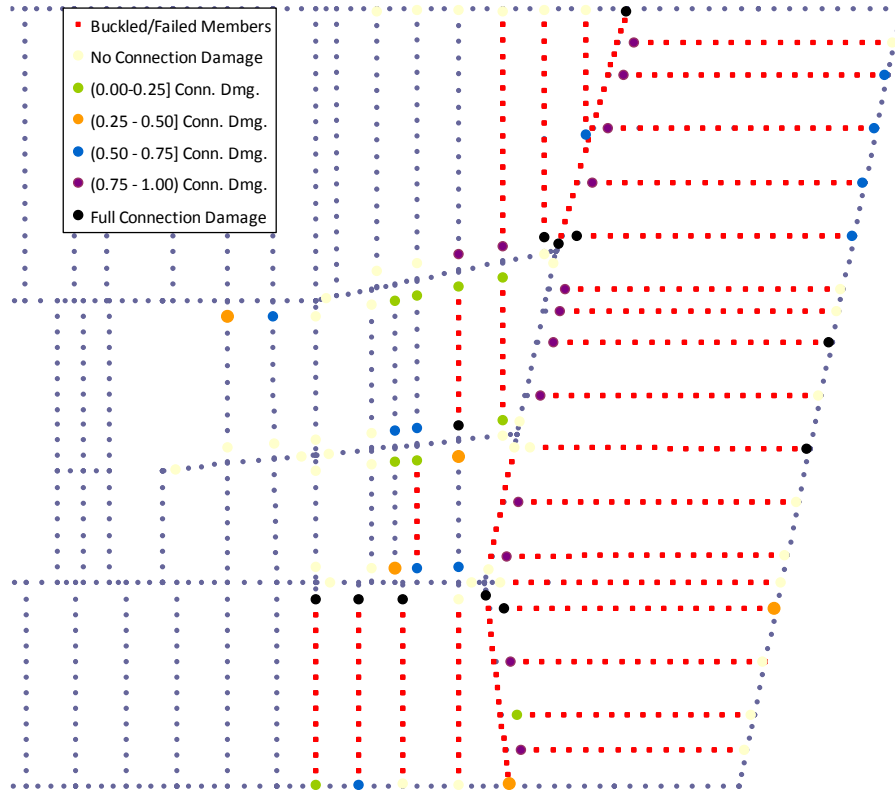
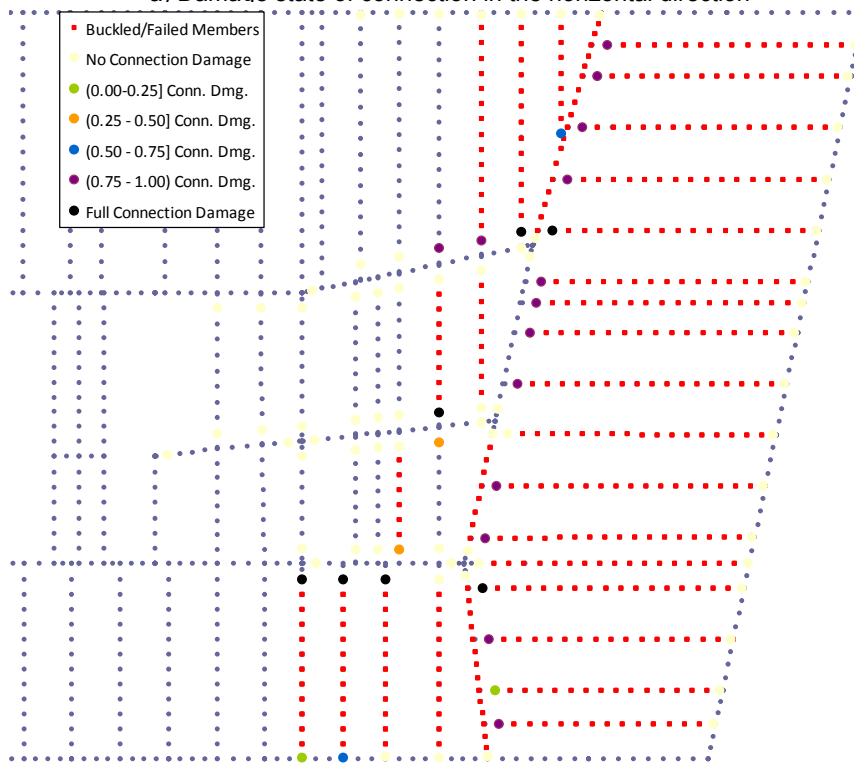
Figure 11–43. Damage state of connections, beams, and girders in Floor 12 at 4.0 h for Case C temperatures.

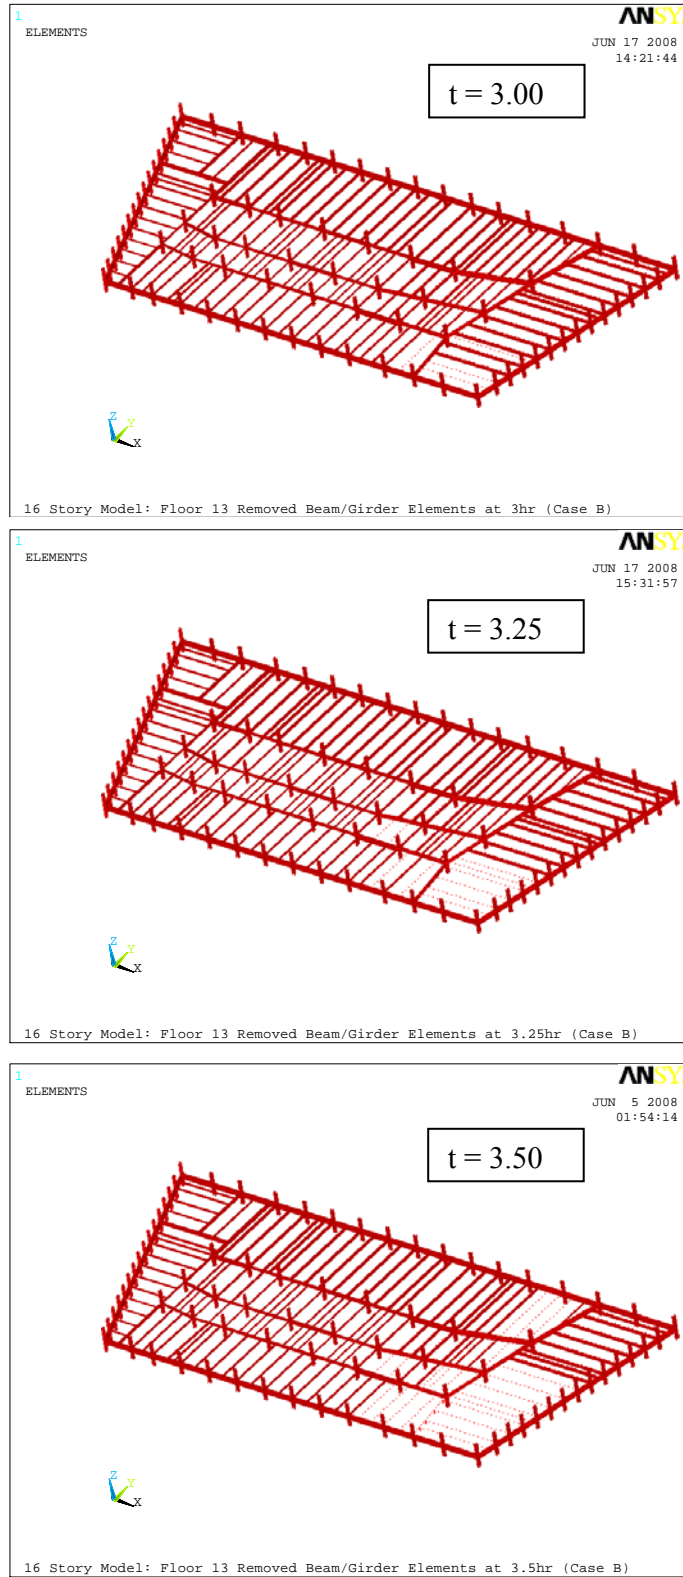
Figure 11–47. Floor 13 Case B temperatures at 3.0 h, 3.5 h, and 4.0 h.

Beams and girders that buckled or had end connection damage are indicated with dotted lines.

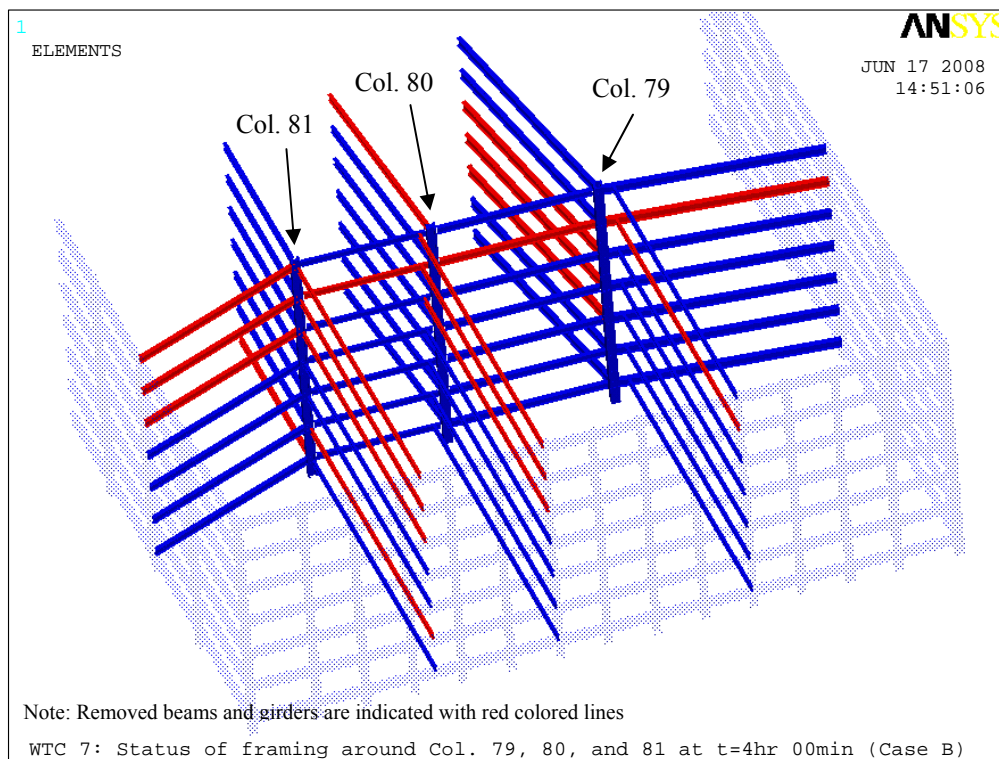
Figure 11–50. Beam and girder failures around Columns 79, 80, and 81 at 4.0 h for Case B temperatures.

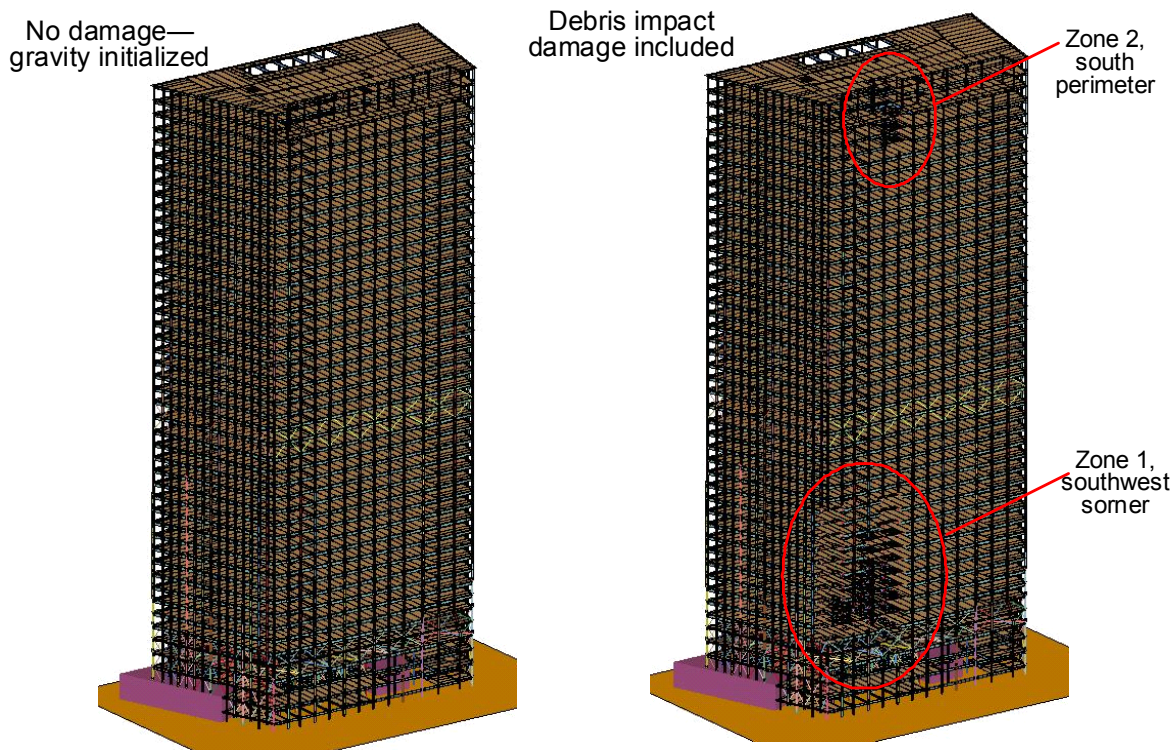
After gravity initialization, debris impact damage due to the collapse of WTC 1 (Chapter 5) was applied to the global model instantaneously. The damage was applied to the building through the sudden removal of a number of elements from the model. The damage included two zones, as shown in Figure 12-33. Zone 1 was in the lower southwest quadrant of the building and included damage to the exterior columns and floor framing extending to the south core perimeter. In Zone 1, exterior Columns 14A through 20 were severed above Floor 7. Some floor sections in the debris zone that were not removed cantilevered out from the core. Damage to Zone 2 at the upper floors along the central-southern face was less extensive. Column 20 and some floor structure extending to the core perimeter were removed from the calculation above Floor 43. After the damage was instantaneously applied to the model, the calculation was allowed to progress for 2 s prior to temperature application.

Figure 12–33. Debris impact damage application to the global LS-DYNA model.

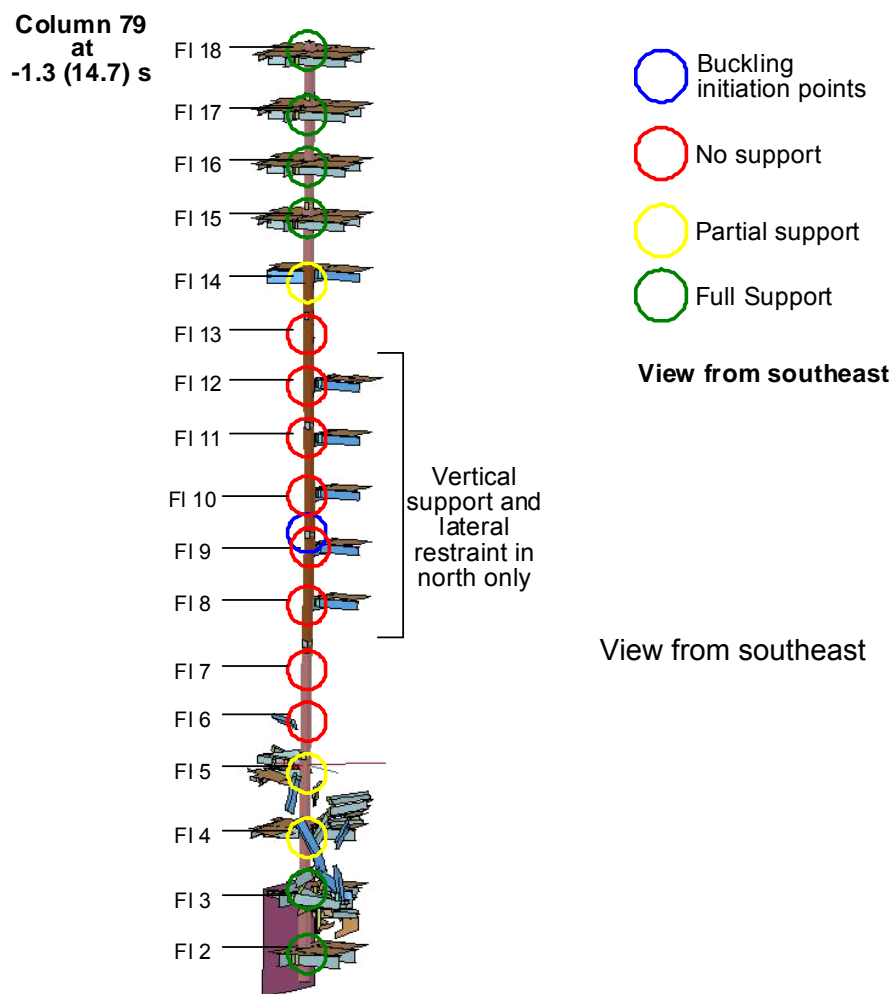
Figure 12–44. Column 79 lateral support status at time of buckling initiation.

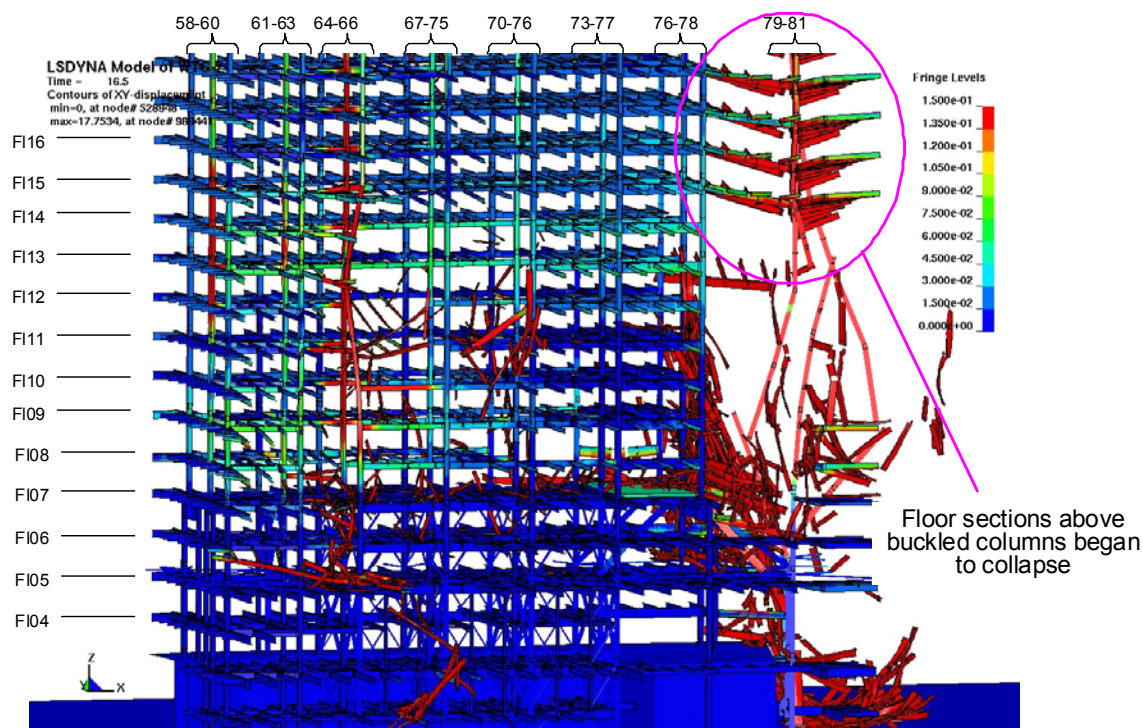
Figure 12–48. Vertical progression of failures on the east side of the building [Time: 0.5 (16.5) s].

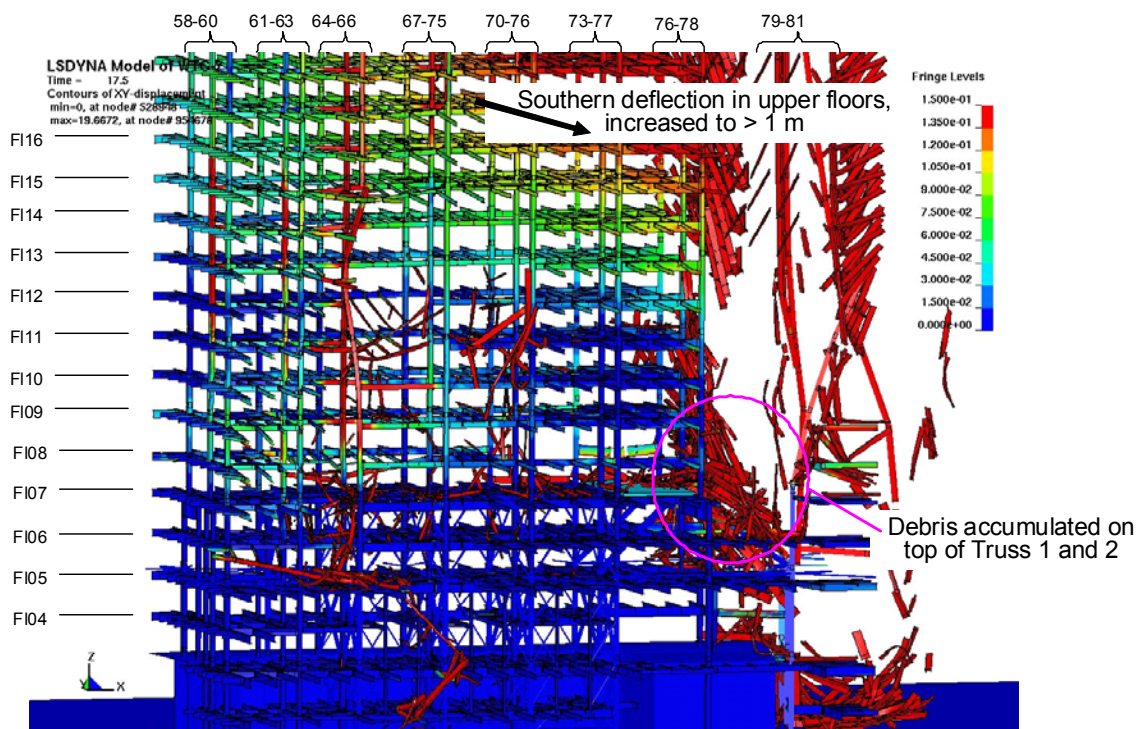
Figure 12–49. Debris from the vertical progression falling onto the lower floors, Trusses 1 and 2, and Columns 76, 77, and 78 [Time: 1.5 (17.5) s].

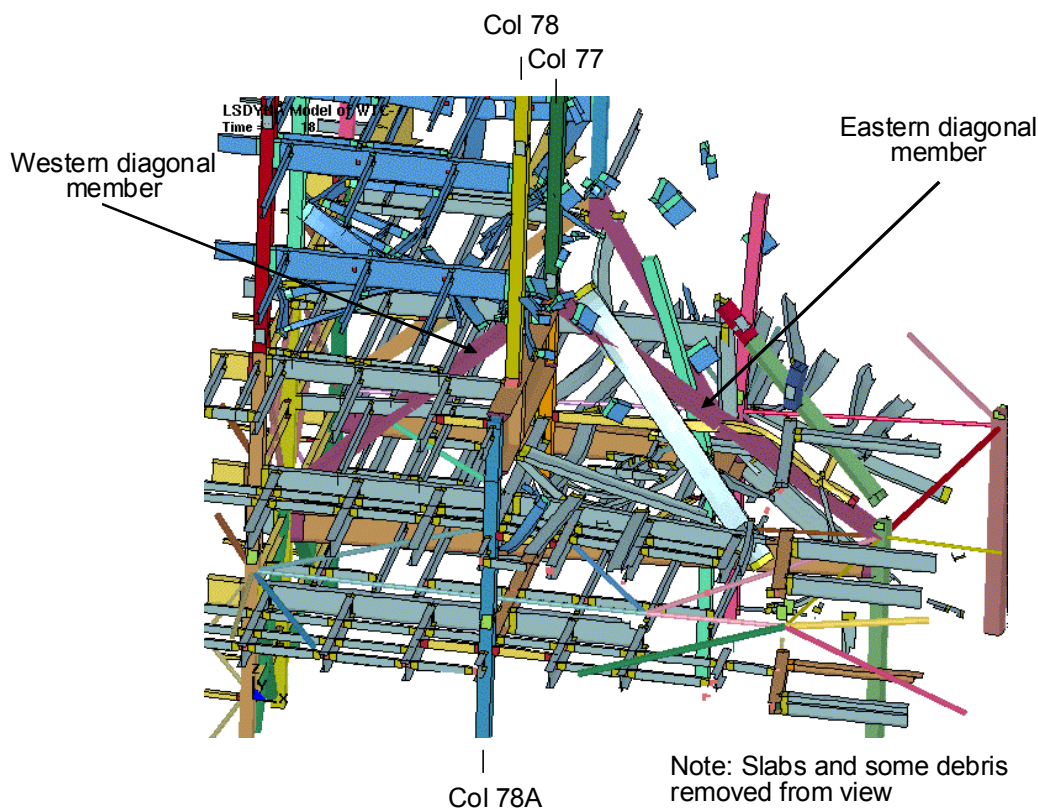
Figure 12–50. Failure of Truss 2 east diagonal. View from southeast and above.

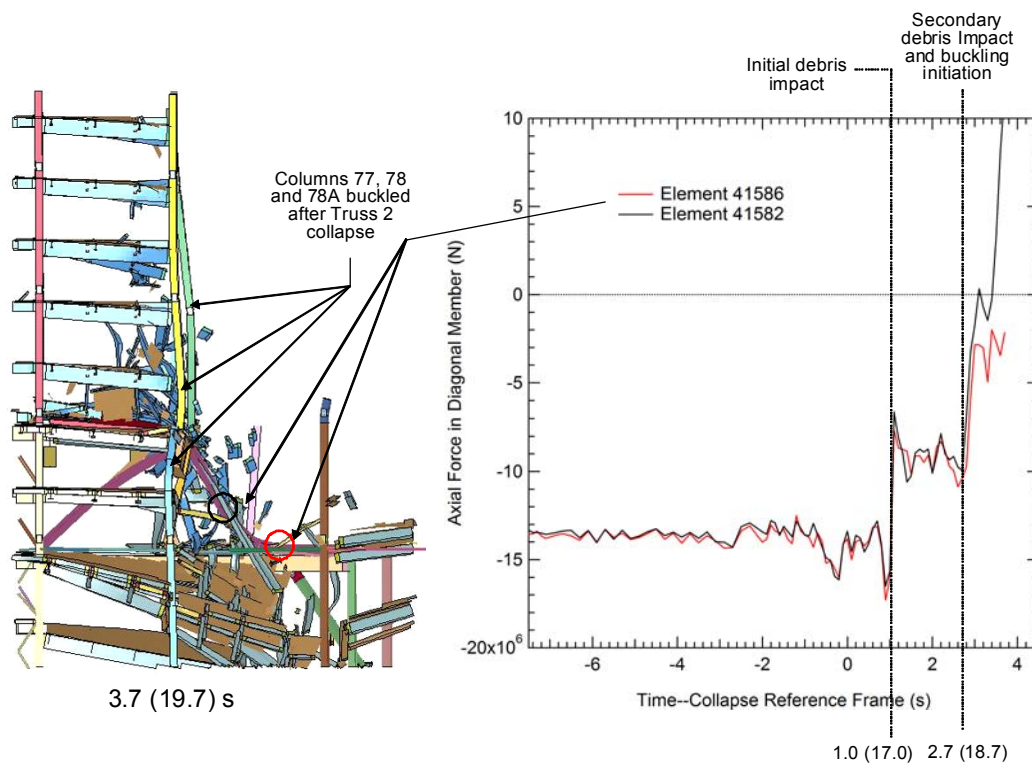
Figure 12–51. Truss 2 collapse. View from south (most of debris removed from view).
