NIST NCSTAR 1-9

**Federal Building and Fire Safety Investigation of the
World Trade Center Disaster**

**Structural Fire Response and
Probable Collapse Sequence of
World Trade Center Building 7**

VOLUME 2

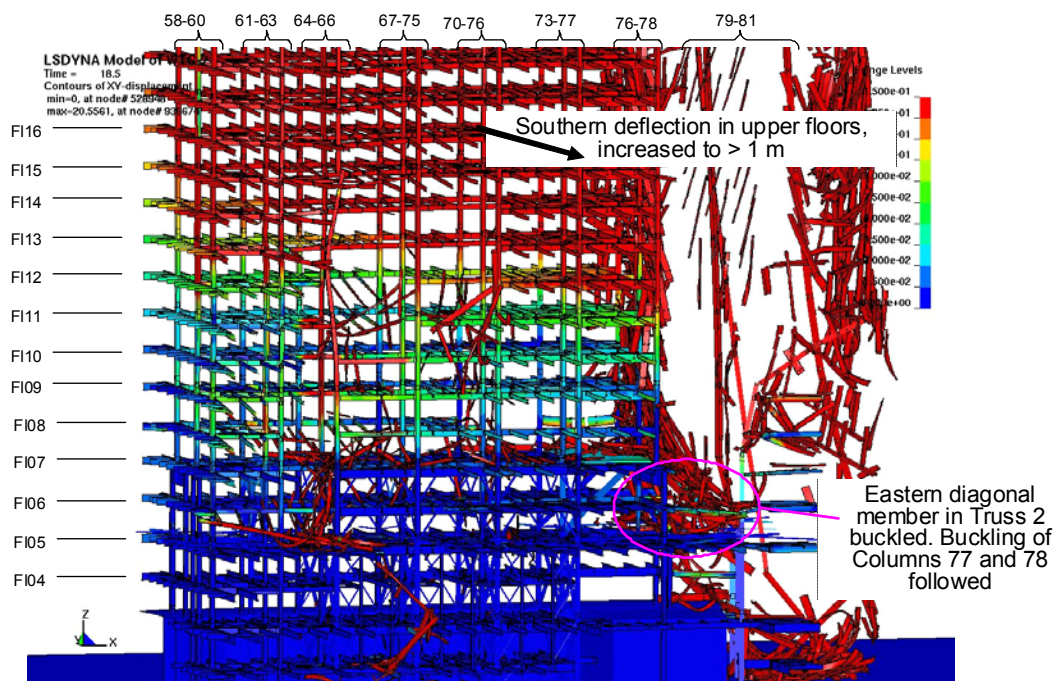
Figure 12–52. Failure of Columns 77 and 78 due to failure of Truss 2 from debris impact [Time: 2.5 (18.5) s].

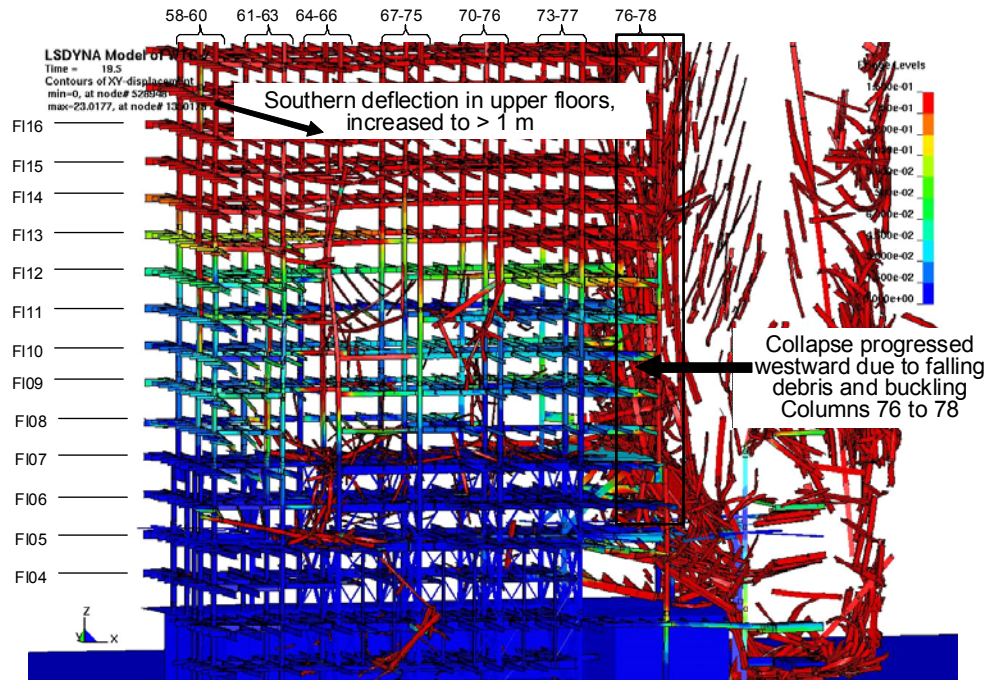
Figure 12–53. Buckling of Column 76 from the load transfer and debris impact from the buckling of Columns 79 and 77 [Time: 3.5 (19.5) s].

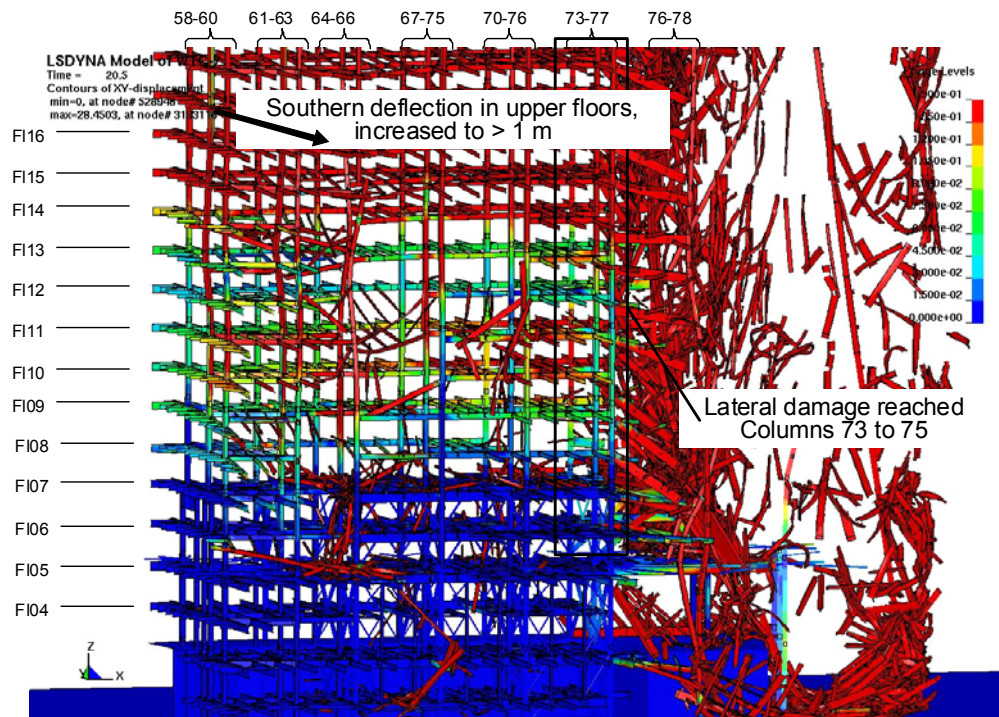
Figure 12–54. Failure of Columns 73 to 75 from the load redistribution and debris impact [Time: 4.5 (20.5) s].

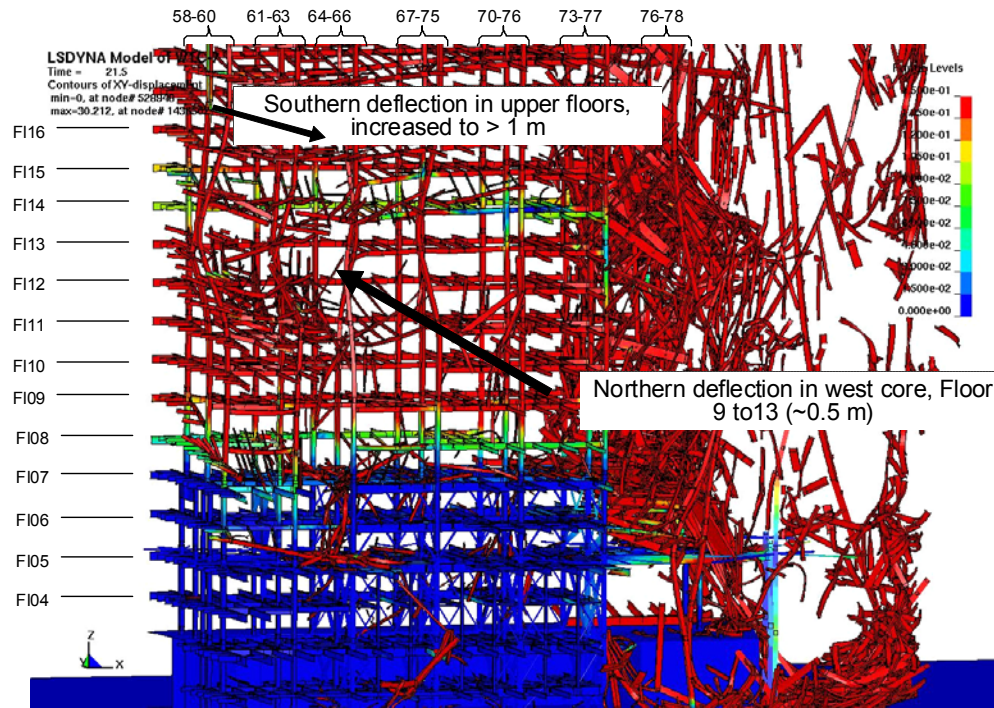
Figure 12–55. Buckling of all interior columns [Time: 6.5 (22.5) s].

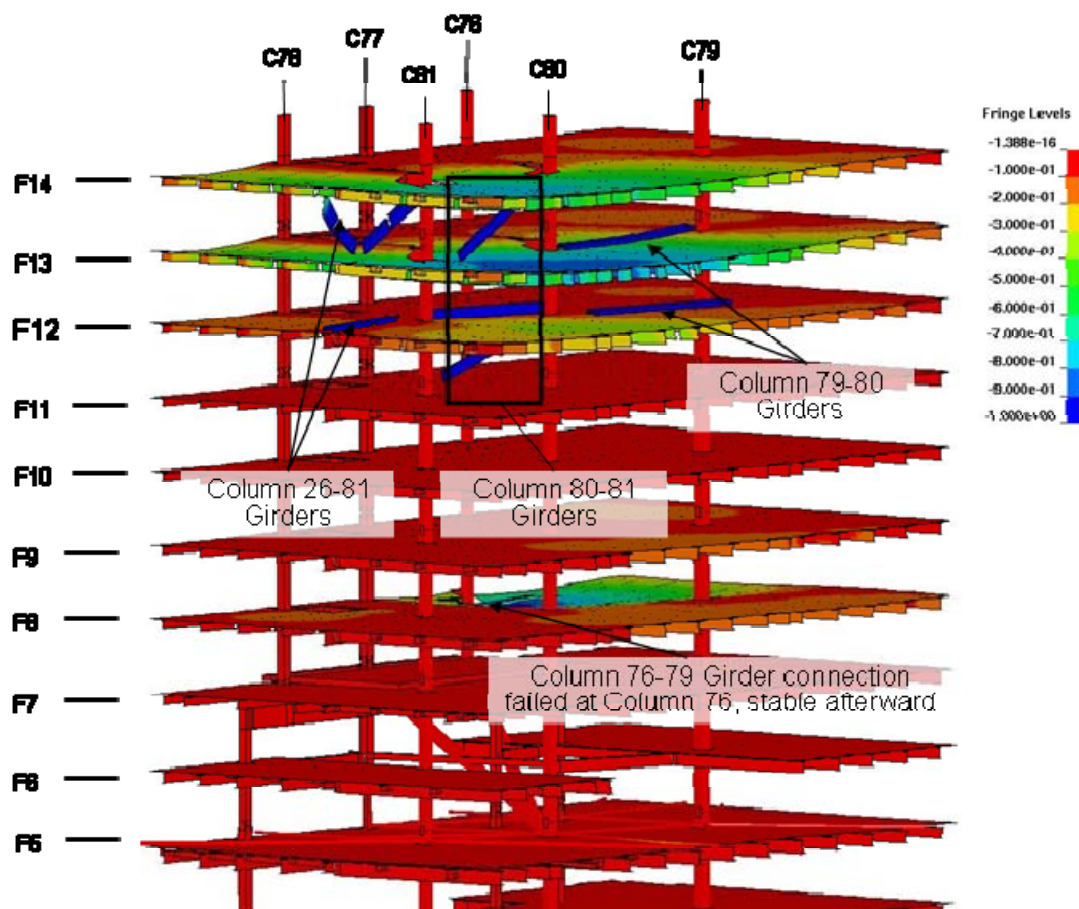
Figure 12–63. Floor framing damage around Columns 76 to 81 after stability has been reached -3.24 s (12.76 s). Contours of vertical displacement shown -39 to 0 in. (-1 to 0 m).

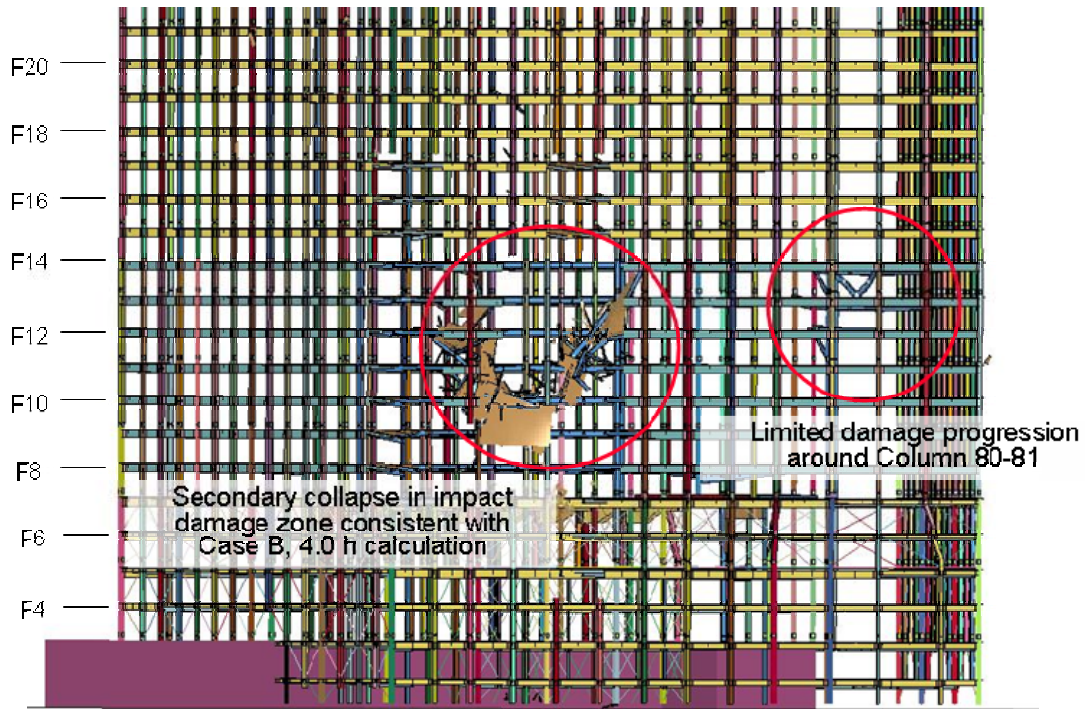
Figure 12–64. Lower floor damage in stable structure at -3.8 s (12.2 s). View from southwest.
