NIST NCSTAR 1-9

**Federal Building and Fire Safety Investigation of the
World Trade Center Disaster**

**Structural Fire Response and
Probable Collapse Sequence of
World Trade Center Building 7**

VOLUME 2

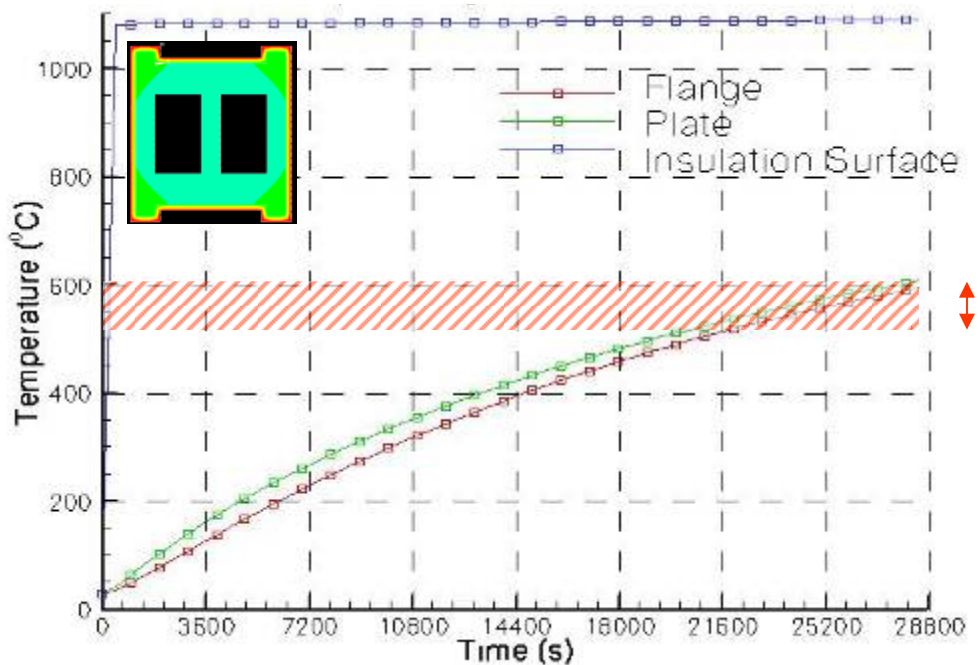
Chapter 8 suggests that the initial effect of a fire weakening the building structure would have occurred toward the east side of the building. The interior columns that might have been affected were Columns 79, 80, and/or 81. Figure 9–3 shows the developing thermal conditions for these heavy columns, insulated with 9/16 in. of thermal insulation², when exposed to a uniform temperature of 1100 °C. It would have required a continuous, fully developed fire at the location of a column for approximately 7 h for a 50 percent reduction in its strength to occur (Section 4.1.2, NIST NCSTAR 1-6).

Figure 9–3. Minimum heating of reinforced heavy columns to initiate global collapse.

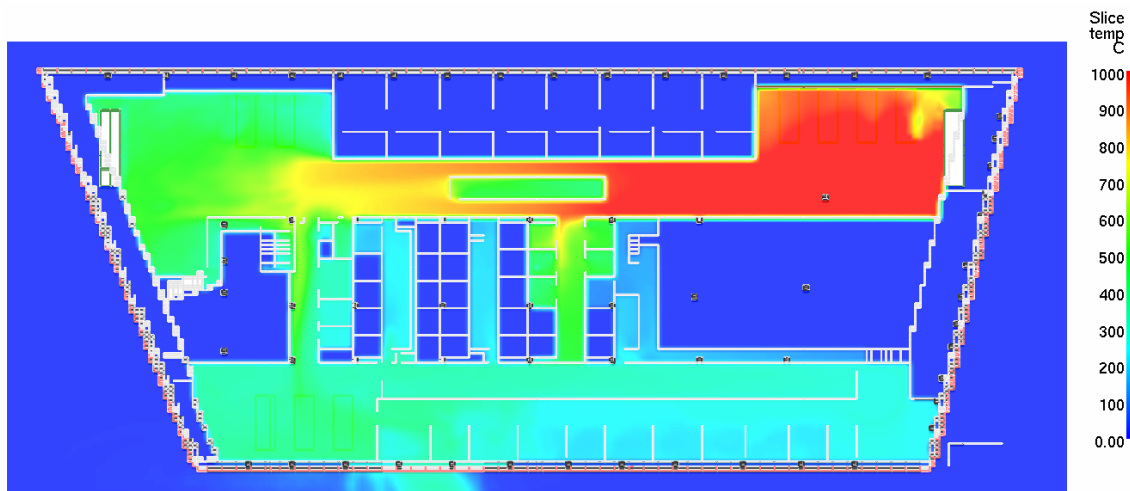
Scenario 1.a, maximum duration, over-ventilated fire: To be sustained for the approximately 7 h between the collapse of WTC 1 and the collapse of WTC 7, the fuel would have had to be pumped at about 1.8 L/s (29 gal/min), which was well within the capacity of the pumps. A large open pool of diesel fuel burns at a surface regression rate of about 4 mm/min (Gottuk and White 2002). A pool fire that burned the fuel at the same rate as it was being pumped would have had a surface area of about 30 m². For the purpose of the simulation, the pool was assumed to be a square, 6 m on a side, sited underneath the valve rig at location (a) in Figure 9-1. The needed air would have been supplied by continuously operating fans (95 m³/s, 200,000 ft³/min) and through breached partitions at elevator lobbies and the large gap on the south face. The steady state heat release rate from the over-ventilated fire would have been 50 MW to 60 MW. As suggested by the FEMA Building Performance Study Report (McAllister 2002), this fire scenario could have heated critical structural elements to high enough temperatures that the structural elements would have become incapable of maintaining the required load.

Figure 9–4. Temperatures near the 5th floor ceiling for the hypothetical maximum duration, over-ventilated diesel fuel pool fire after 7 h (Scenario 1.a).

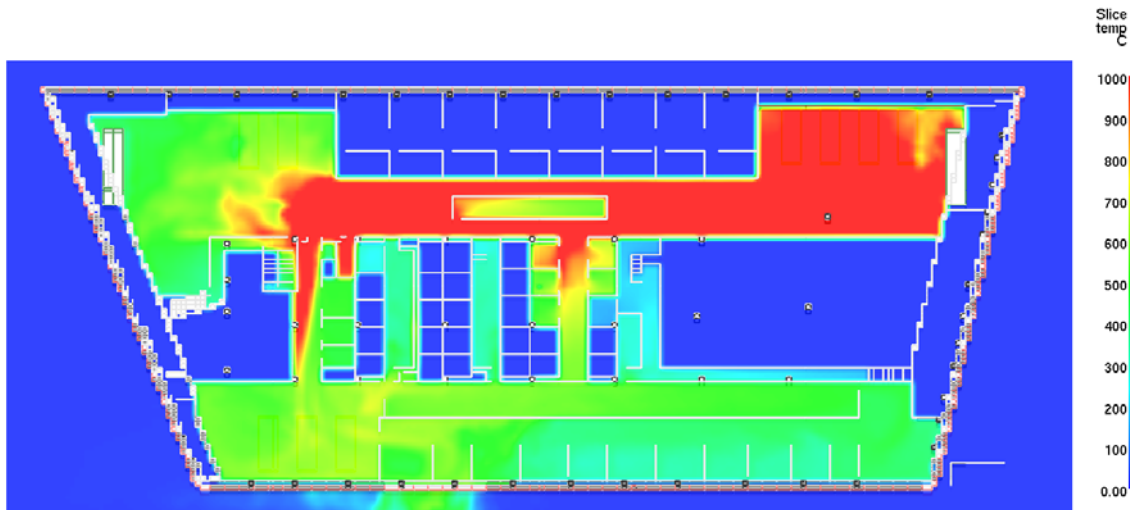
Result: The predicted temperatures of the upper layer of the 5th floor about 3.5 h into the fire are shown in Figure 9–5. The temperatures were somewhat higher across the floor as compared to Scenario 1.a, even though the total energy content was the same (that is, 100 MW to 120 MW heat release rate for half the time). The higher temperatures were due to the reduced amount of time for heat to be lost through the walls. The outcomes for Scenarios 1.a and 1.b were the same: the high temperatures near Column 79 could not be sustained because the environment around all the diesel generators and the electrical distribution system would likely have caused the electrical power to the fuel pumps to fail. Neither Column 79 nor the 7th floor composite floor system would have been thermally weakened.

Figure 9–5. Temperatures near the 5th floor ceiling for the hypothetical maximum intensity, over-ventilated diesel fuel pool fire after 3.5 h (Scenario 1.b).

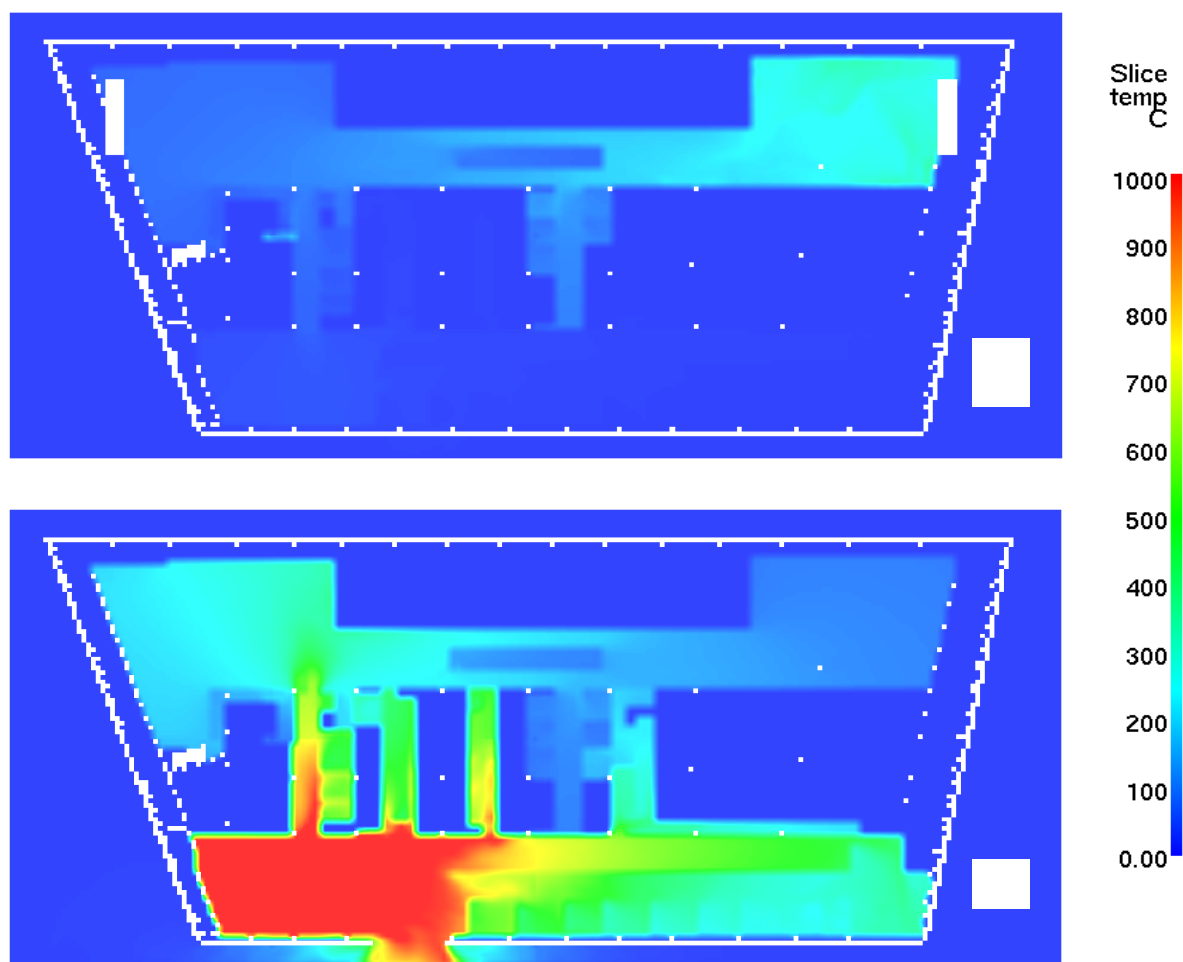
Result: An FDS simulation showed gas temperatures near the ceiling ranging between 300 °C and 400 °C after about 15 min. A map of the temperatures near the ceiling for this time is shown in Figure 9–6a. Figure 9–6b shows the estimated gas temperatures near the ceiling more than two hours later,

Figure 9–6. Estimated gas temperatures near the 5th floor ceiling for a hypothetical under-ventilated diesel fuel pool fire with the louvers closed (Scenario 1.c); (a) after 15 min; (b) after 3 h.

when the oxygen in the vicinity of the liquid fuel had been consumed and the flames were forced to find a fresh supply in the southwest corner of the building. This stage of the fire was highly speculative since the flames were no longer available to provide the heat needed to vaporize the diesel fuel in the pool. At any rate, the sustained temperature in the vicinity of Columns 79 did not exceed 400 °C. Thus, the column temperature would not have risen to the point where significant loss of strength could have occurred. The generators in the northeast, northwest, and southwest sections would likely have all ceased to operate at these temperatures. Neither Column 79 nor the 7th floor composite floor system would have been thermally weakened.

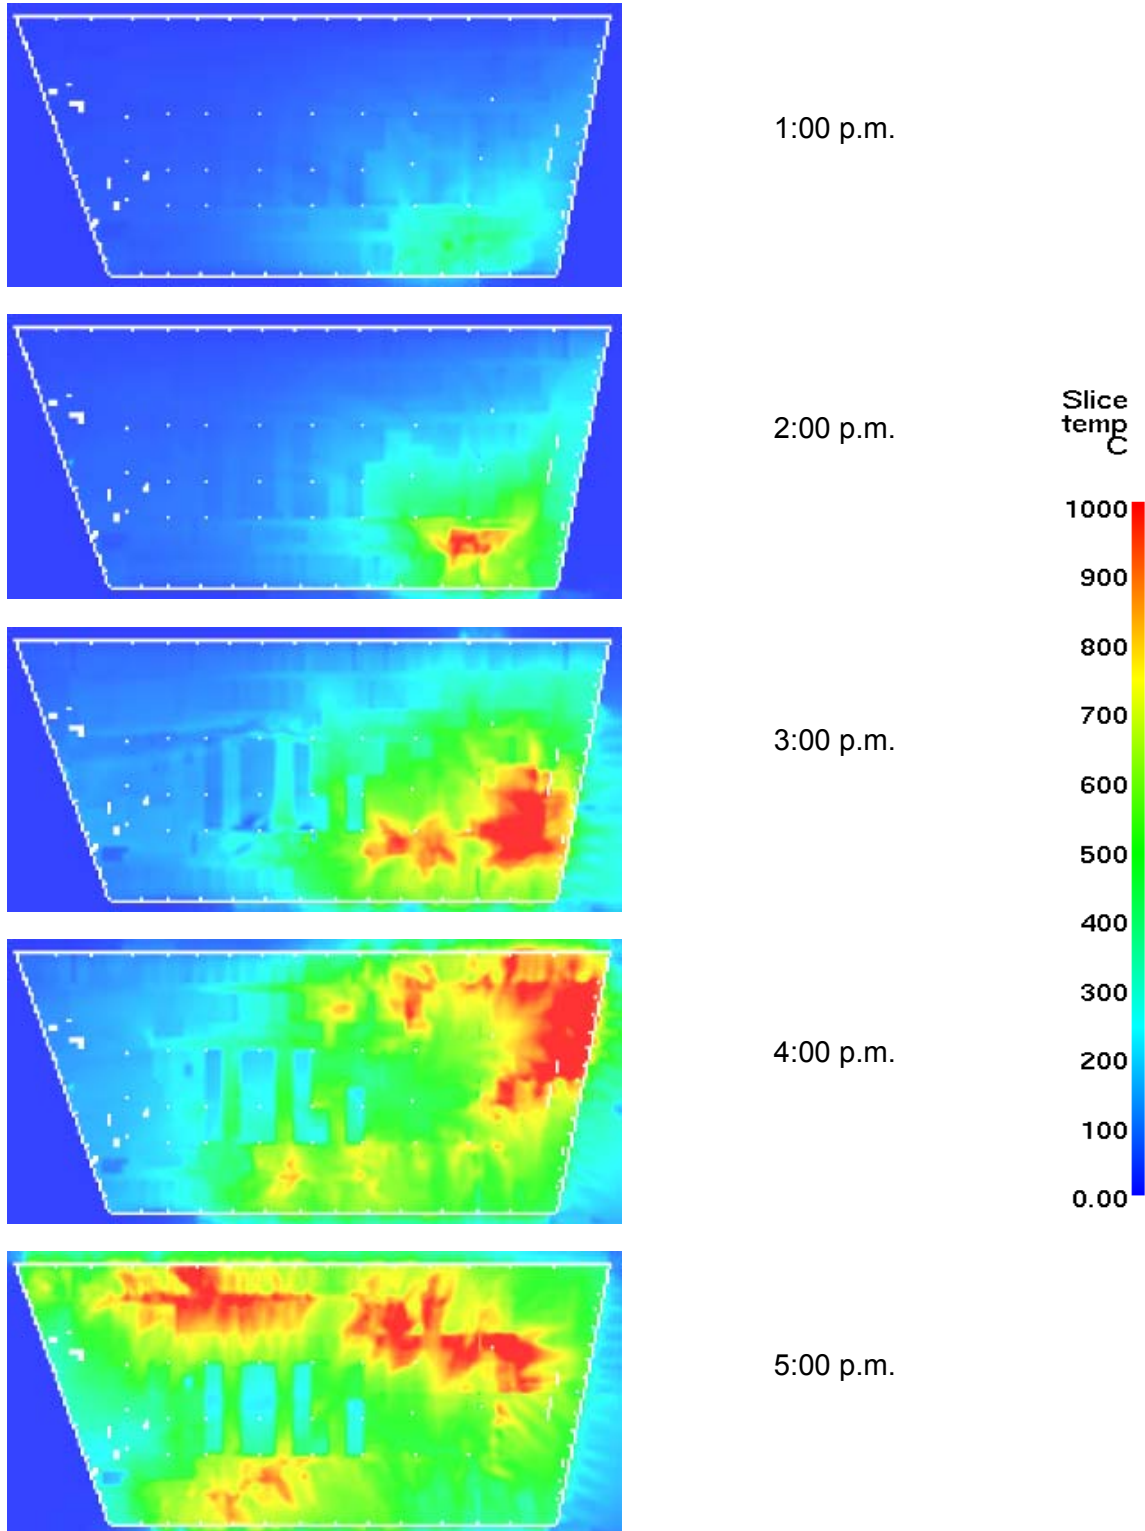
The prescribed window breakage pattern in the model drove the fires in a counter-clockwise direction, consistent with the visual evidence. The fires also spread along the south face in the simulation, although there is no evidence to confirm this observation. The spread rate was about one-third to one-half slower than that on the lower floors due to the higher fuel load. The burning time near the north face was longer in the simulation than in the visual evidence, suggesting that (a) additional gasified fuel from the building interior was burning near the windows in the simulation, (b) the input fuel load was too high, and/or (c) the office partitions were more effective at slowing the fire progress in the simulation than in the actual fires. The first possibility would lead to overestimated temperatures near the north curtain wall, but not necessarily between the curtain wall and the building core. The second possibility would imply reduced heat release, which, in turn, would lead to overestimates of structural temperatures throughout the area between the north curtain wall and the building core. The third possibility would lead to heating of the northeast corner slightly earlier than in the actual fires. Explanations (a) and (c) are more likely the cause of longer apparent burning time than (b). (See Section 9.3.3.)

Figure 9–12. Progression of simulated fire on Floor 12 of WTC 7, with more durable ceiling tile system.

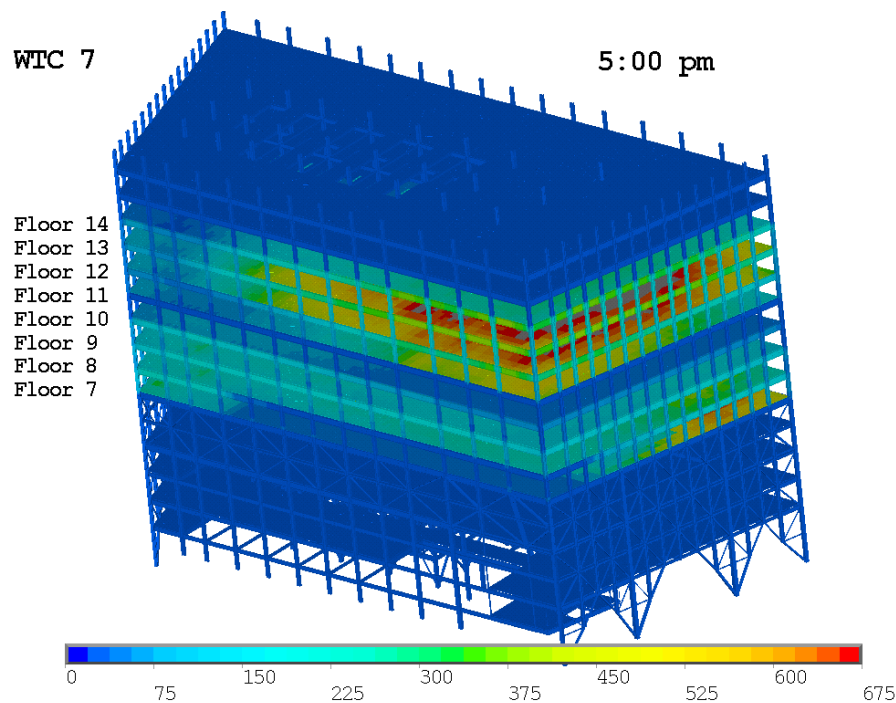
Figure 10–1 is an example of a rendition of WTC 7, (viewed from the southeast corner), showing the thermal data generated with FSI and subsequently transferred to the ANSYS and LS-DYNA structural models for analysis (Chapters 11 and 12). The figure shows the perimeter and core columns extending from the ground level to Floor 16. The figure also shows the beams that support the concrete floor slabs. Only a fraction of the entire model is visible because of the concrete slabs. As noted above, the simulations showed essentially no thermal gradient across the thickness of the steel components. The depicted slab temperatures are in the midpoint of the uppermost thermal element. For the 7th floor slab, this was approximately 12.5 mm (0.5 in.) below the top surface; for the other floors, this was approximately 6 mm (0.25 in.) below the top surface.

Figure 10–1. View from the southeast of the computed thermal loading of the 16 lower floors of WTC 7 at 5:00 p.m. (Case A).

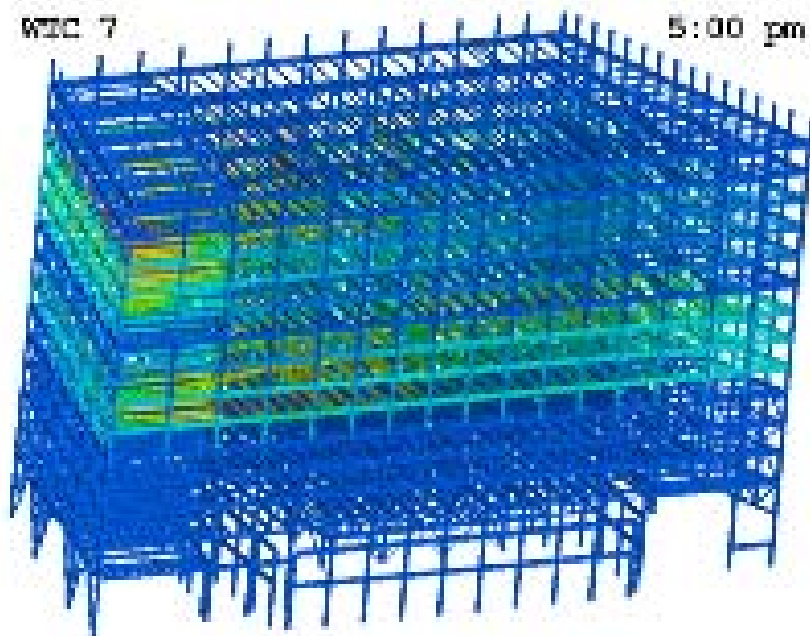
Figure 10–2 shows a view of the same 16 floor simulation from the northeast corner. Here, the concrete slabs have been removed in the image to allow a better view of the heating of the internal floor beams and columns.

Figure 10–2. View from the northeast of the computed thermal loading of the 16 lower floors of WTC 7 at 5:00 p.m. (Case A, floor slabs removed).

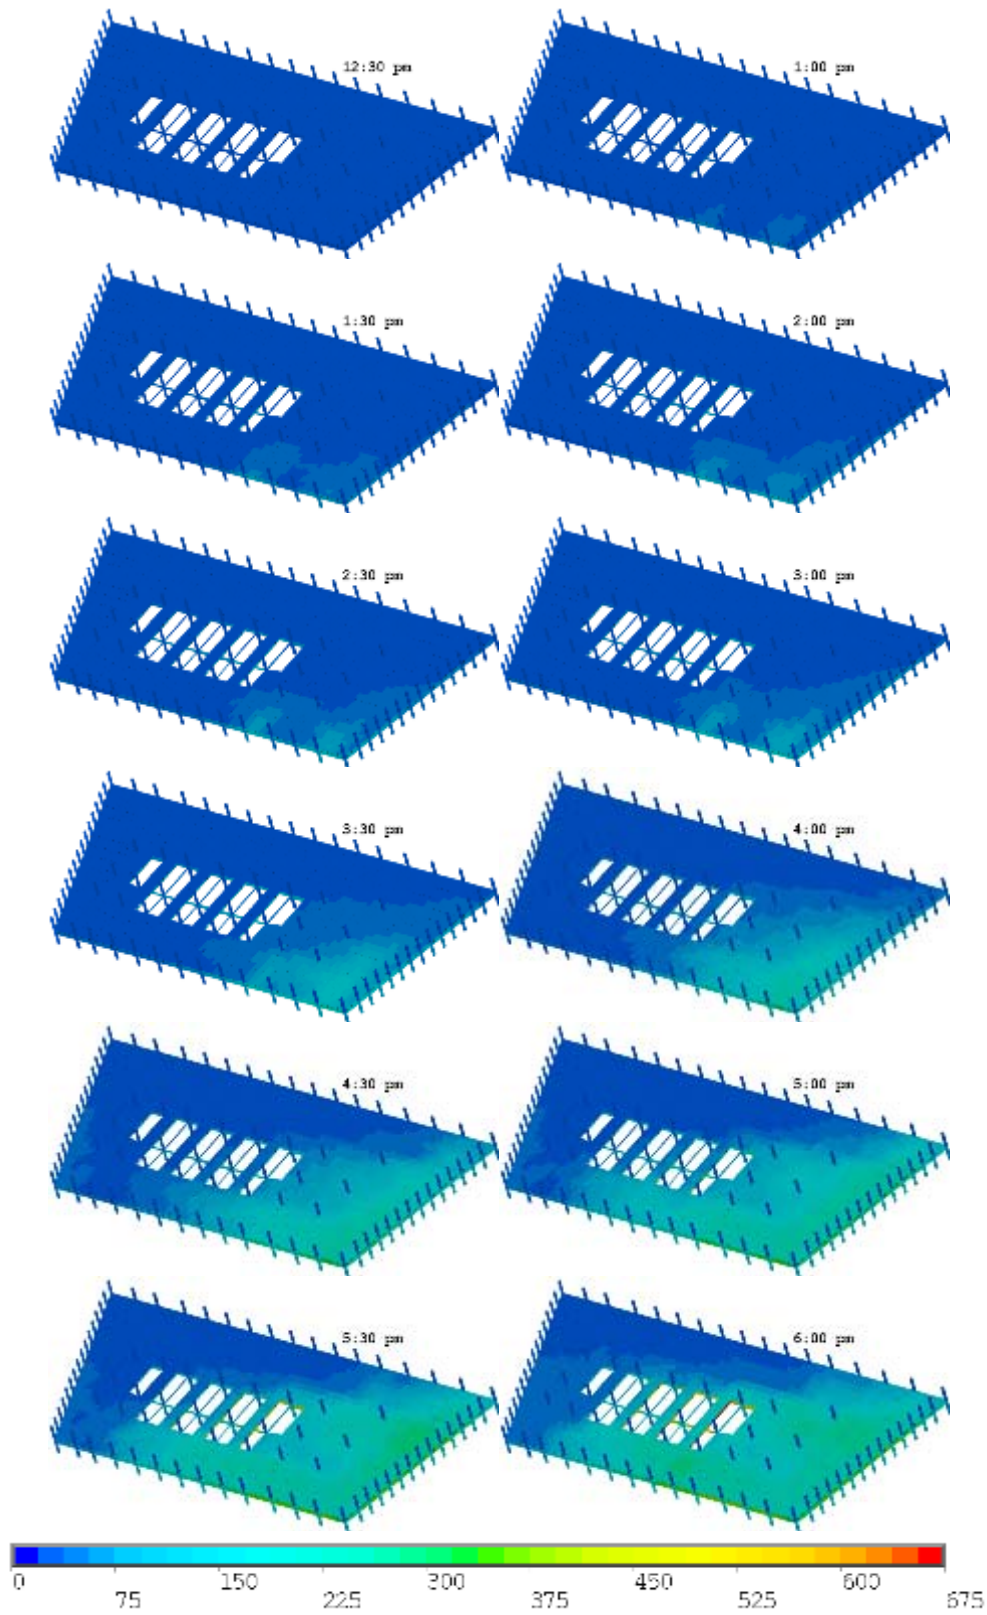
Figure 10–19 provides an example of the degree of conductive heat transfer through the floor slab. With no fire on the 14th floor, but a severe fire on the 13th floor, the temperature on the top of the slab rose only about 100 °C by the end of the simulation. The temperature rise in the floor beams in Figure 10–20 was as expected from a fire on the 13th floor that was equal to the 12th floor fire displaced one-half hour earlier.

Figure 10–19. Computed temperature distribution (°C) in the top layer of the concrete slab of floor 14 at 12 different instants in time (Case A).

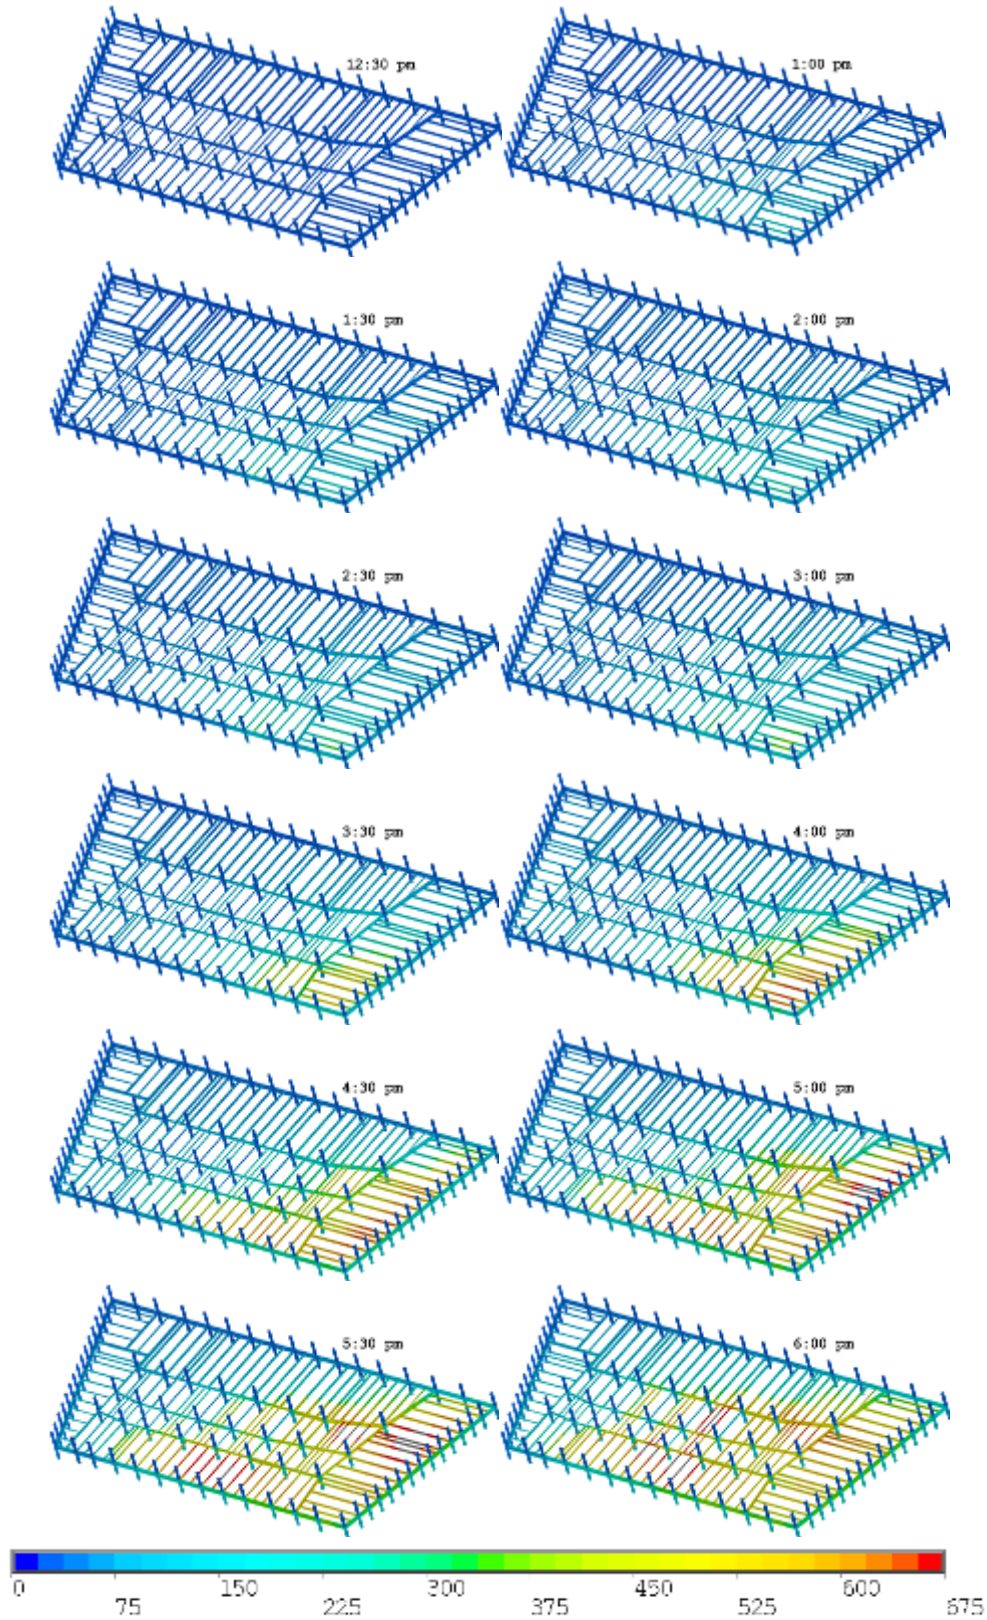
Figure 10–20. Computed temperature distribution (°C) on the floor beams of floor 14 at 12 different instants in time (Case A, floor slab removed).

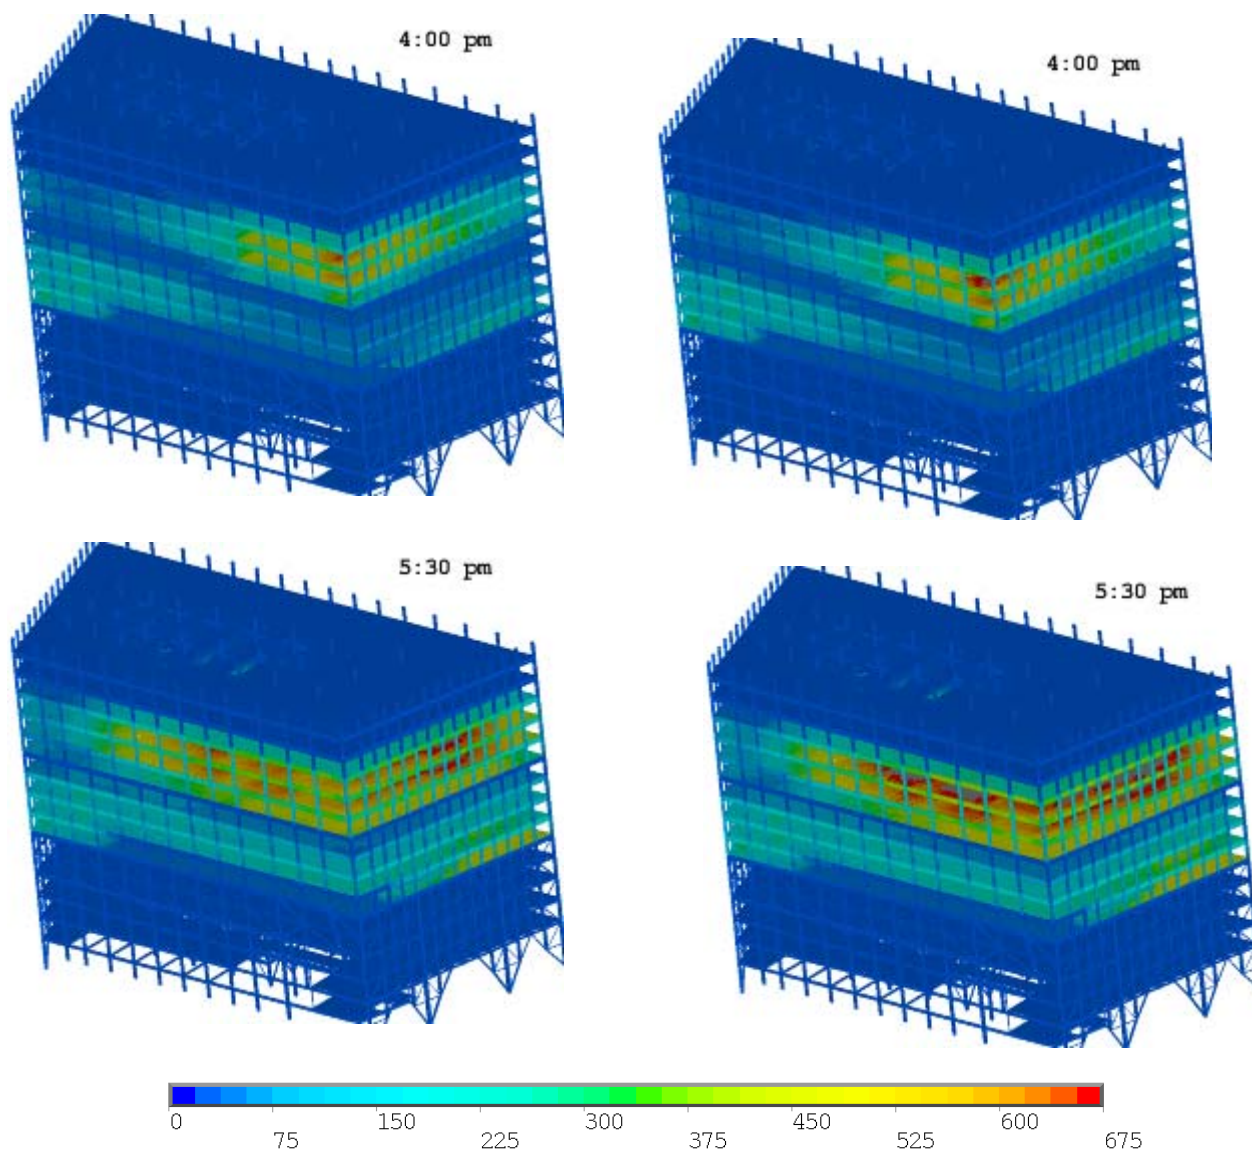
For Case B, the temperature increase at each location on Floors 7 through 14 was assumed to be 10 percent higher than that computed from the FDS simulation of Case A, which was within the expected range of reasonable and realistic fire-generated temperatures. Figure 10–21 and Figure 10–22 compare the temperatures of the building at two times for these two cases. Case A is on the left, and Case B is on the right. As expected, Case B resulted in mildly higher temperatures in the steel and concrete, wider hot zones, and greater overlap of hot zones between adjacent floors.

Figure 10–21. View from the southeast of the 16 lower floors of WTC 7, comparing Case A (left) and Case B (right) temperatures at two different times.

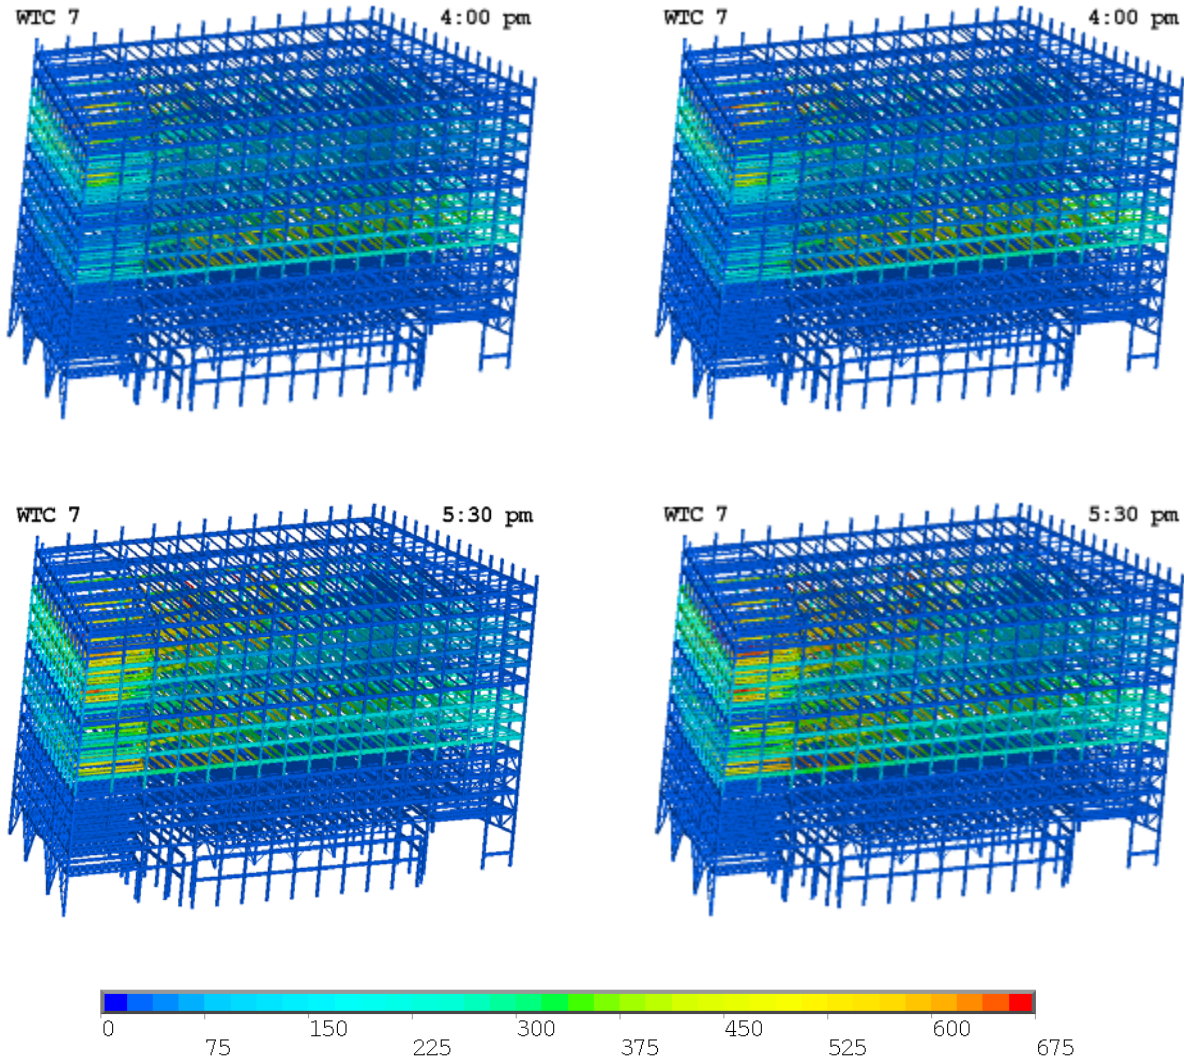
Figure 10–22. View from the northeast of the 16 lower floors of WTC 7, comparing Case A (left) and Case B (right) temperatures at two different times (floor slabs removed).

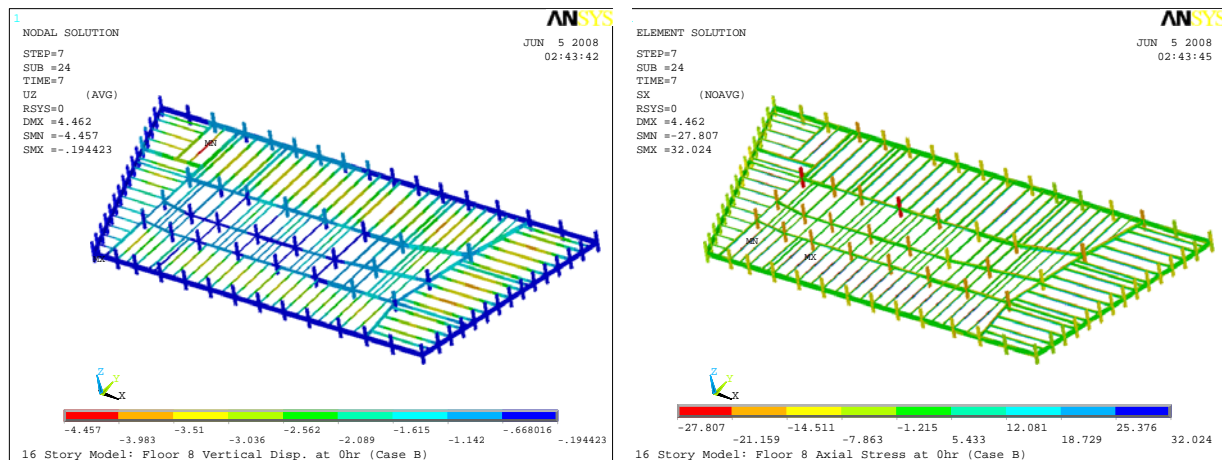
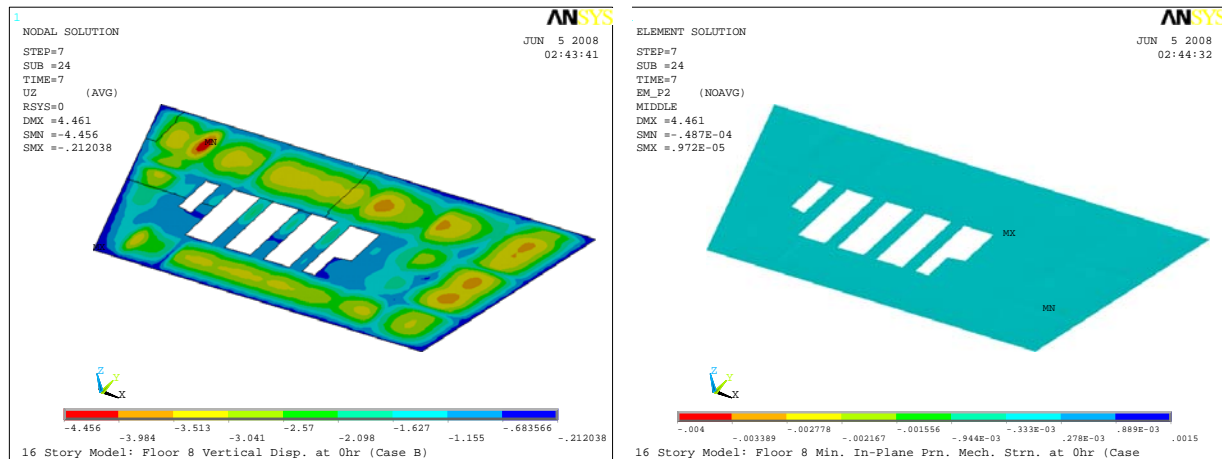
Displacements. The typical vertical floor displacement on the tenant floors was about 3.5 in. as shown in Figure 11–21a. The maximum vertical deflection of 4.5 in. occurred at the northwest corner. The floor beams were cambered in the design drawings (1.75 in. to 2.5 in. at the east tenant floor, 1.75 in. to 2.75 in. at the north tenant floor, 1.0 to 1.25 at the west tenant floor, and 1.0 in. at the south tenant floor). The camber could not be modeled in ANSYS. Thus, the vertical floor displacements would have been about one to two inches, if the camber was subtracted from the computed displacements.

Axial stresses from axial forces in the floor beams and in-plane slab strains were small, as expected for gravity load conditions. The stress in the floor beams due to axial loads was less than 1 ksi (floor beams had a nominal yield strength of 50 ksi). The in-plane slab strains were less than -5×10^{-5} (concrete failure strain in compression was -4×10^{-3} and failure strain in tension was 1.5×10^{-3}).

Axial column stresses (Figure 11–21b) ranged from 15 to 28 ksi in the interior columns and in exterior Columns 44 and 55 on the north face. The axial column stress in the other exterior columns ranged from 8 to 15 ksi.

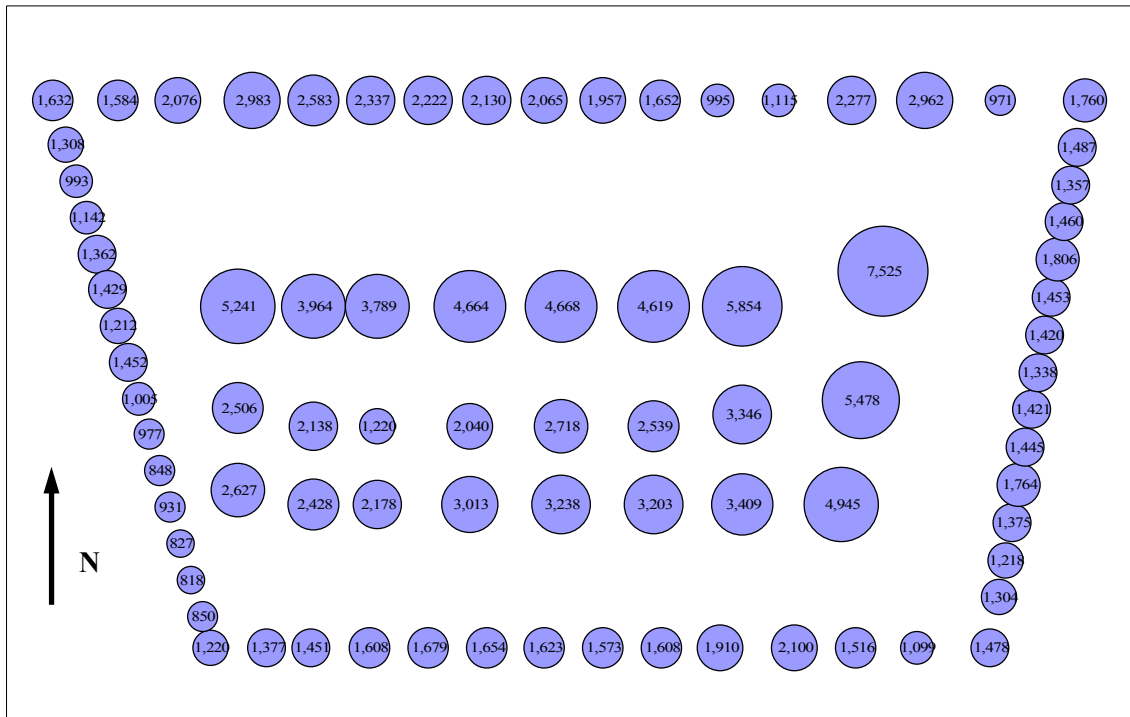
Column Loads. The column loads at Floor 8 are presented for comparison to the column loads at 3.5 h and 4.0 h of heating, which are presented at the end of Sections 11.3.2 and 11.3.3. Axial forces in the columns at Floor 8 are shown in Figure 11–22. The maximum column force of 7,525 kip was at Column 79. The axial force ranged from 2,000 kip to 5,000 kip in the rest of the interior columns and 1,000 kip to 3,000 kip in the exterior columns. The sum of all column forces was 176,500 kip, with the interior and exterior columns carrying these loads in about equal parts. Based on the design drawings, the sum of all column loads for a loading condition of dead loads and service live loads was 174,100 kip.

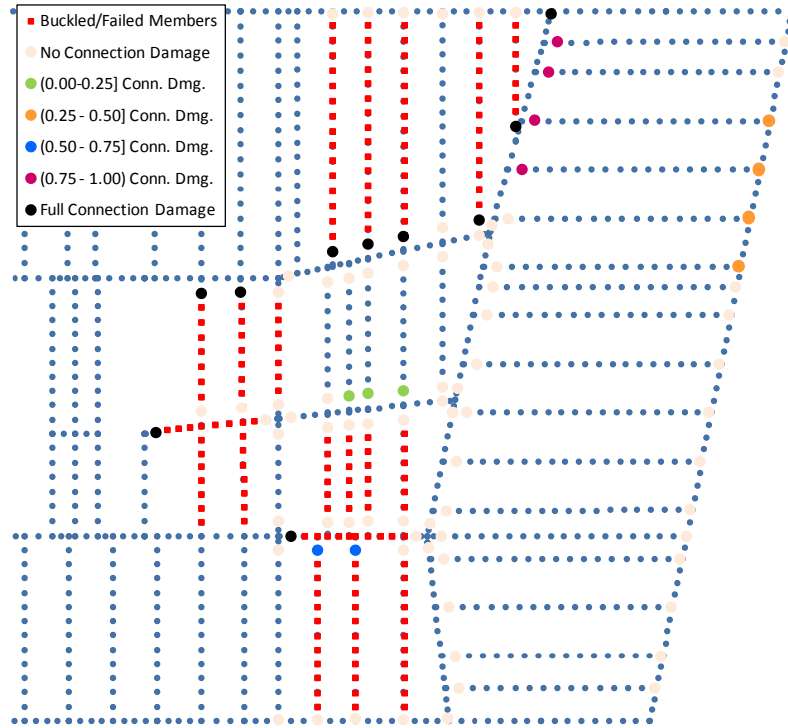
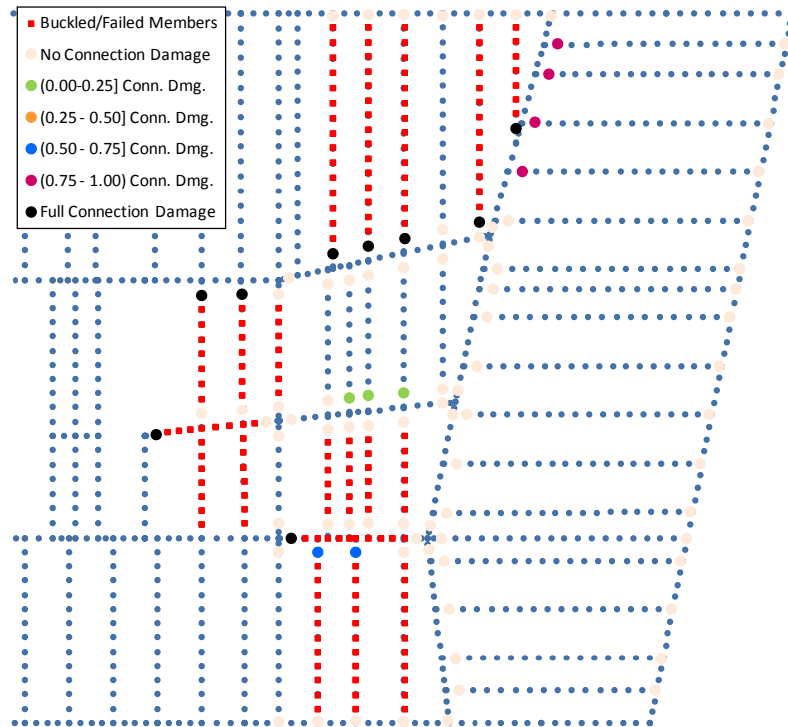
Figure 11–23. Damage state of connections, beams, and girders in Floor 8 at 3.5 h for Case B temperatures.

Fin connections failed for the north floor beams on Floor 8 that were attached to the girder between Columns 76 to 79 (see Figure 2-4 for column locations), due to thermal expansion in the beams, by shearing the bolts at the girder. Figure 11–23 shows connection and floor framing damage that occurred.

The northeast beam-to-girder fin connections had a 0.75 to 0.99 damage level between Columns 44 and 79 and a 0.25 to 0.49 damage level at the east exterior columns. The header connections failed at Columns 74 and 78, due to thermal expansion of the girder. The beams that were supported by these girders are also indicated as failed, since they would fall with the girder.

Summary. The connections between the girders and interior columns were all intact, except for the girder between exterior Column 26 and interior Column 81 on Floors 13 and 14. At the seated connection at Column 79, all the bolts had sheared on Floor 13 and 2 to 3 bolts had sheared on Floors 12 and 14. Approximately one-half to three-quarters of the east floor beams had a connection damage index of 0.75–0.99 on Floors 11, 12, 13, and 14. While the floor systems had experienced fire-induced damage to connections, beams, and girders after 3.5 h of heating, primarily due to the effects of thermal expansion, the WTC 7 structural system had damage on the north floor and east side of the core on Floor 8 and the south and east area of Floors 12, 13, and 14.

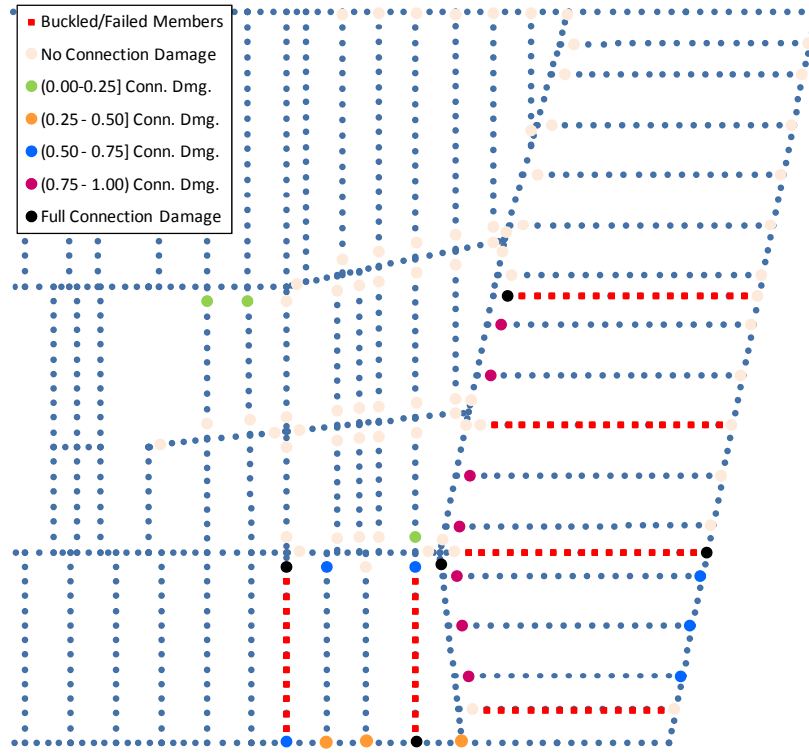
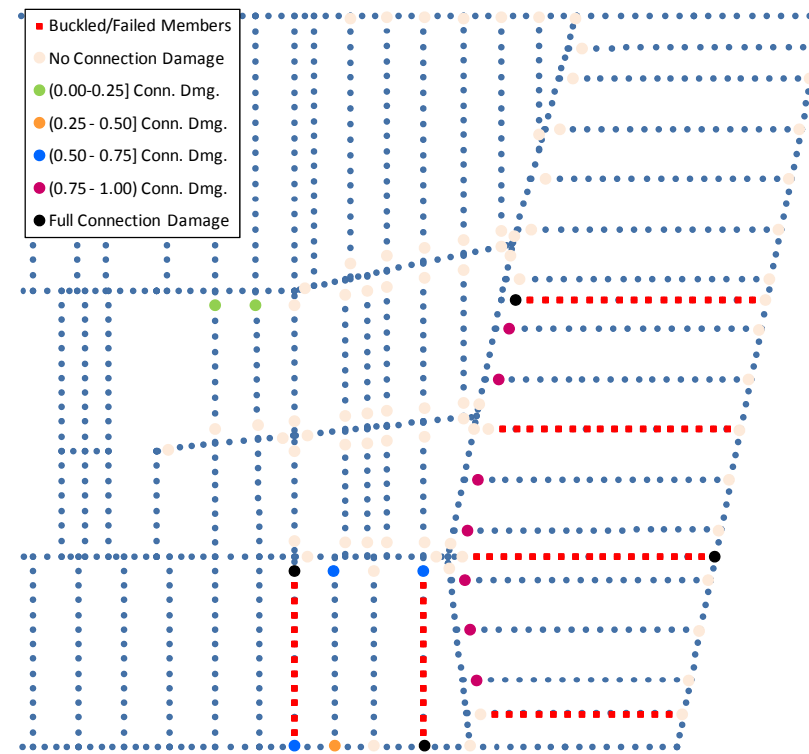
Figure 11–27. Damage state of connections, beams, and girders in Floor 12 at 3.5 h for Case B temperatures.

Floors 12, 13, and 14. Elevated temperatures in the southeast region on Floors 12, 13, and 14 of the floor framing ranged from 150 °C to 350 °C for Floor 12, 500 °C to 700 °C in Floor 13, and 300 °C to 500 °C in Floor 14. However, the thermal analysis did not account for failed floor framing as the structure was heated over time. Figure 11–27, Figure 11–28, and Figure 11–29, based on the ANSYS analysis of the structural response to heating, show that floor beams had failed in areas where the steel temperatures were greater than 400 °C to 500 °C. The following beam and girder failures occurred:

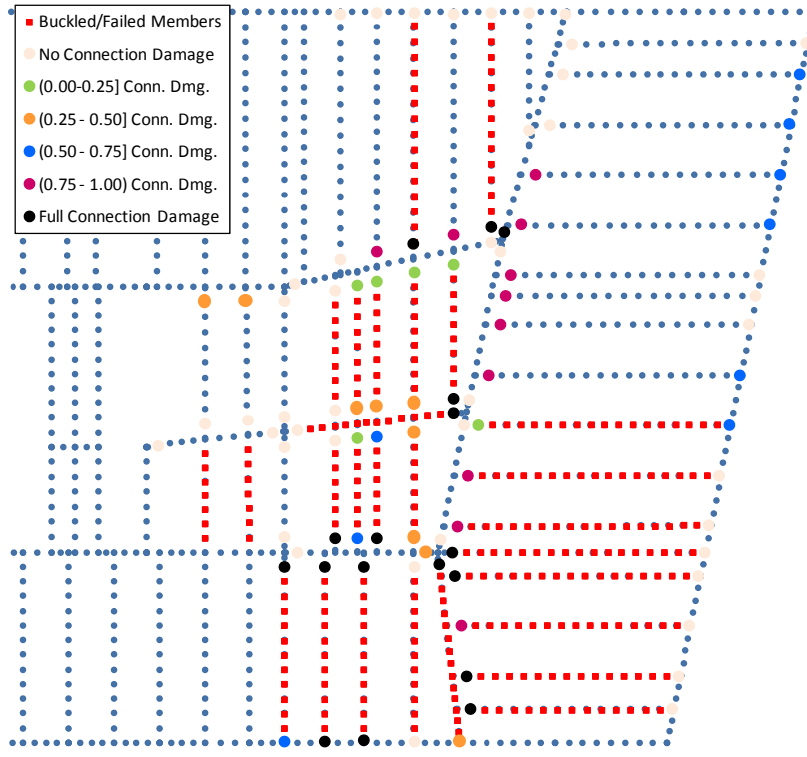
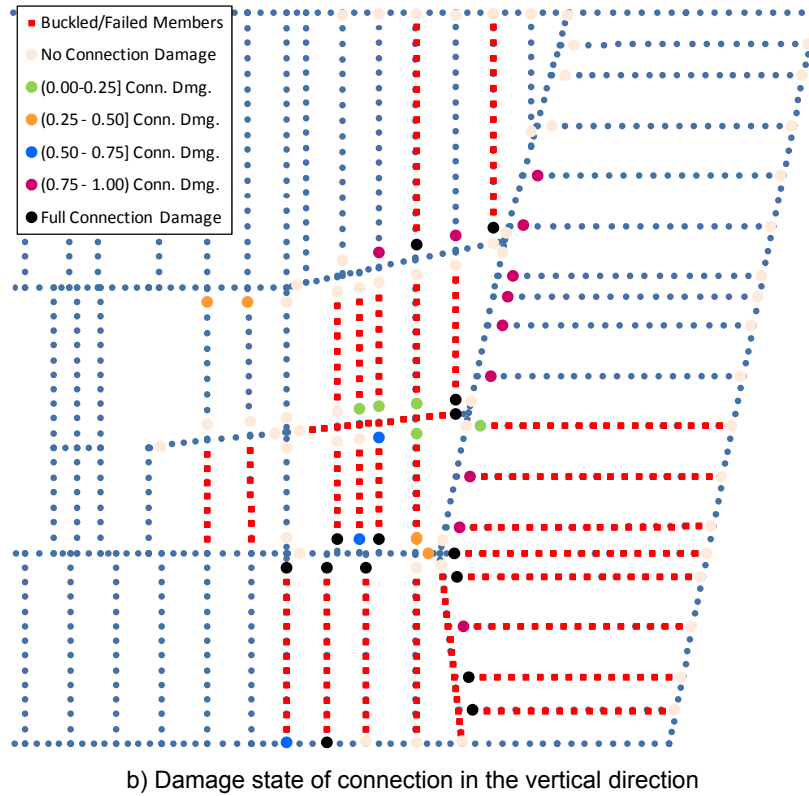
Figure 11–37. Damage state of connections, beams, and girders in Floor 14 at 4.0 h for Case B temperatures.

- **Case C 4 h.** The girder between Columns 76 and 79 failed due to tensile weld failure of the knife connection at Column 79 on Floor 11 (Figure 11–34).
Case B 4 h. After 4 h of heating, the girder between Columns 76 to 79 had failed due to tensile forces on Floors 10, 11, and 12 (Figure 11–33, Figure 11–34, and Figure 11–35).
- **Case C 4 h.** The girder between Columns 80 and 81 on Floor 14 failed (Figure 11–45).
Case B 4 h. This girder had not yet failed (Figure 11–37).

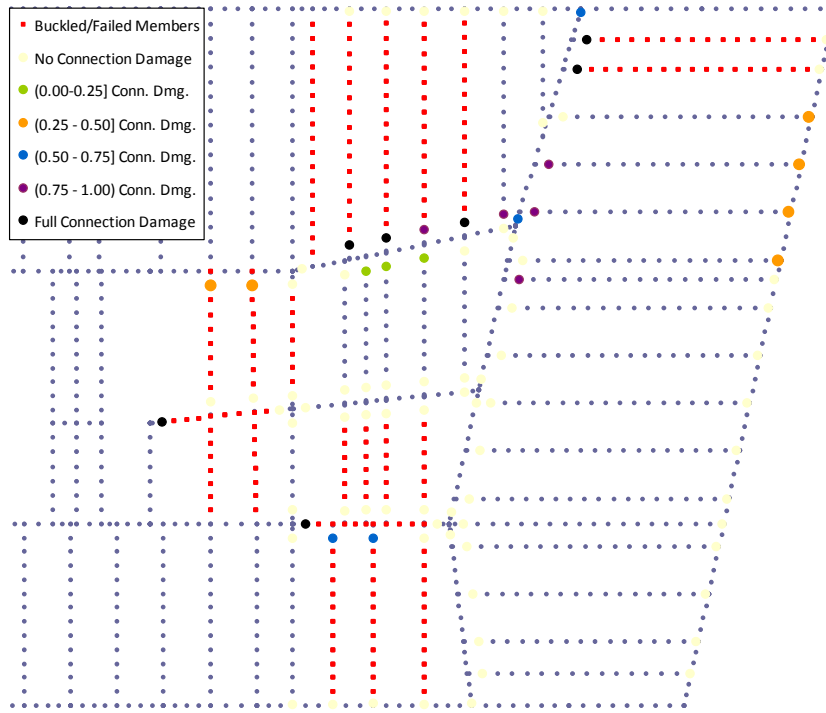
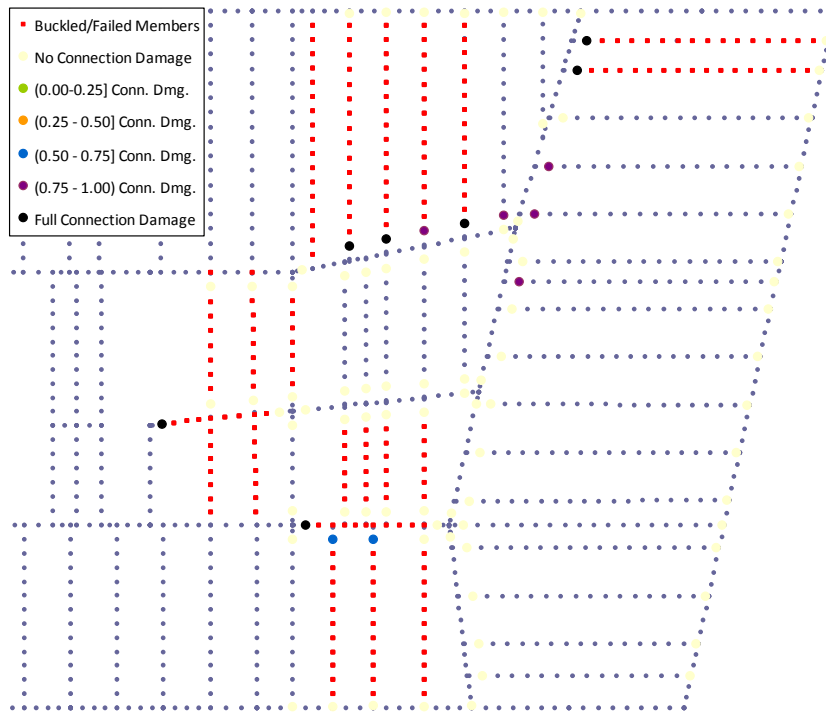
Figure 11–39. Damage state of connections, beams, and girders in Floor 8 at 4.0 h for Case C temperatures.

Floor 8. Figure 11–39 shows connection and floor framing damage that occurred. Fin connections failed for the north floor beams on Floor 8 that were attached to the girder between Columns 76 to 79 (see Figure 2-4 for column locations), due to thermal expansion in the beams, by shearing the bolts at the girder. The northeast beam-to-girder fin connections had a 0.75 to 0.99 damage level between Columns 44 and 79. The header connections failed at Columns 74 and 78, due to thermal expansion of the girder. The beams that were supported by these girders are also indicated as failed, since they would fall with the girder.
