NIST NCSTAR 1-9

**Federal Building and Fire Safety Investigation of the
World Trade Center Disaster**

**Structural Fire Response and
Probable Collapse Sequence of
World Trade Center Building 7**

VOLUME 2

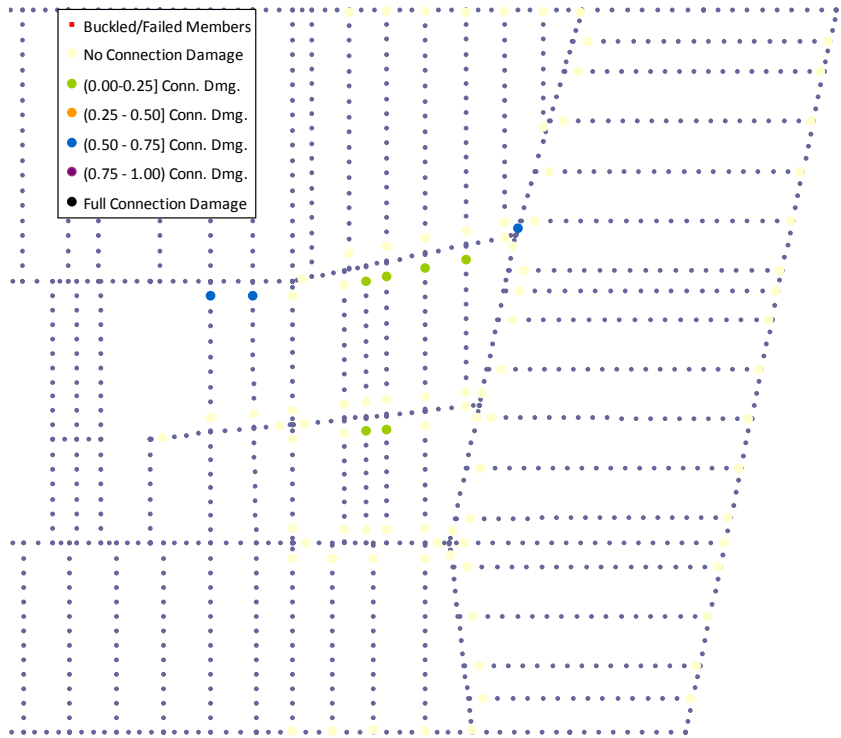
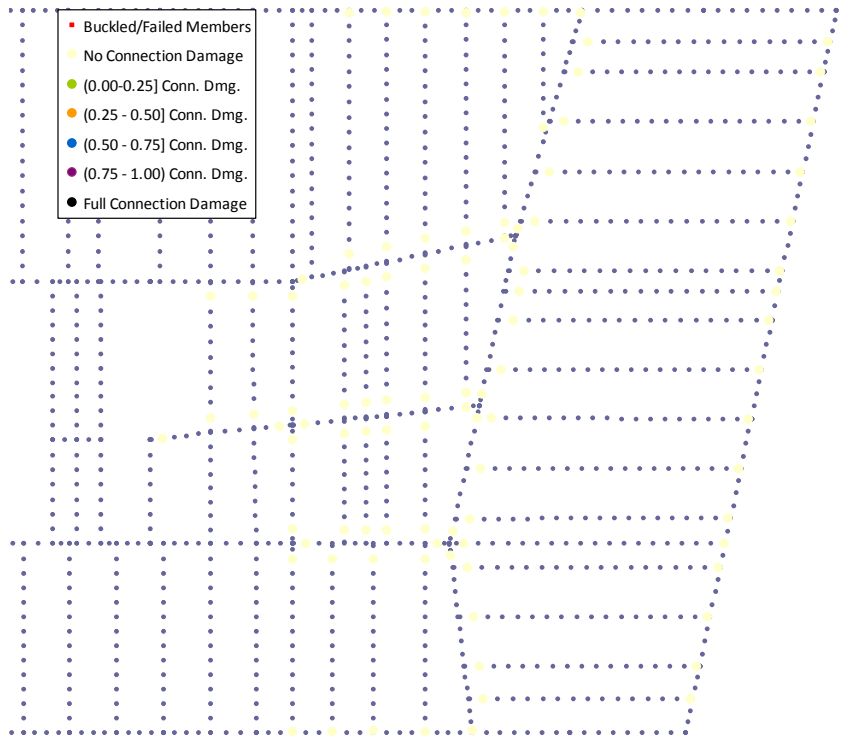
Figure 11–40. Damage state of connections, beams, and girders in Floor 9 at 4.0 h for Case C temperatures.

Floors 9 and 10. On Floor 9, SWC connections in the core area between Columns 73 to 79 had damage levels of 0.0 to 0.24 and 0.50 to 0.74, depending on the number of bolts that had sheared (Figure 11–40). Floor 10 had no damage from fire (Figure 11–41).

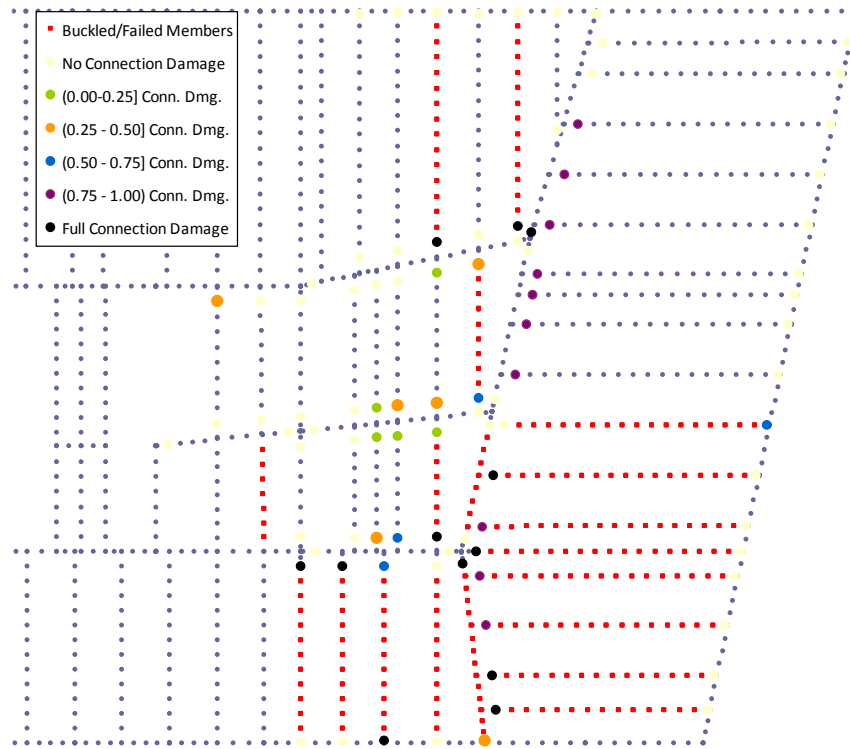
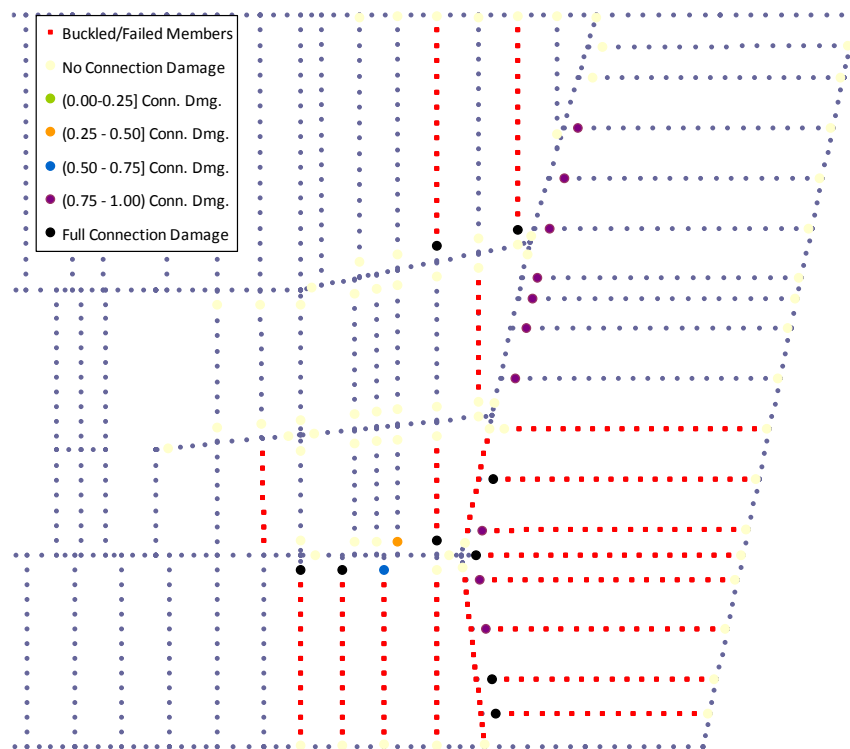
Figure 11–45. Damage state of connections, beams, and girders in Floor 14 at 4.0 h for Case C temperatures.

Floors 12, 13, and 14. On Floors 12 and 14, most of the floor beams on the south and east floor areas near Columns 78, 81, and 80 had failed. The floor beams either buckled or lost vertical support when all the fin connection bolts were sheared off due to thermal expansion. Both floors had a 0.75–0.99 damage level in floor beam fin connections extending past Column 79 in the east floor beams (Figure 11–43 and Figure 11–45). The girder between Columns 26 and 81 buckled on Floors 12 and 14 and the girder between Columns 80 and 81 buckled on Floor 14. All four of the erection bolts in the seated connection at Column 79 on Floor 14 had failed.

- **Case C 4 h.** The girder between Columns 76 and 79 failed due to tensile weld failure of the knife connection at Column 79 on Floor 11 (Figure 11–34).
Case B 4 h. After 4 h of heating, the girder between Columns 76 to 79 had failed due to tensile forces on Floors 10, 11, and 12 (Figure 11–33, Figure 11–34, and Figure 11–35).
- **Case C 4 h.** The girder between Columns 80 and 81 on Floor 14 failed (Figure 11–45).
Case B 4 h. This girder had not yet failed (Figure 11–37).

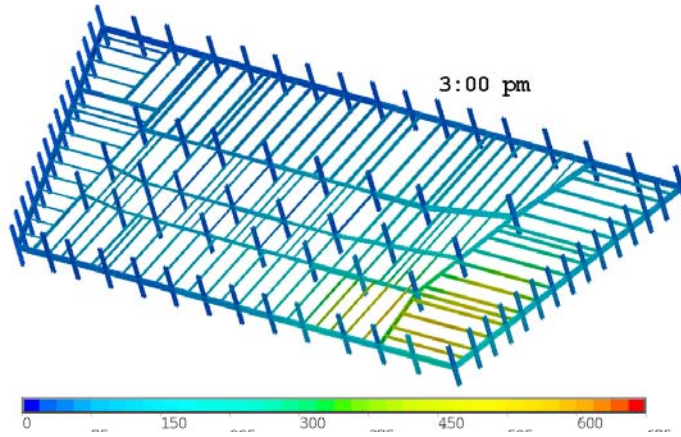
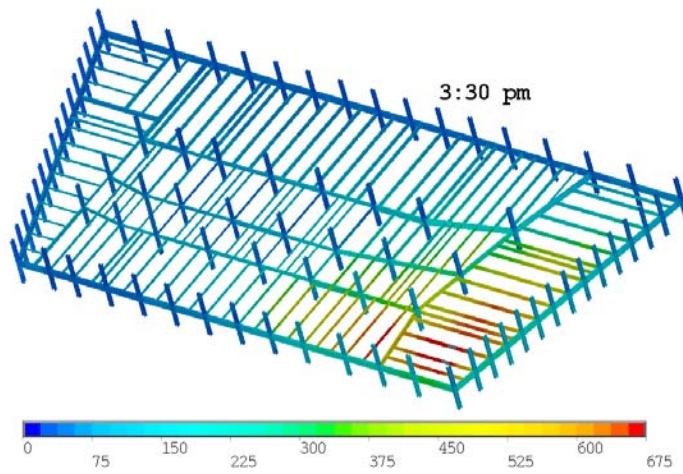
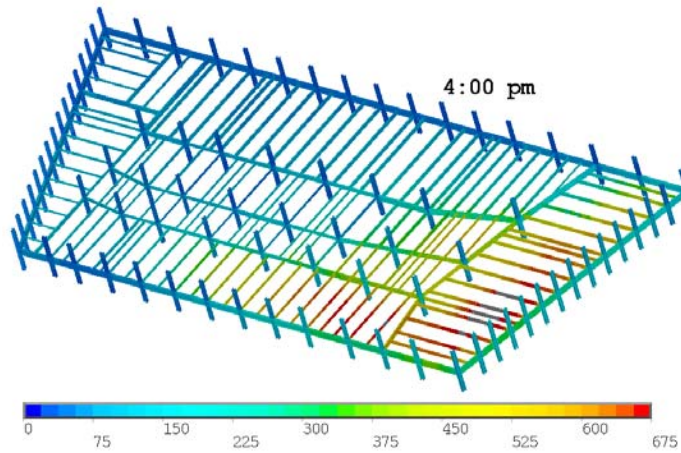
Figure 11–47. Floor 13 Case B temperatures at 3.0 h, 3.5 h, and 4.0 h.

Figure 11–47 shows temperatures in the steel framing for Floor 13 at 3.0 h, 3.5 h, and 4.0 h (Chapter 10). The temperature in the steel framing was linearly ramped between the temperatures at 3.0 h and 3.5 h, and at 3.5 h and 4.0 h, as the ANSYS structural analysis progressed. Figure 11–48 and Figure 11–49 show the floor beams and girders that had failed at different points in time as the temperatures were applied. Beams and girders subject to fires were loaded and/or displaced by the combined effects of gravity loads from the floor slab and compressive axial forces that developed due to thermal expansion that was restrained by the structural system. At temperatures below approximately 400 °C (when averaged over the beam length), thermal expansion effects caused two types of failures in the floor beams and girders: the buckling of beams and girders and the failure of end connections (discussed in the next section). At temperatures greater than 400 °C, the strength and stiffness of the steel floor beams, girders, and their connections began to degrade, depending on the component temperatures reached.

Figure 11–48 shows the east floor beam failures (due to buckling and connection failures) that occurred between 3.25 h and 3.5 h on Floor 13. Comparison of Figure 11–47 and Figure 11–48 showed that floor beams had failed prior to the beam temperatures reaching 400 °C.

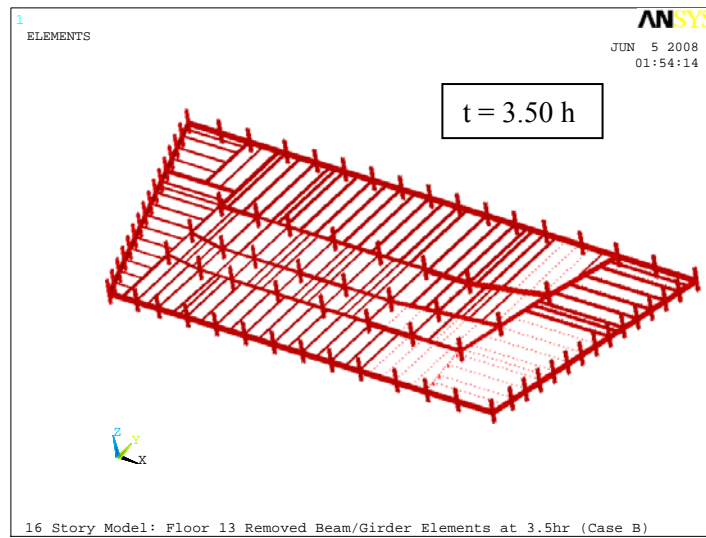
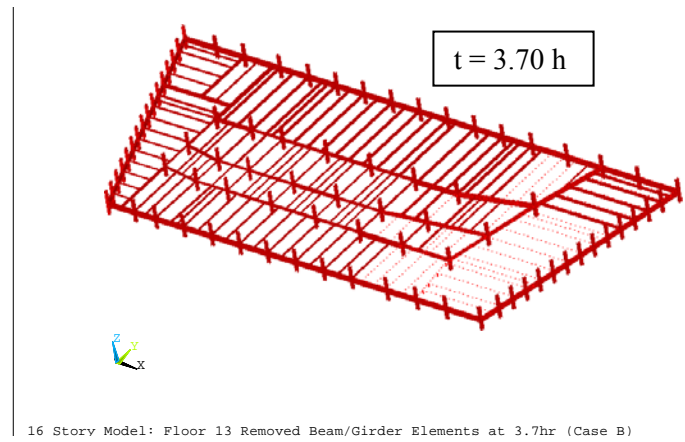
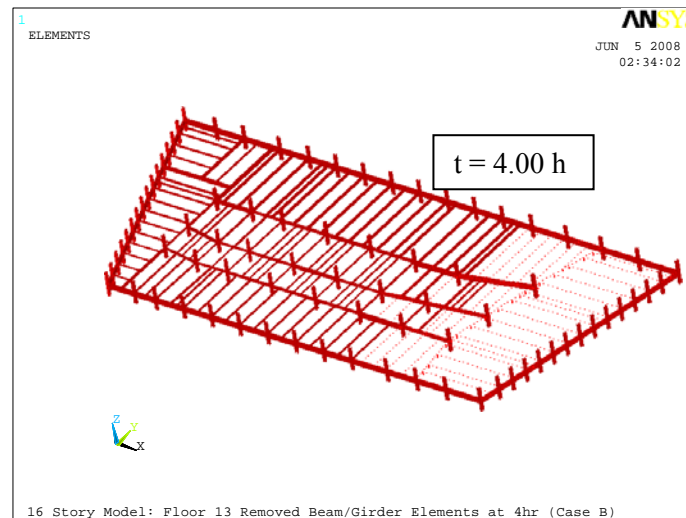
Figure 11–49. Floor 13 Case B temperatures at 3.5h to 4.0 h.

Beams and girders that buckled or had end connection damage are indicated with dotted lines.

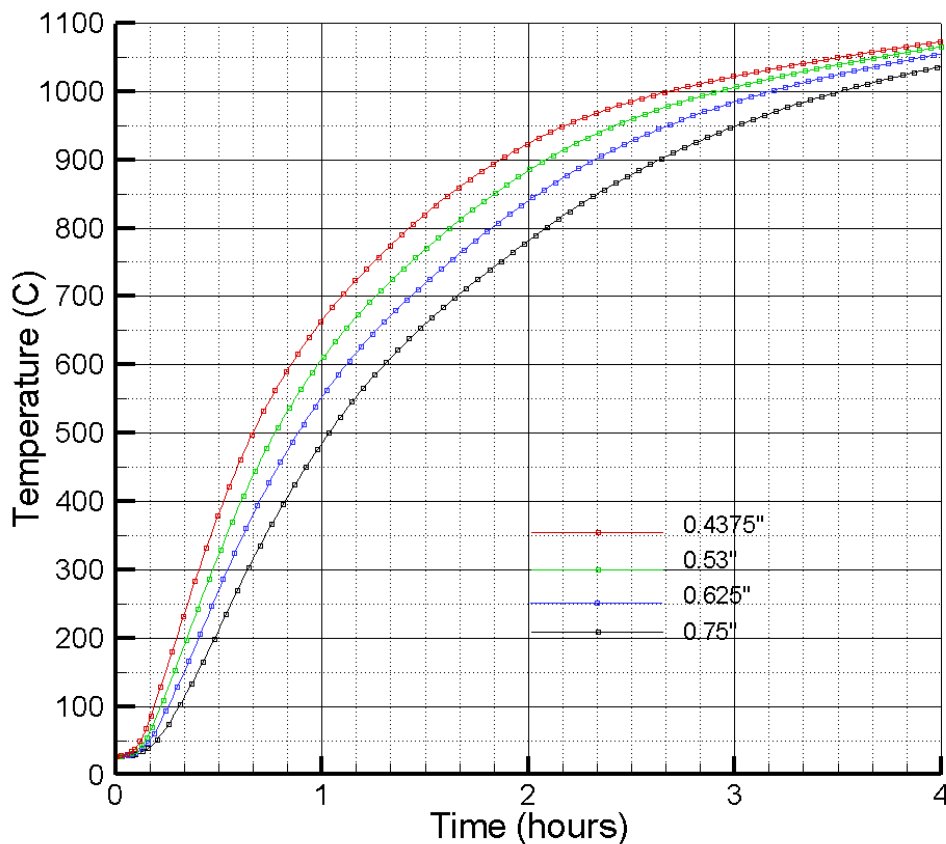
Figure 11–51. Heating of a typical floor beam (W24 x 55) subject to a uniform 1100 °C gas temperature for different SFRM thicknesses.

Thus, an increase in the SFRM thickness on the floor beams would have delayed heating of the floor beams by 10 min to 20 min, which was unlikely to have prevented the heating of the floor system and initiation of collapse.

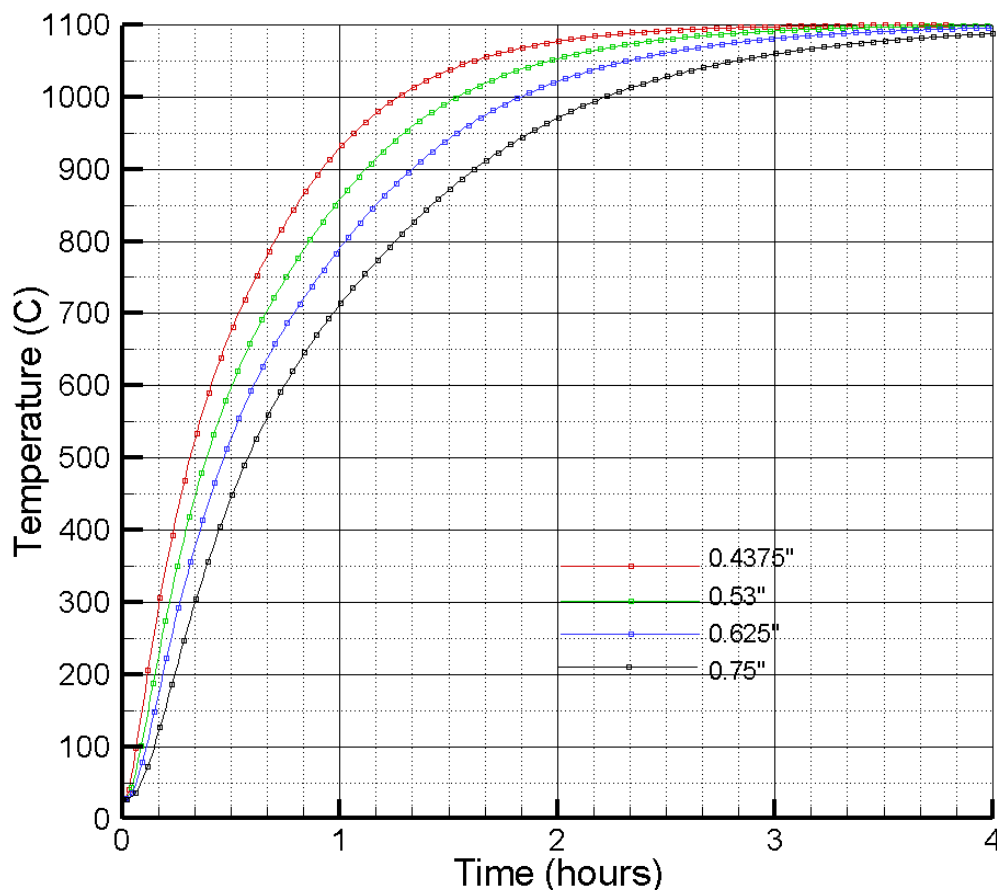
Figure 11–52. Heating of a typical floor beam (W24 x 55) subject to an ASTM E 119 temperature profile for different SFRM thicknesses.

When the steel beam reached 600 °C under the ASTM E 119 temperature curve, the additional protection provided by increasing the SFRM thickness to 0.625 in. (5/8 in.) or 0.75 in. (3/4 in.) was approximately 8 min to 15 min, as shown in Figure 11–52.

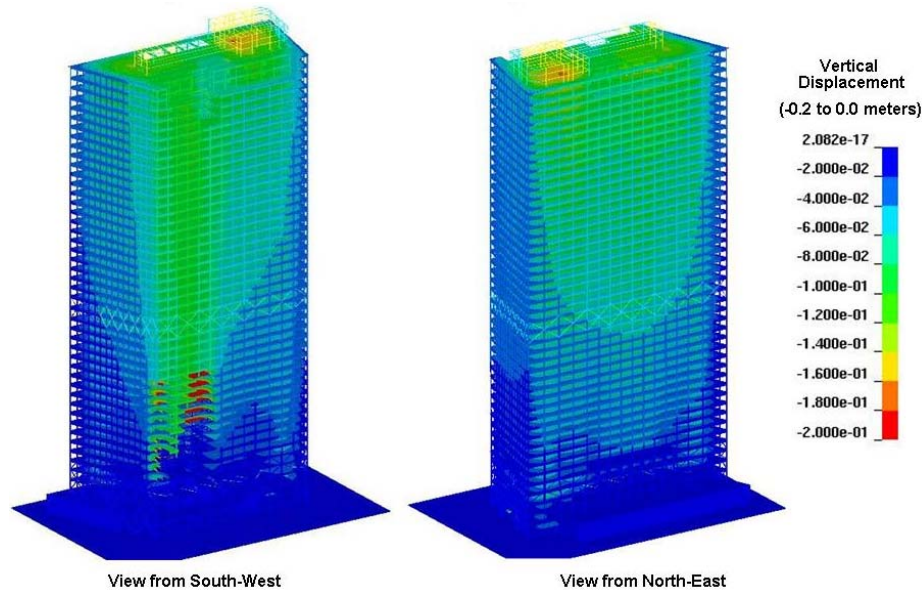
Subsequent to the application of the gravity loads, damage due to debris impact from the collapse of WTC 1 was applied to the global 47 story model. Figure 12–39 presents the vertical displacements due to debris impact damage application. The figure shows a downward displacement of up to 8 in. (about 1/900 of the total building height) on the south face toward Zone 1 damage due to column removal. The analysis shows that the building remained stable and that columns and floors above the damaged zone were able to redistribute the loads through Vierendeel truss action.

Figure 12–39. Calculated vertical displacements after impact damage.

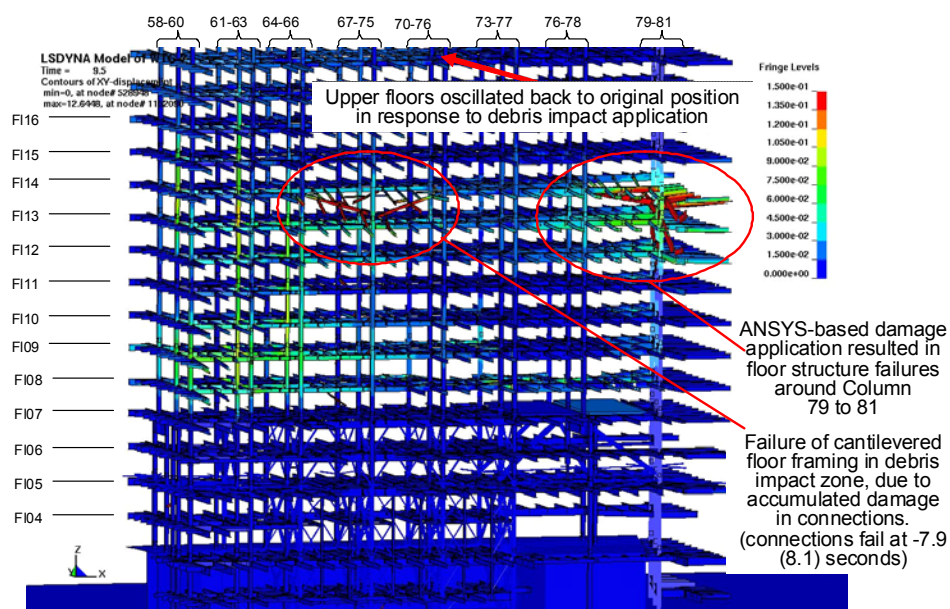
After the fire-induced ANSYS damage was applied, floor sections surrounding Columns 79 to 81 on Floors 13 and 14 collapsed to the floors below, as shown in Figure 12–42. The LS-DYNA analysis

calculated the dynamic response of the structure to the floor failures and resulting debris impact loads on the surrounding structure. The thermally weakened floors below the initial collapse event could not withstand the impact from the collapsing floors, and resulted in sequential floor collapses. The floor systems progressively failed down to Floor 5, where the debris accumulated, as shown in Figure 12–42.

Figure 12–42. The collapse of Floors 13 and 14 in the northeast region [Time: -6.5 (9.5) s]

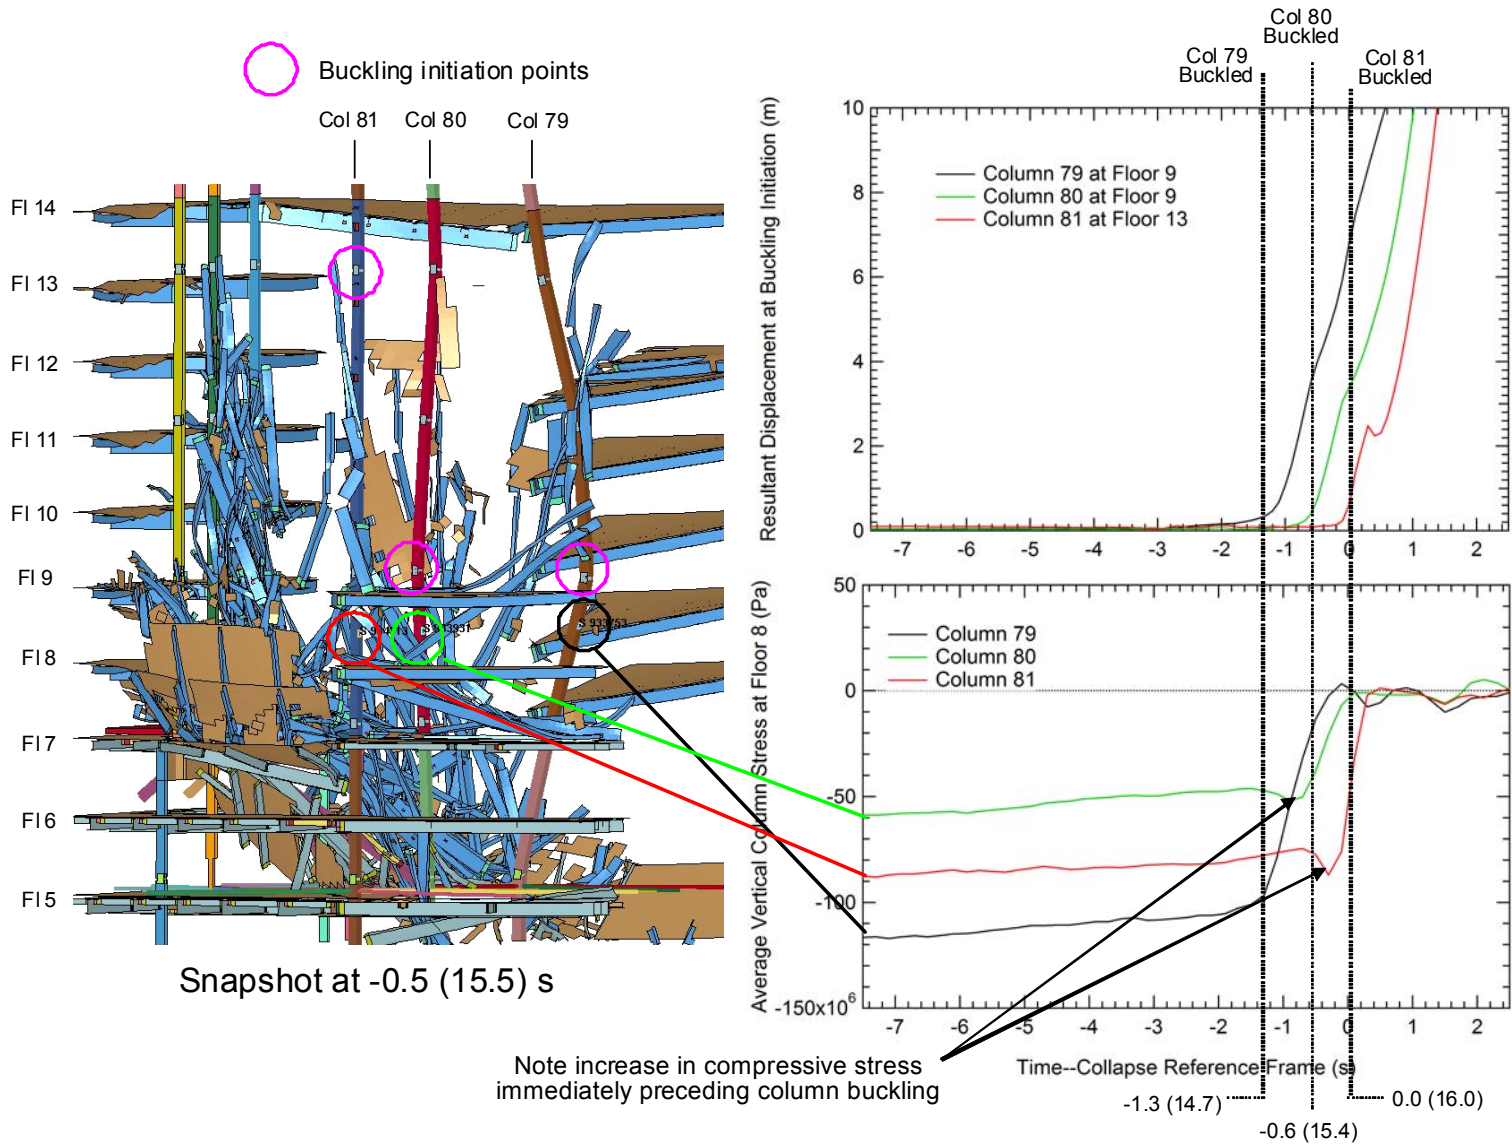
Figure 12–43 is a cutaway view that illustrates the structural condition surrounding Column 79 as it buckled to the east. The plot in Figure 12–43 shows that Column 79 buckled 1.3 s before the kink was observed in the East Penthouse roof framing (which occurred at 0 (16.0) s in the analysis). Figure 12–43 includes resultant lateral displacements and column axial stress histories for Columns 79 to 81. The rapid lateral displacement indicates column buckling. Likewise, the column stresses indicated a rapid loss of stress at the time, signifying column buckling. Column 79 was laterally unsupported in the east-west and south directions between Floors 5 and 14. There was still some lateral support in the north direction at Floors 8 to 12 and Floor 14, as the erection bolts in the seated connections had all failed at these girder ends, but the girders had not walked off the bearing seat. Thus, the north girder connection possibly prevented lateral displacement in the north direction, but provided no resistance to lateral displacements in the east, west, or south direction. At Floor 14, the girder to the west of Column 79 (between Column 79 and 76) was still attached and provided lateral restraint from the west. Figure 12–44 illustrates the girder-to-column connection status at the time of buckling of Column 79.

Figure 12-43. Column 79 to 81 stress and displacements.

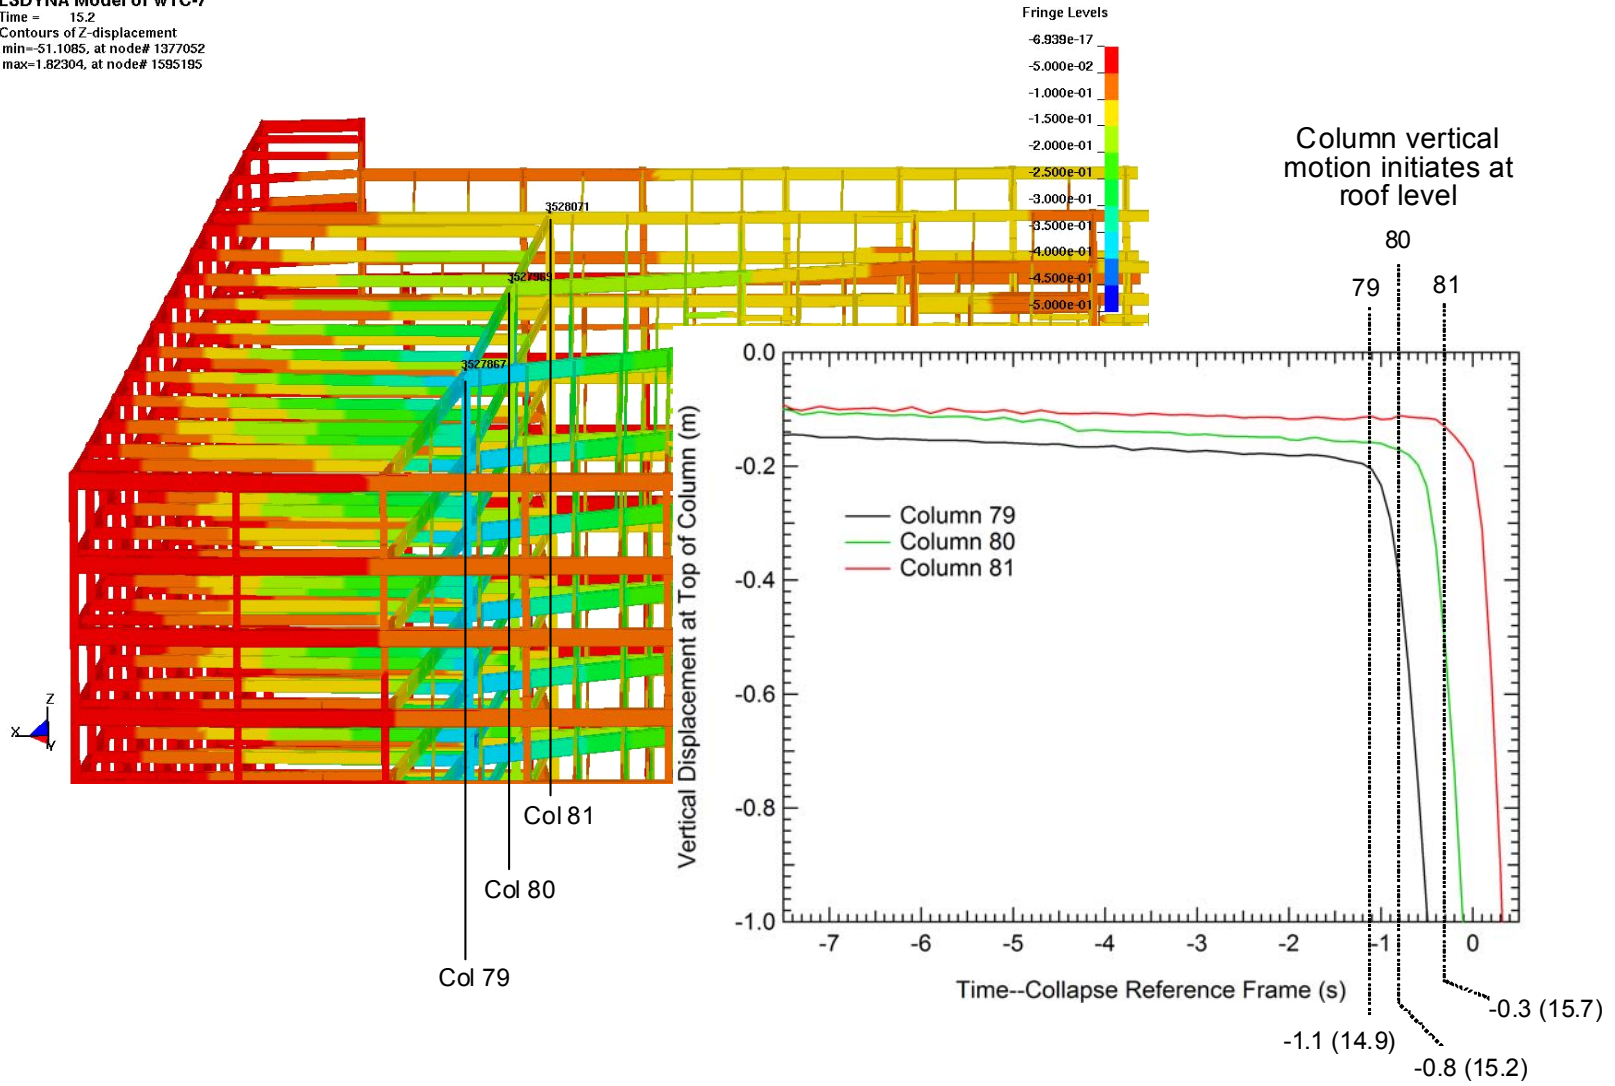
Figure 12-45. Column 79-81 vertical displacement with contours from -0.5 m to 0 m.

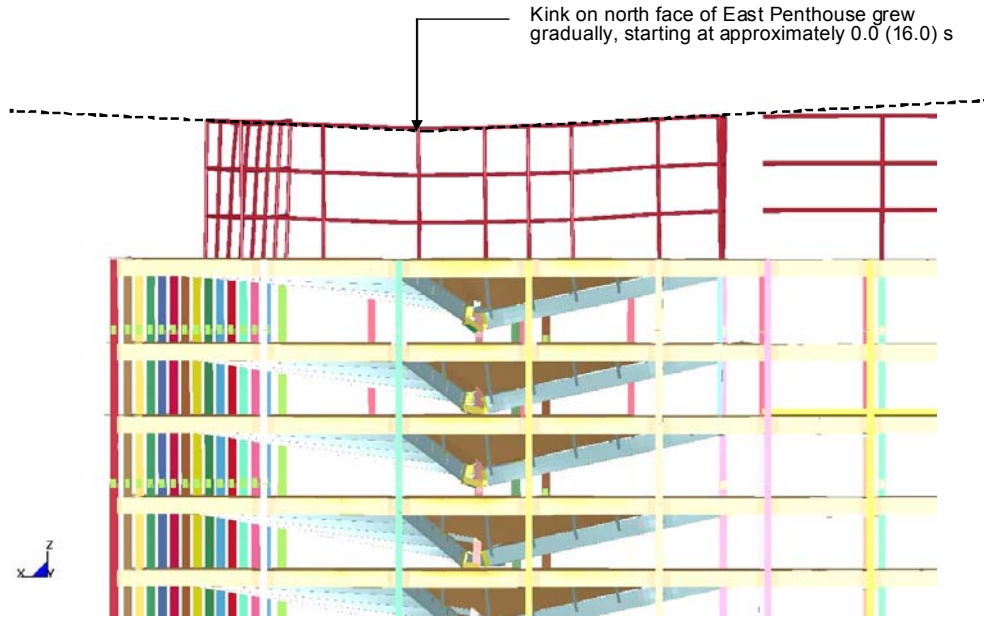
- Once Column 79 buckled, the column section above Floor 14 began to descend downward. Column 79 began moving downward at the roof level approximately 0.2 s after Column 79 buckled and 0.6 s before Column 80 buckled.
- As Column 79 moved downward, the floor framing adjacent to Column 79 was pulled downward, which led to the observed kink in the East Penthouse roof framing on the north side.

Figure 12-46. Kink on East Penthouse as it moves downward [Time 0.2 (16.2) s]. View from north.

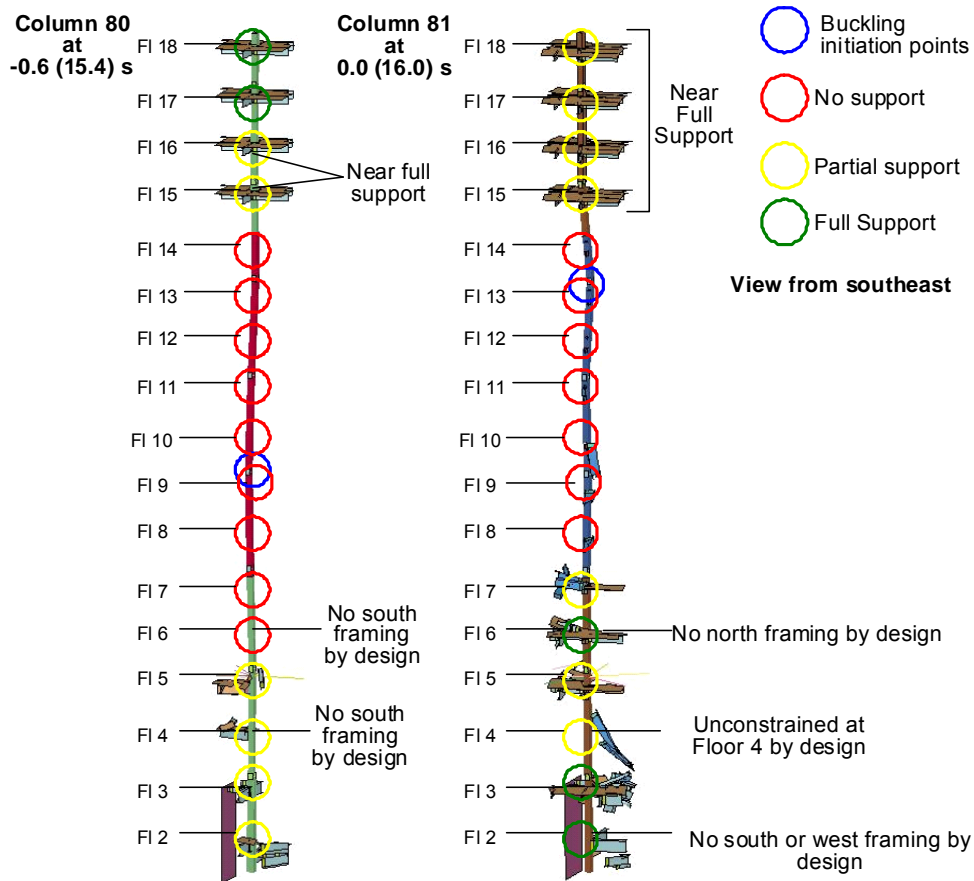
- Column 80 became laterally unsupported in both directions between Floors 5 to 15, as a result of the progressive floor system failures. Column 80 buckled about 0.8 s after Column 79 buckled.

Figure 12-47. Columns 80 and 81 lateral support status at time of buckling initiation.

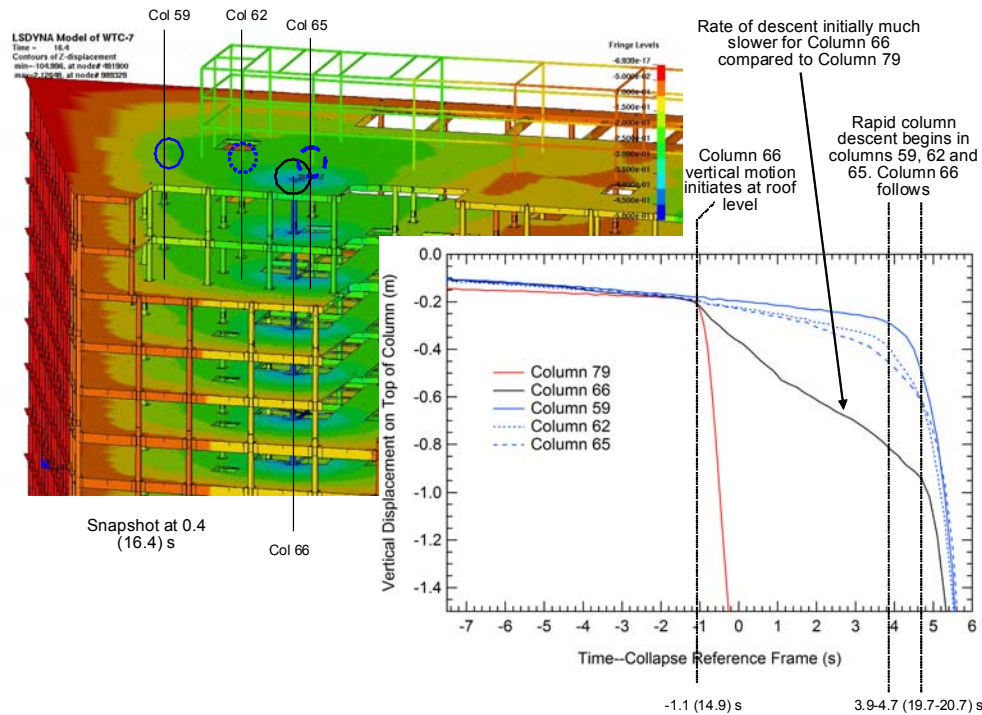
Figure 12–56. Western core column vertical displacements (contours: -0.5 to 0 m).

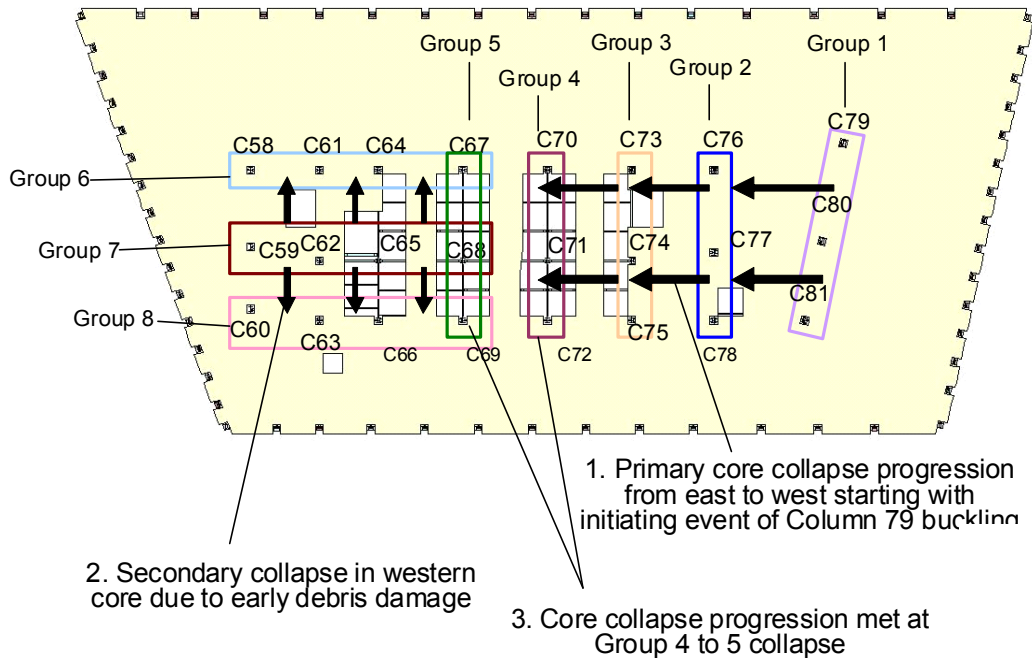
12-57 shows the general westward progression of interior column failures. Corresponding loads for the column groups 1 to 5 during the horizontal progression of buckling are shown in Figure 12-58. Column group 1 (Columns 79, 80, and 81) failed at -0.5 s before the kink was observed in the East Penthouse, and column groups 1 to 5 had failed by 6.3 s. Column loads for column groups 6 to 8 are shown in Figure 12-59. Column group 7 failed at 4.3 s and column groups 6 to 8 had failed by 6.3 s. At this time, all the interior columns had buckled.

Figure 12-57. Horizontal progression of column buckling and interior column groupings.

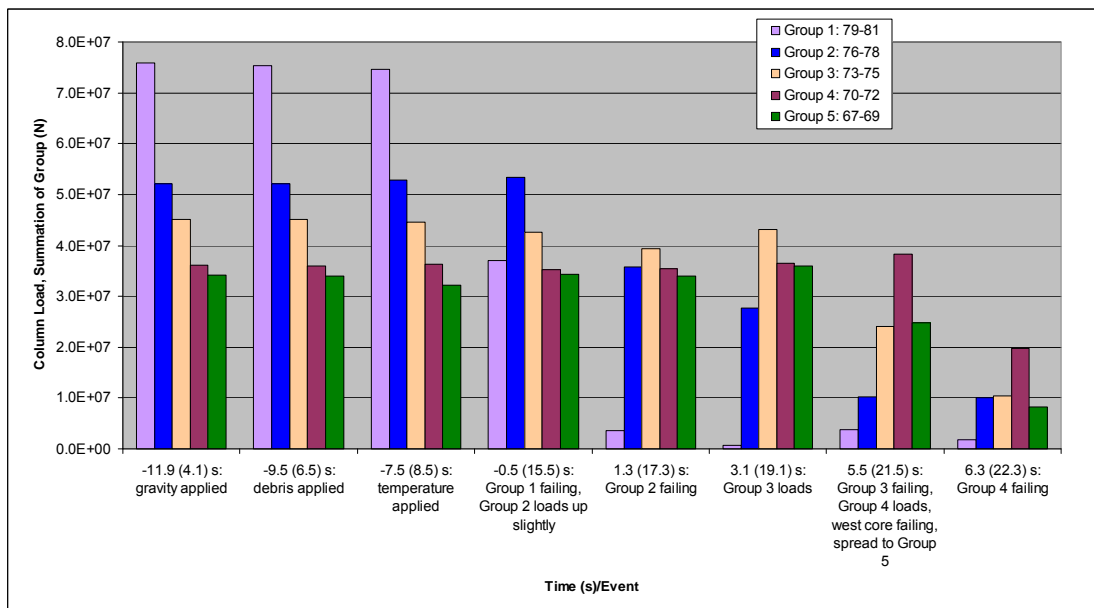
Figure 12-58. Interior column loads illustrating east to west collapse progression.

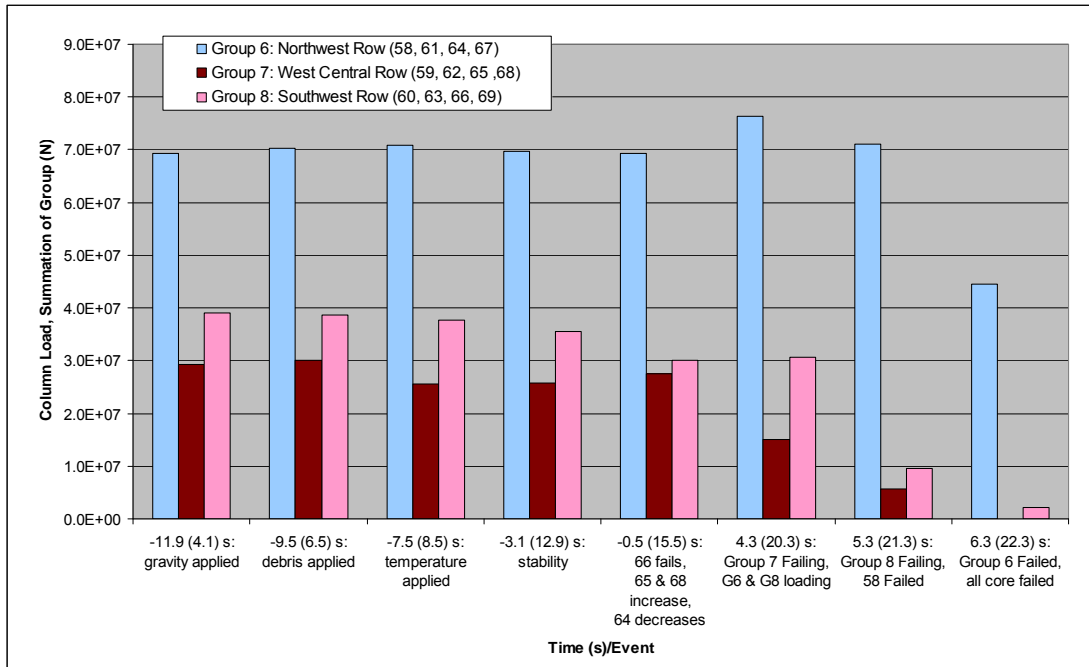
Figure 12–59. West interior column loads illustrating progression of failure.

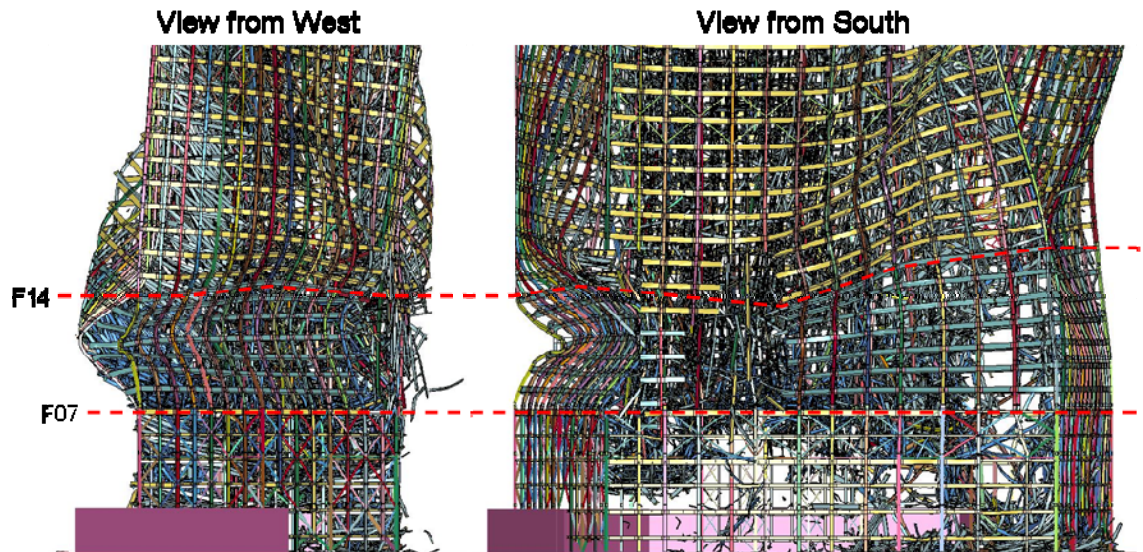
When all the exterior columns had buckled, the entire building above the buckled-column region moved downward as a single unit, resulting in the global collapse of WTC 7. Detailed views of the lower exterior column buckling are shown in Figure 12–62.

Figure 12–62. Exterior column buckling at lower floors (slabs removed from view).

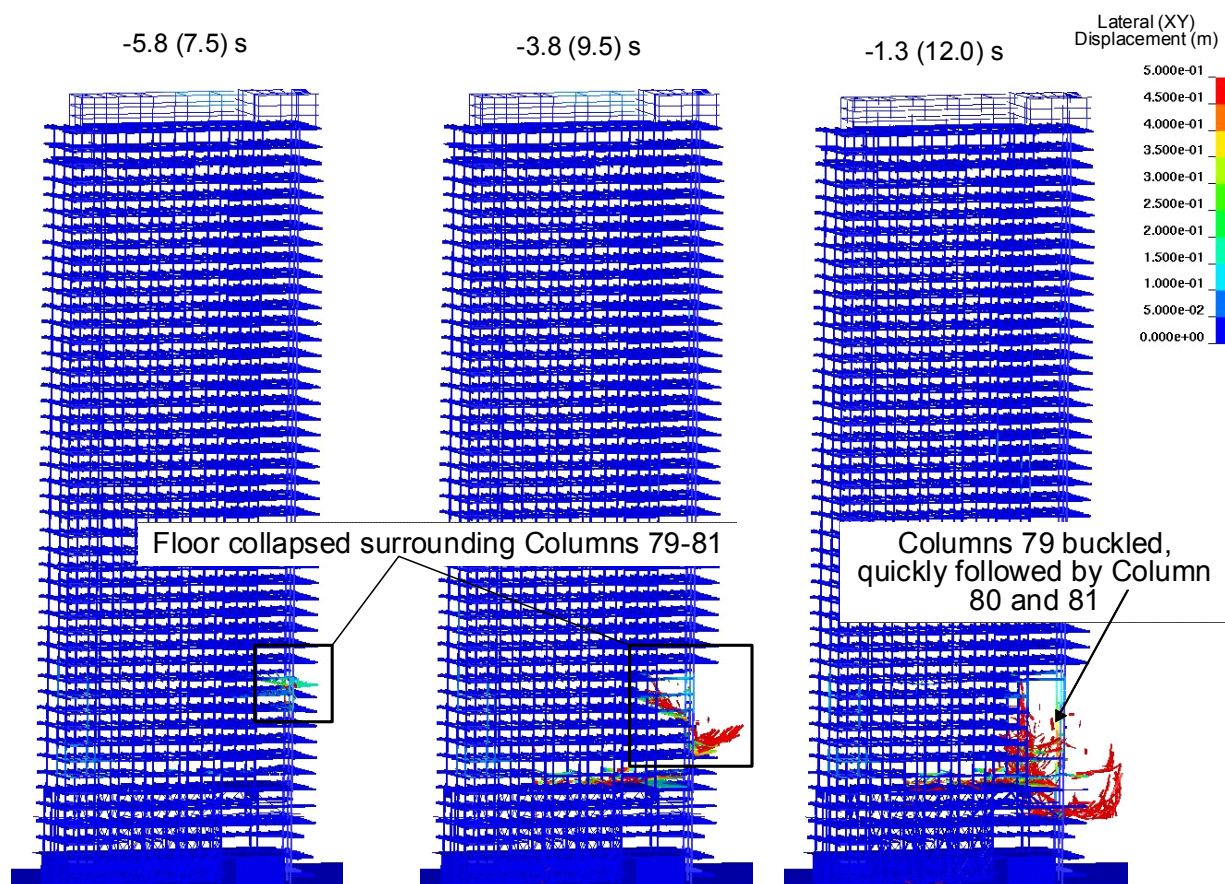
Figure 12–65 shows the structural response from just after application of the fire-induced damage to 1.3 s prior to the kink formation in the East Penthouse. The left and center images show the failures that started in Floors 13 and 14, and the cascade of floor failures that occurred subsequently, due to their thermally weakened condition. The right image shows the loss of lateral support around Column 79 and the start of Column 79 buckling. Similar response was shown in Figure 12–42 for the global analysis with impact damage. Note that in this stage of the analysis, relative to the analysis with debris impact damage, there was no early development of western core column buckling that was caused by the application of debris impact damage.

Figure 12–65. Core collapse sequence viewed from the south. Time: -5.8 s to -1.3 s (7.5 s to 12.0 s). Contours of resultant lateral displacement 0 in. to -20 in. (0 m to -0.5 m).

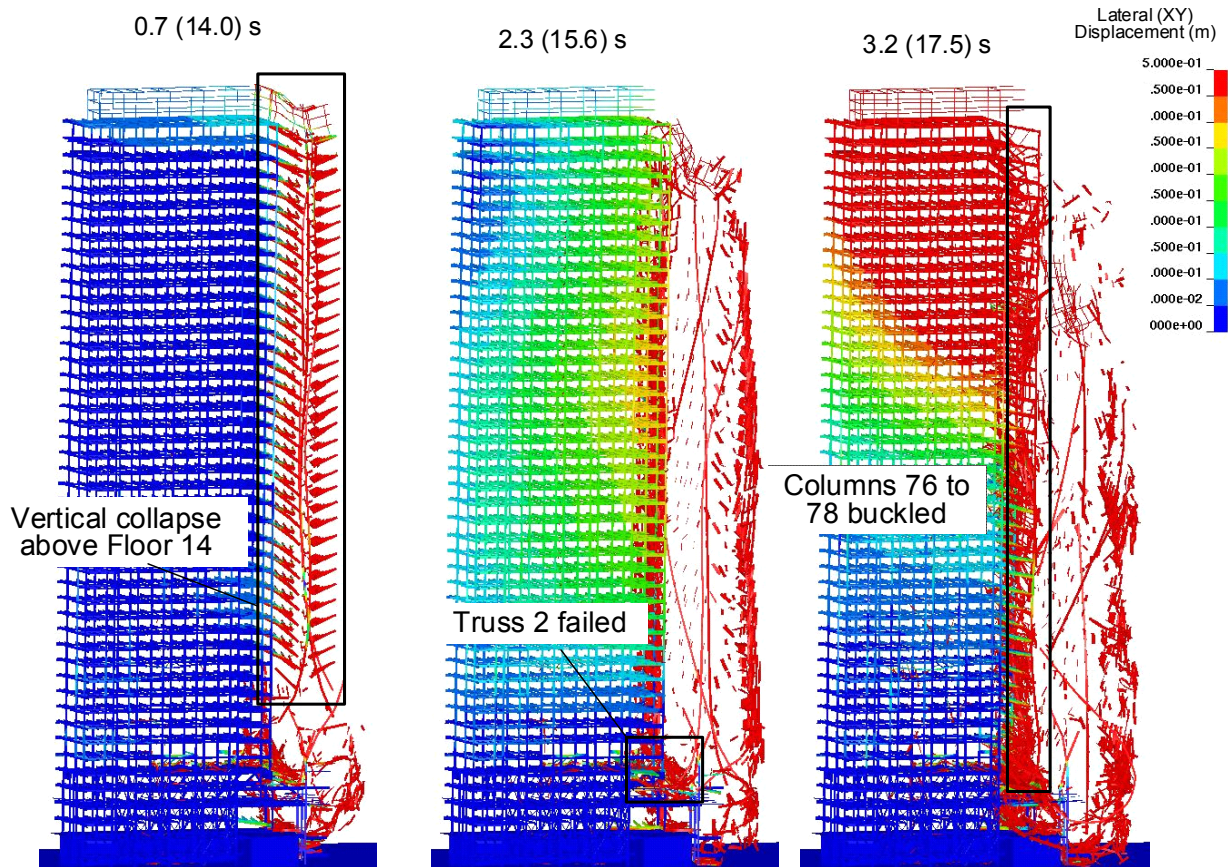
Figure 12–66 shows the structural response from 0.7 s (14.0 s), shortly after the East Penthouse kink was observed, to 3.2 s (17.5 s), when Columns 76 to 78 buckled as the horizontal progression of failure began. The left image shows the vertical progression of failure. The center image shows the loss of lateral support to Columns 76 to 78, as well as the failure of Truss 2, due to the effects of debris accumulation and impact during the vertical progression of failure. The right image shows the buckling of Columns 76 to 78. Similar responses were shown in Figure 11–49, Figure 12–49, and Figure 12–53 for the global analysis with impact damage.

Figure 12–66. Core collapse sequence viewed from south. Time: 0.7 s to 3.2 s (14.0 s to 17.5 s). Contours of resultant lateral displacement 0 in. to -20 in. (0 m to -0.5 m).

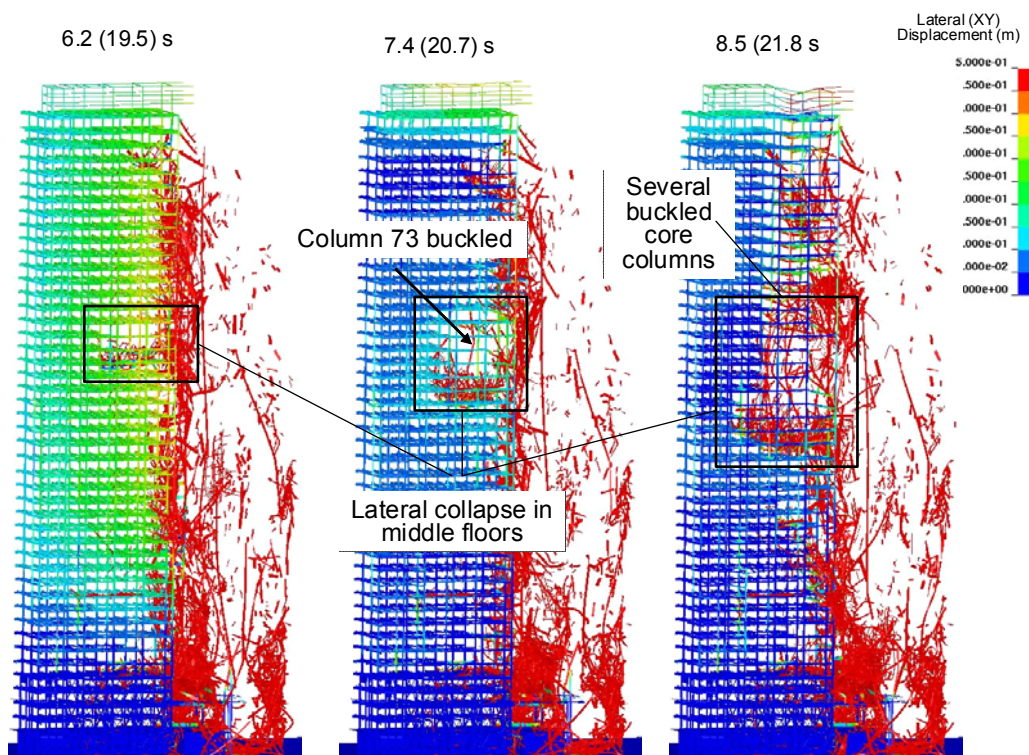
The progression of horizontal failure in the analysis without debris impact damage was due to loss of lateral support as floors failed, the effect of debris impact from adjacent failing floors and columns, and load redistribution. The right image in Figure 12–67 shows that the screening wall fell downward prior to the West Penthouse (view is from the southwest), which is consistent with the observed sequence of events. In the analysis without impact damage, the horizontal progression continued to move westward after Columns 70 to 72 buckled. In the analysis with impact damage (Section 12.4.4), the horizontal progression moved westward until Columns 70 to 72 buckled, after which the damaged west core columns also buckled.

Figure 12-67. Core collapse sequence. Time: 5.5 to 7.8 s (21.5 to 23.8 s). Contours of resultant lateral displacement 0 to -20 in. (0 to -0.5 m).

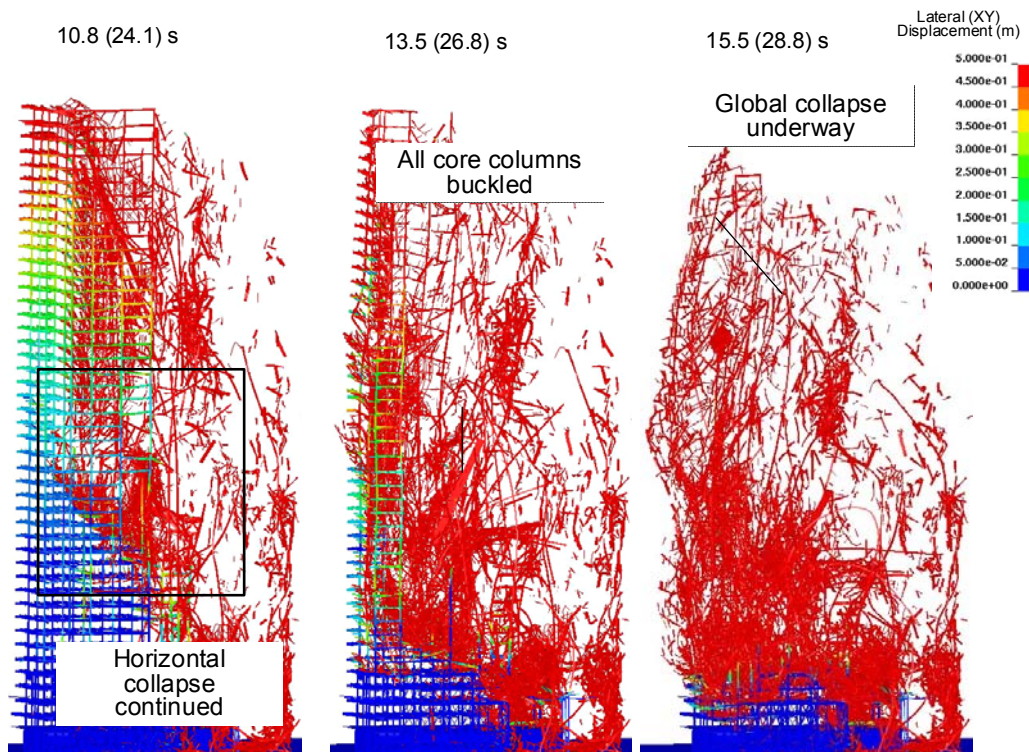
As the horizontal progression moved from east to west, some differences began to occur relative to the analysis with impact damage, as shown in Figure 12–67 and Figure 12–68. Some floors failed at mid-height of the building around Columns 73 to 75, leading to the buckling of some interior columns at this location, rather than at lower floors. Between 6.2 (19.5) s and 13.5 (26.8) s, the damage progressed westward and downward across the core as floor structures failed and fell onto the floors below. The horizontal progression in the analysis without debris impact damage moved from east to west over a longer duration. This was due to the lack of western core damage that was caused by debris impact damage in the earlier calculation.

Figure 12-68 Core collapse sequence viewed from the south. Time: 10.8 to 15.5 s (24.1 to 28.8 s). Contours of resultant lateral displacement 0 in. to -20 in. (0 m to -0.5 m).
