NIST NCSTAR 1-9

**Federal Building and Fire Safety Investigation of the
World Trade Center Disaster**

**Structural Fire Response and
Probable Collapse Sequence of
World Trade Center Building 7**

VOLUME 2

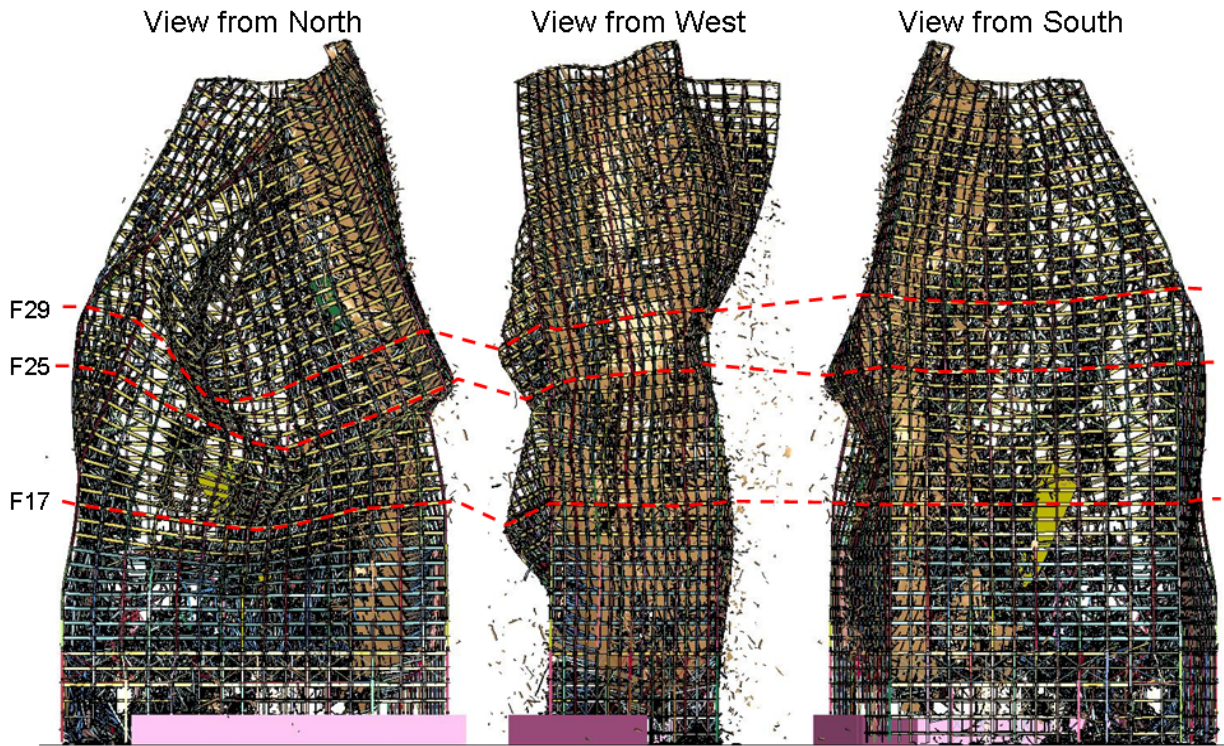
By 13.5 (26.8) s, all the interior columns had buckled and, at 15.5 (28.8) s, the global collapse (i.e., buckling of exterior columns) was underway, as shown in Figure 12–69. The exterior columns buckled near mid-height of the building, approximately between Floors 17 and 29.

Figure 12–69 Exterior buckling after global collapse initiation.

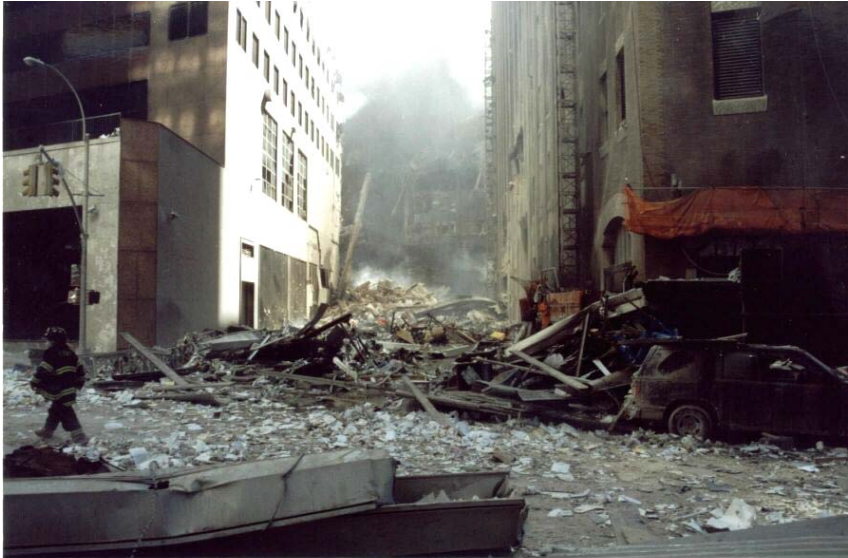
Figure A-4. Northwest corner of the Con Edison substation (building on left), showing light damage from WTC 1 debris. (Photo taken sometime in the afternoon on Sept. 11, 2001.)

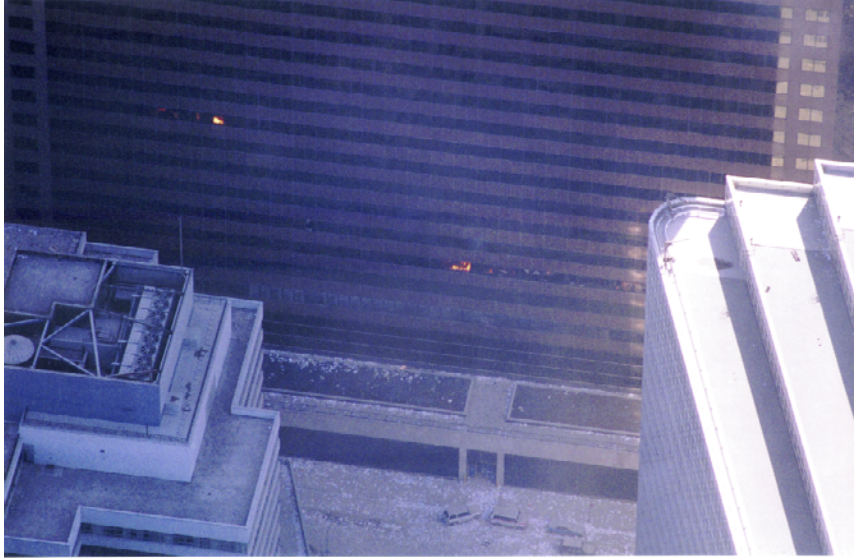
Figure A-5 shows another view of the Con Edison portion of WTC 7, shot from a police helicopter between about 1:00 p.m. and 3:00 p.m. Fires can be seen on the 7th and 12th floors of WTC 7. Light debris is visible on the grill work which formed the roof of the north portion of the Con Edison substation; this portion of the Con Edison substation appears to be intact, with no visible evidence of smoke. No photograph, video record, or witness account gathered during the investigation identified smoke or flames originating from the Con Edison portion of WTC 7.

Figure A-5. Aerial view of the middle of the north side of the Con Edison substation, taken sometime between 1 p.m. and 3 p.m. on September 11, 2001.

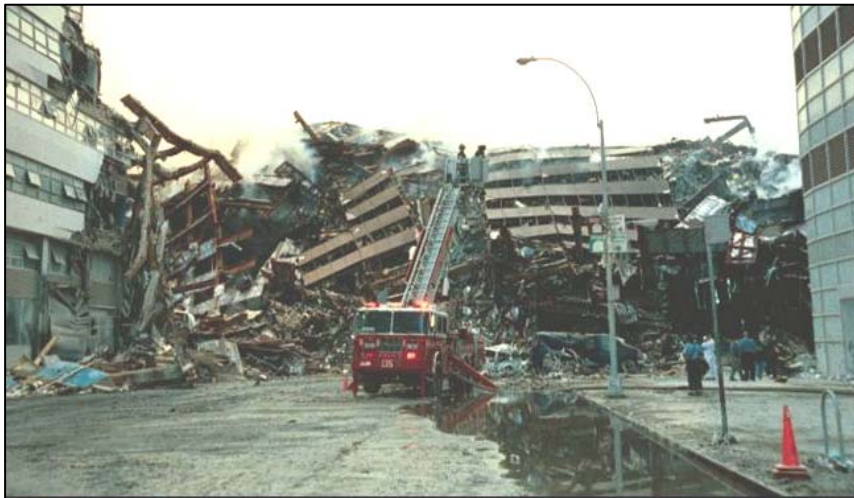
The collapse of WTC 7 buried the Con Edison structure and all the equipment in it. Figure A-6 shows the collapsed building at the beginning of the salvage and clean up operations, viewed looking south from Greenwich Street.

Figure A-6. Debris pile from collapse of WTC 7 onto the Con Edison substation, viewed looking south from Greenwich Street, date undetermined.

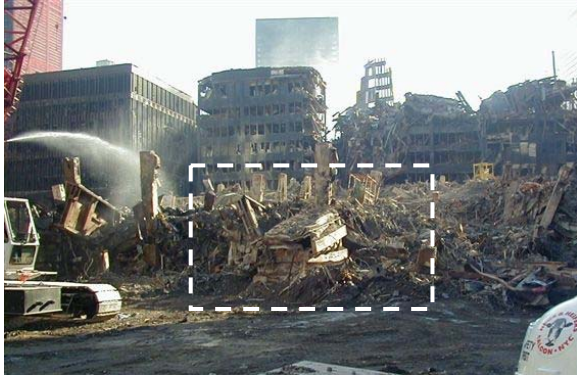
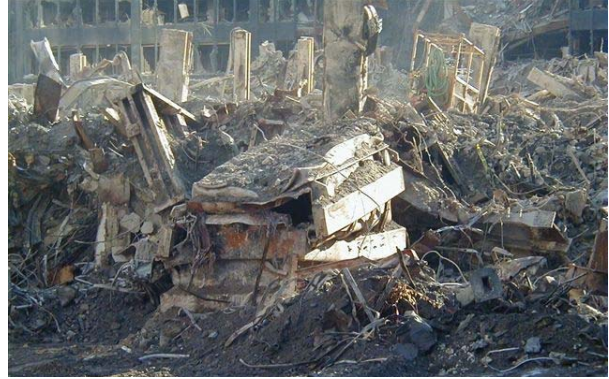
The left photograph in Figure A-7 was taken about five weeks after September 11, 2001. It shows the remnants of the Con Edison substation after the removal of much of the debris. The area outlined in a dotted white line is enlarged in the right photograph in Figure A-7A. From its location in the pile, this appears to be transformer #4, but also may be #8 or #9. The interior of this transformer was described as being severely thermally damaged, possibly by fire (G&S Technologies 2005e)¹³.

Figure A-7. Photographs taken on mid-October, 2001, showing Con Edison transformer #4 (or #8 or #9) uncovered from the debris pile of WTC 7.

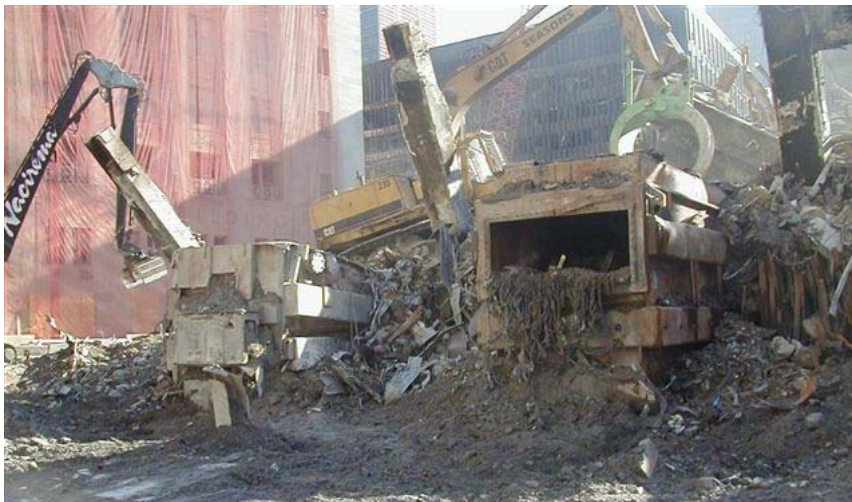
A similar assessment of thermal damage was made for transformer #1, shown on the right in Figure A-8. This is in contrast to transformer #6, which is the unit on the left in Figure A-8. The gray paint on transformer #6 is clearly evident, with little indication of rust or excessive heat.

Figure A-8. Photograph taken in mid-October, 2001, showing Con Edison transformers #6 and #1 uncovered from debris pile of WTC 7.

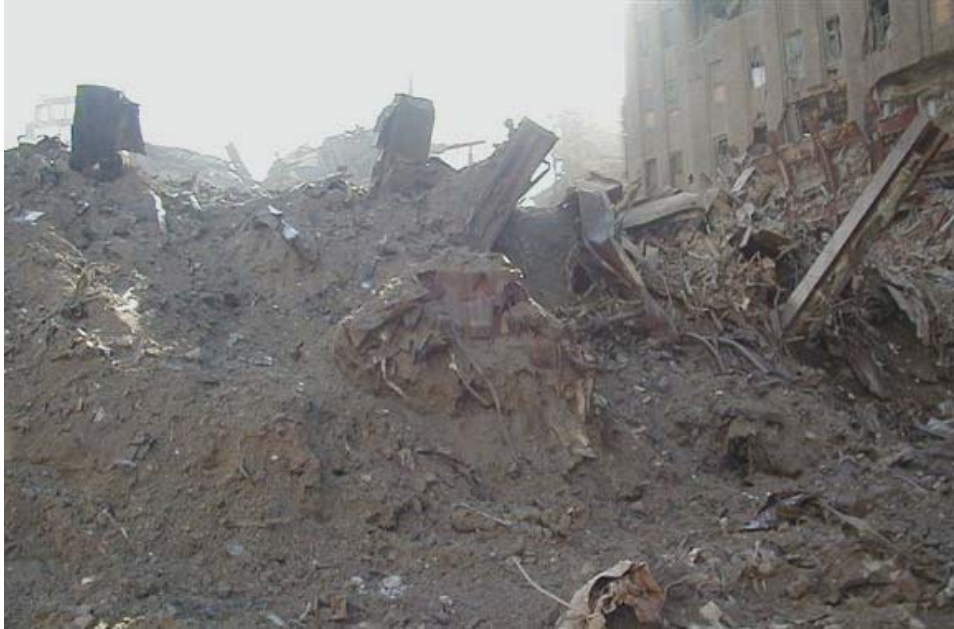
Transformer #7 (or possibly #5) is barely visible within the white box in Figure A-9. This transformer and the other three depicted in Figures A-7 and A-8 were not salvageable and were discarded (G&S Technologies 2005e)⁴.

NIST was unable to determine whether the thermal damage to the transformers occurred due to electrical overheating, due to a fire in the substation after the SCADA logs were terminated around 4:33 p.m., or due to burning within the rubble pile subsequent to the collapse of WTC 7.

Figure A-9. Con Edison transformer #7 (or #5) uncovered from debris pile of WTC 7; photo taken mid-October, 2001.

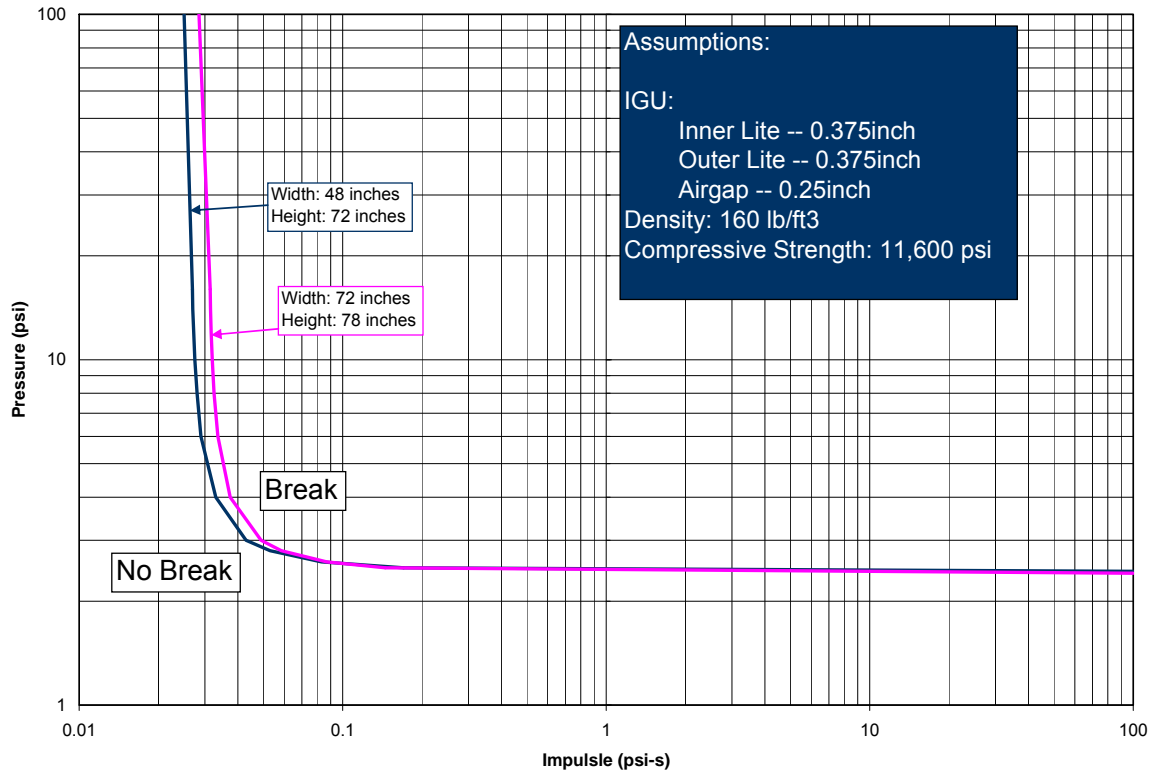
Figure D-8. Pressure-impulse requirements for WTC 7 window breakage.

The SFOM window fragility analysis was conducted using available and assumed window details. The resulting P-I curves for two window sizes are shown in Figure D-8. The P-I curves indicate that a minimum overpressure of 2.5 psi was required for window failure in WTC 7. Slightly different minimum impulses were required for failure for the two window sizes considered in the analysis.

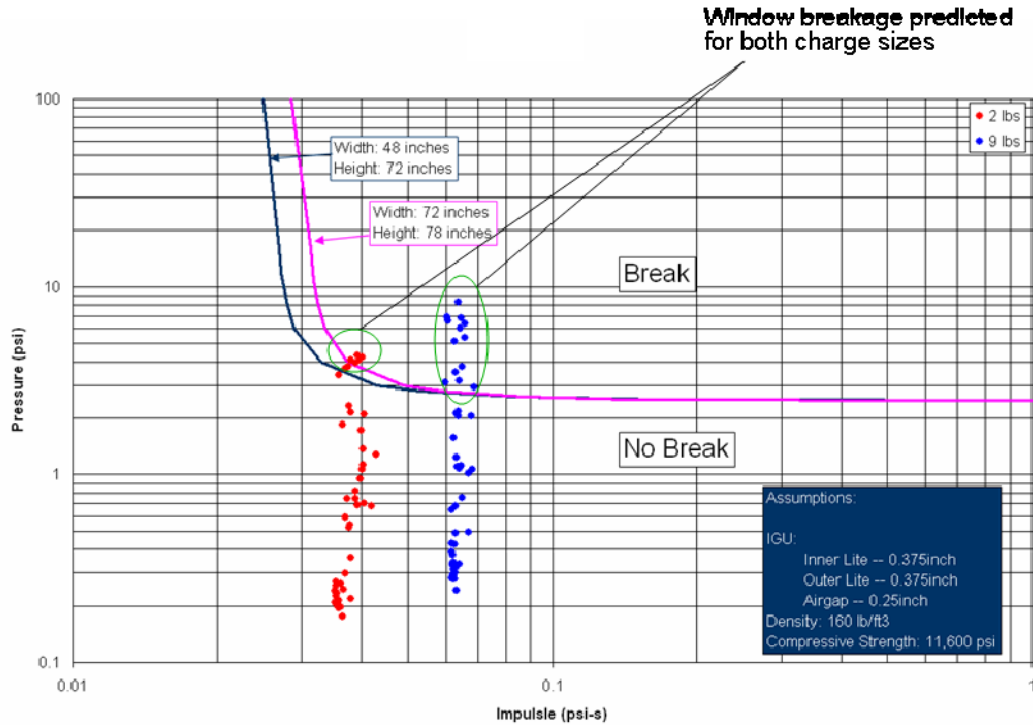
Figure D-9. Layout 2 pressure-impulse values at window locations compared to predicted failure profiles.

Key results from the Phase II blast analyses are shown in Figure D-9 through Figure D-14. Figure D-9 and Figure D-10 illustrate the predicted pressure-impulse levels at each window location around the building perimeter for Layouts 2 and 3, respectively. Two blast initiating charge sizes are shown: the minimum recommended 9 lb of RDX explosive from Phase I, and a smaller 2 lb charge to examine the sensitivity of the window breakage to charge size. The P-I values at each window location are overlaid on the predicted break/no-break criteria from the window fragility analysis conducted earlier in Phase II. Failure pressure-impulse curves are commonly used in blast analyses to illustrate system failure sensitivity to transient pressure loads.

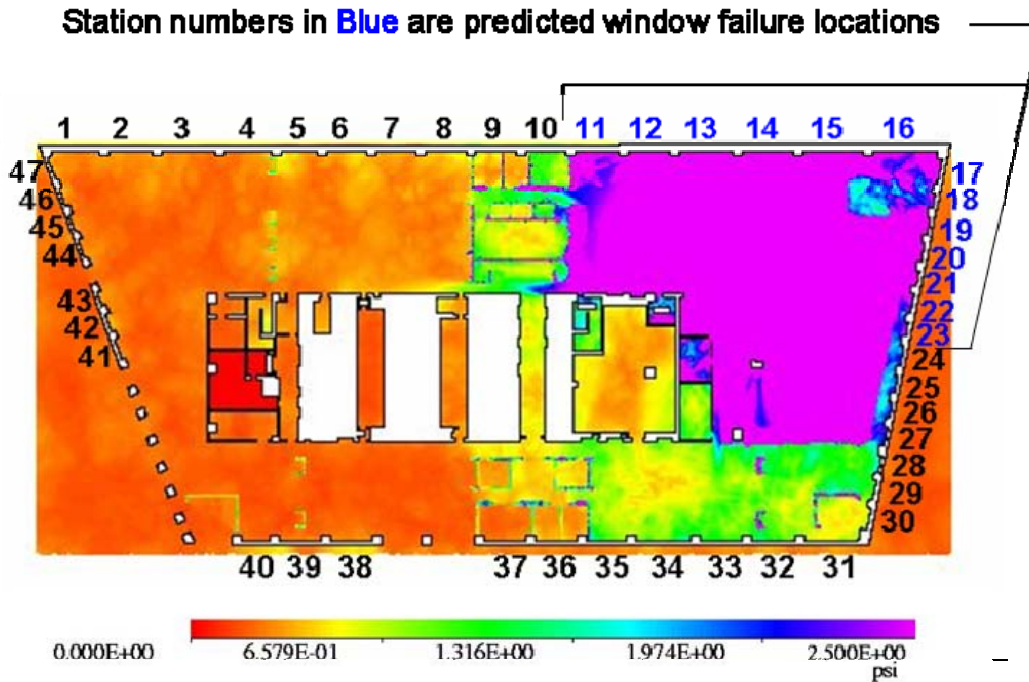
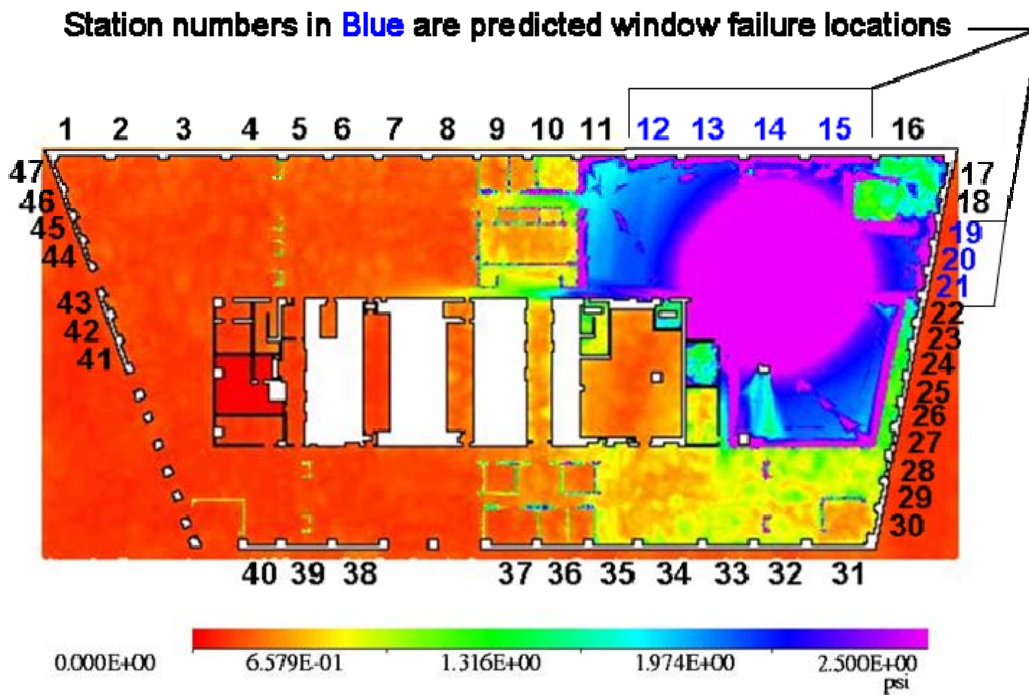
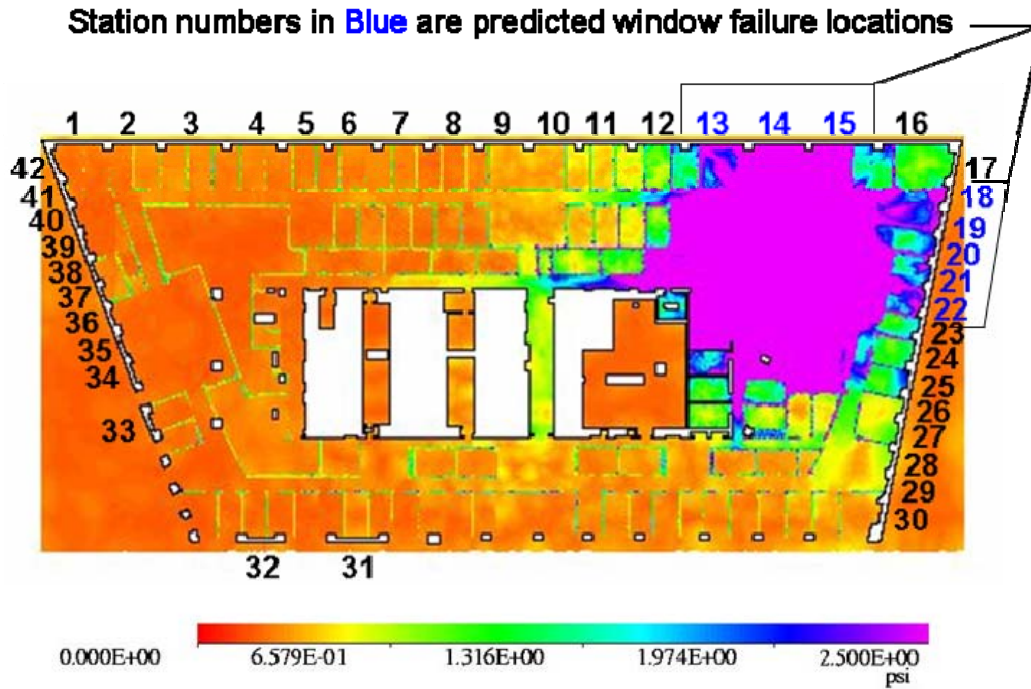
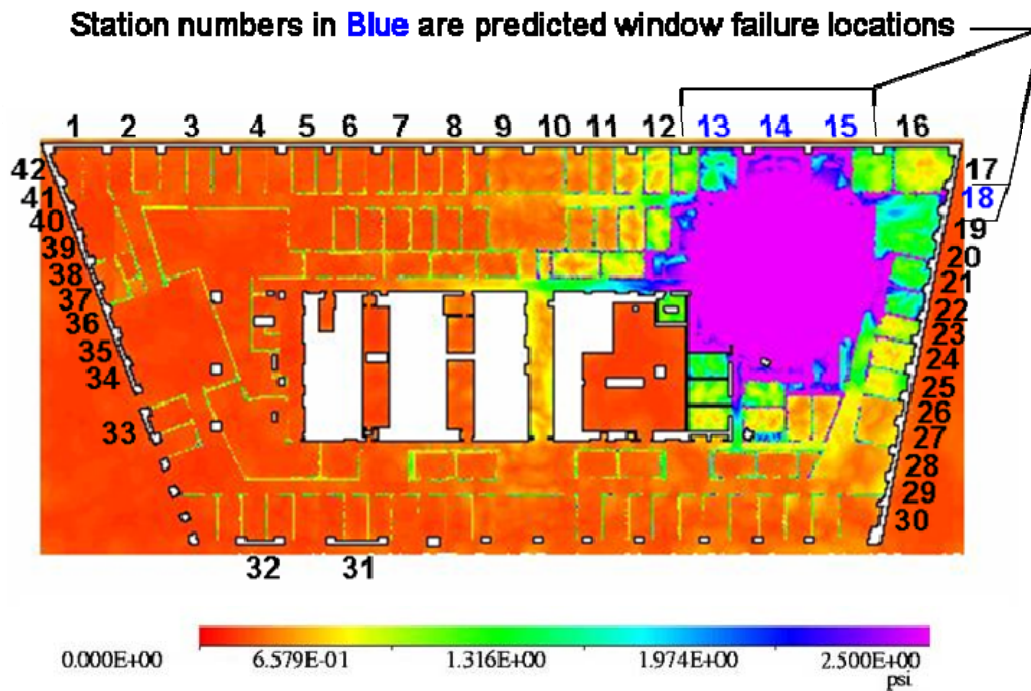
Figure D-11 through Figure D-14 show plan views of the 2-D SHAMRC results for predicted window failure locations. Contours of peak overpressure are shown, as well, to illustrate pressure propagation throughout the floor. The maximum contour value, shown as purple, was set at 2.5 psi, which corresponds to the minimum overpressure required to break a window. Any area displayed as purple experienced overpressures at or above the 2.5 psi threshold, but did not necessarily experience the minimum required impulse. Only station numbers shown in blue experienced the necessary combination of pressure and impulse to exceed the failure threshold.

Figure D-11. Layout 2 peak overpressure and broken window locations, 9 lb charge.

Figure D-12. Layout 2 peak overpressure and broken window locations, 2 lb charge.

Figure D-13. Layout 3 peak overpressure and broken window locations, 9 lb charge.

Figure D-14. Layout 3 peak overpressure and broken window locations, 2 lb charge.

As expected, the more open Layout 2 resulted in more predicted window failure locations for a given charge size, compared to the more extensively built-out Layout 3. Furthermore, the larger 9 lb explosive charge resulted in more window failures than the corresponding 2 lb charge analyses, predominantly on the east face of the building.

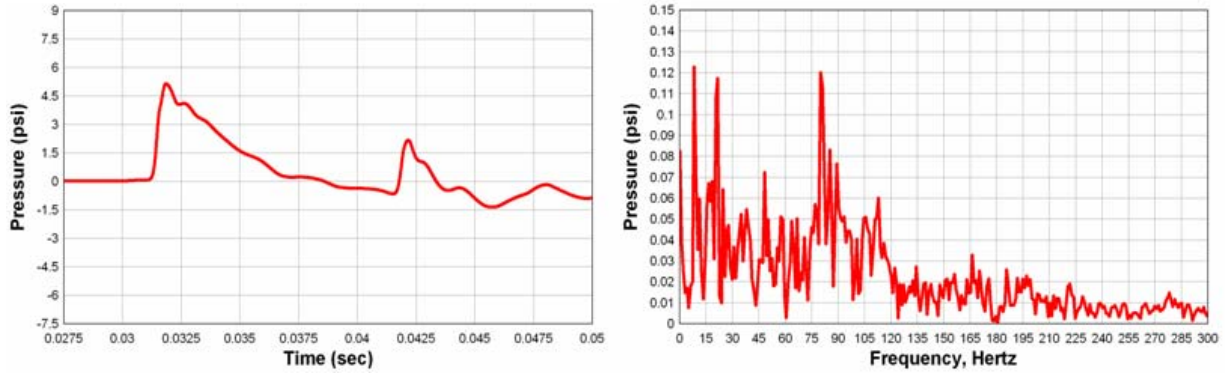
Figure D-15. Typical waveform and corresponding Fourier transformation at a broken window location.

Figure D-15 shows a typical waveform at a broken window location and its Fourier transformation. Most of the sound lies below 200 Hz. Approximately 40 Hz is the lower limit for human audible perception. In this frequency range, the blast would sound like a low rumble. Figure D-16 illustrates a typical waveform in the vicinity of the open window locations in the southwest corner.

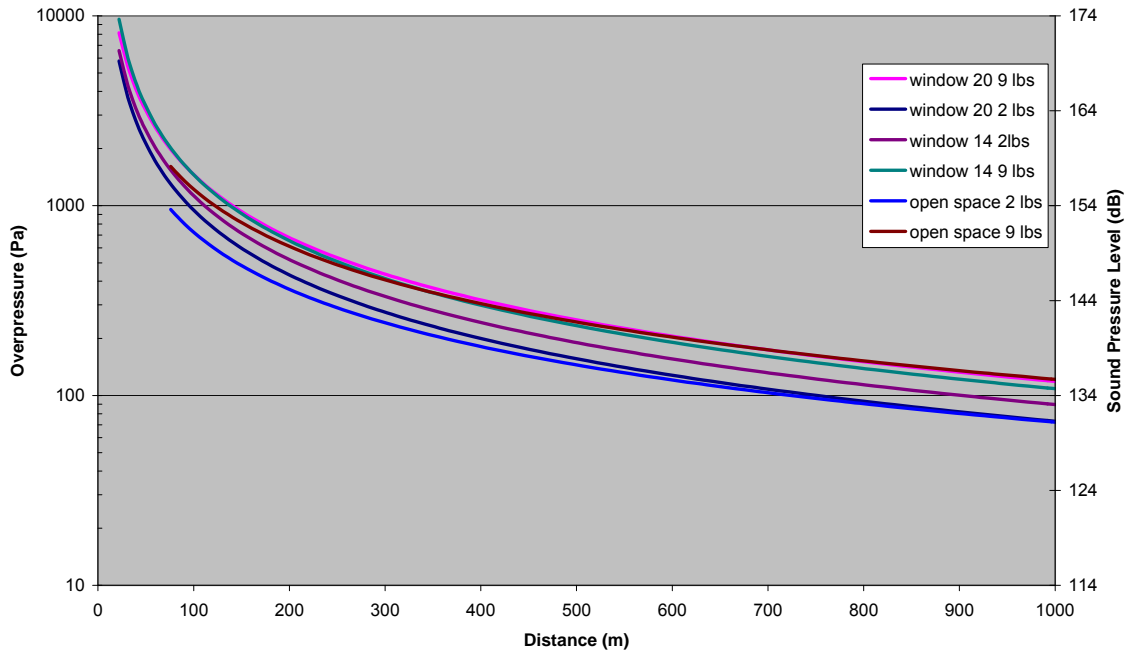
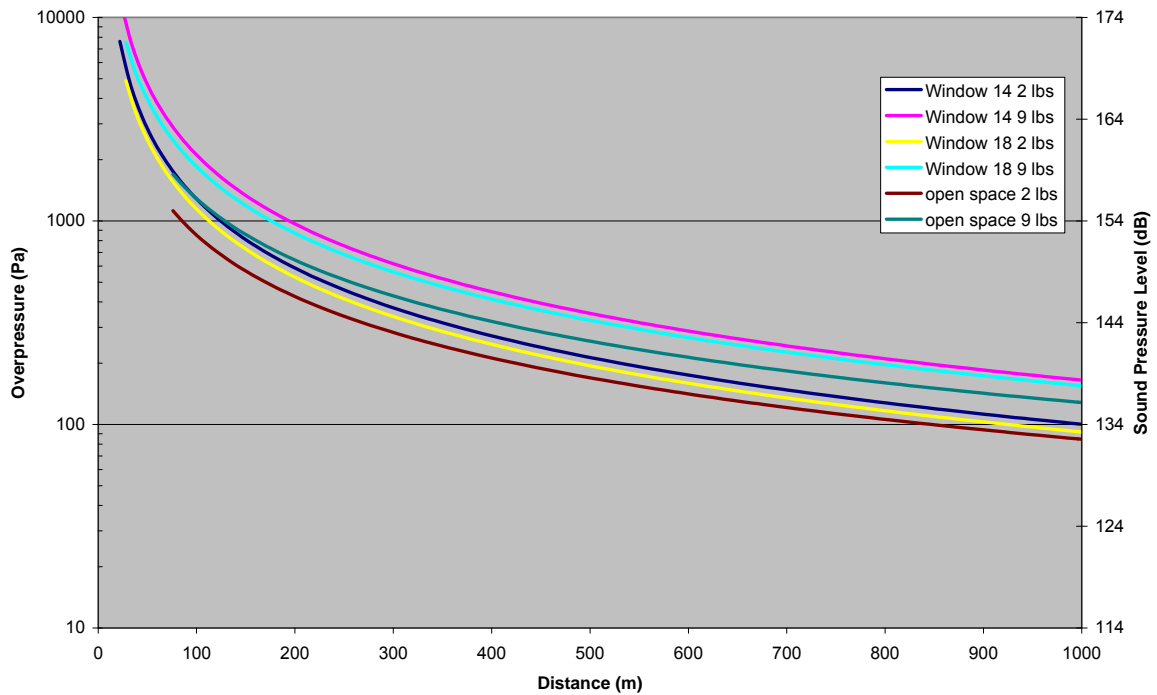
Figure D-17 and Figure D-18 show the results of the acoustic analysis for both floor layouts, in which overpressure and sound pressure level vs. distance from the opening are plotted. Intense audible sound was predicted from all building faces for all four combinations of layout and charge size. If propagation were unobstructed, as would be the case for a person standing on a street with a direct view of any WTC 7 face with open windows, the sound level from all building perimeter openings at 1 km would be approximately 130 to 140 dB. Adjacent buildings and their effect on the sound propagation was not considered in this analysis. The analysis was intended to be a simple estimate of the sound potential emanating from the building due to blast pressures.

Figure D-17. Layout 2 acoustic overpressure-distance predictions.

Figure D-18. Layout 3 acoustic overpressure-distance predictions.
